Crystallography of Stress corrosion cracking of austenitic stainless steel by scanning electron microscope and electron backscatter diffraction.

Hazem Mubarak, Sébastien Jégou*, Laurent Barrallier **

Summary

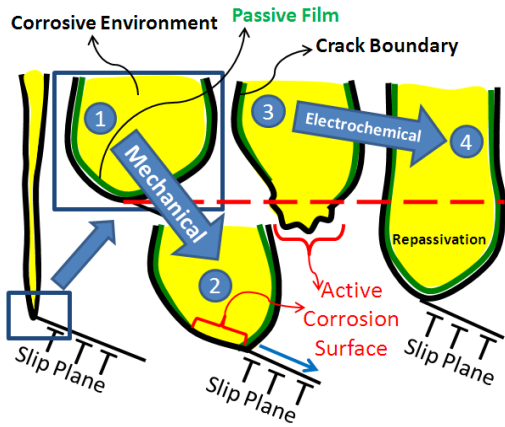
Figure 1: Representation of FRM showing a crack propagation cycle of mechanical slip (1-2), chemical dissolution (2-3), and passivation (3-4).

Film Rupture dissolution Model (FRM) describes intergranular SCC of stainless steel as a cyclic process of local surface activation by mechanical slipping and chemical dissolution of the freshly exposed surface at that location until it passivate again. The process is represented in Fig.1 and 2 [1,2,3].

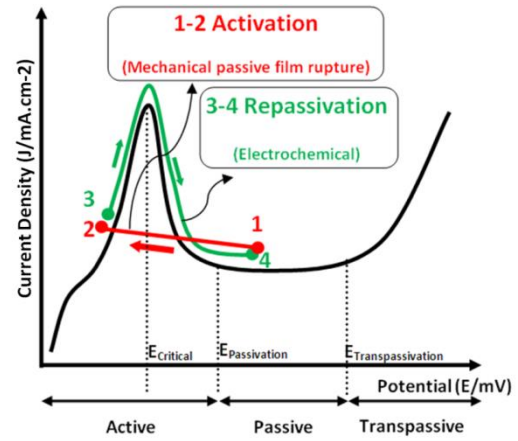
Figure 2: Stainless steel polarization curve representing an activation/passivation cycle of SCC of stainless steel.

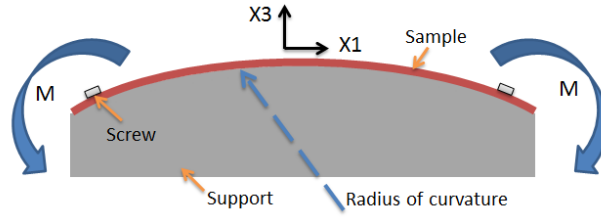
Figure 3: Side view of the support-sample assembly. Bending moment is applied to the sample resulting in a constant uniaxial stress.

To apply certain value of tensile stress, the samples were elasto-plastically deformed using curved supports having different radii of curvature, as shown in Fig.3.

By this assembly, the sample is subjected to constant bending moment by the two screws fixing it to the curved support. This creates an applied uniaxial stress on the central part of the sample. Assuming that the volume doesn't change, the sections of the sample remain flat after deformation, and the stress is uniaxial, the stress tensor is reduced to σ_1 ; where σ_2 and σ_3 are negligible, and σ_{12} and σ_{23} are zero.

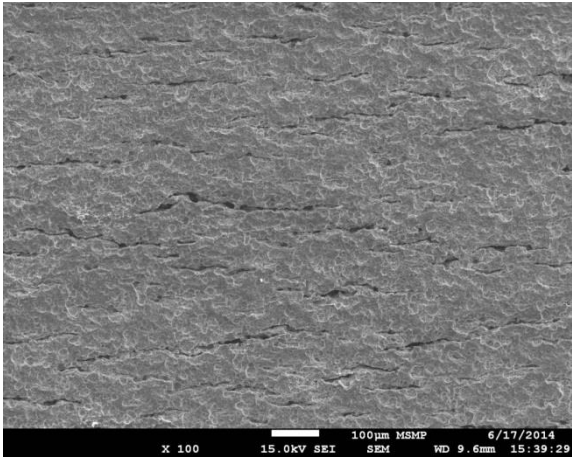
Figure 4: Upper surface, $\epsilon = 0.16\%$.

The topography of the upper surface and the cracks profiles has been observed by SEM. Fig.4-5 show the resulting images.

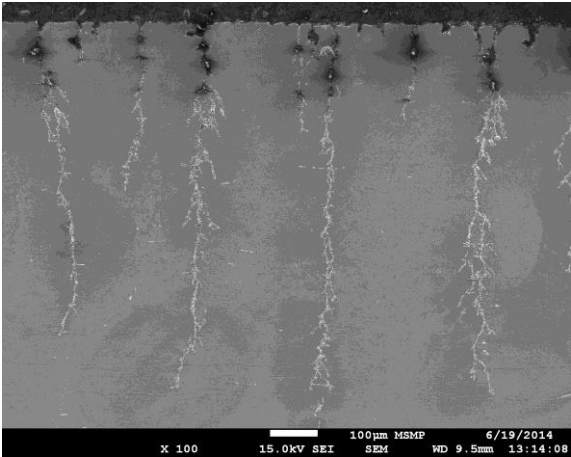
Figure 5: Cross section, $\epsilon = 0.16\%$.

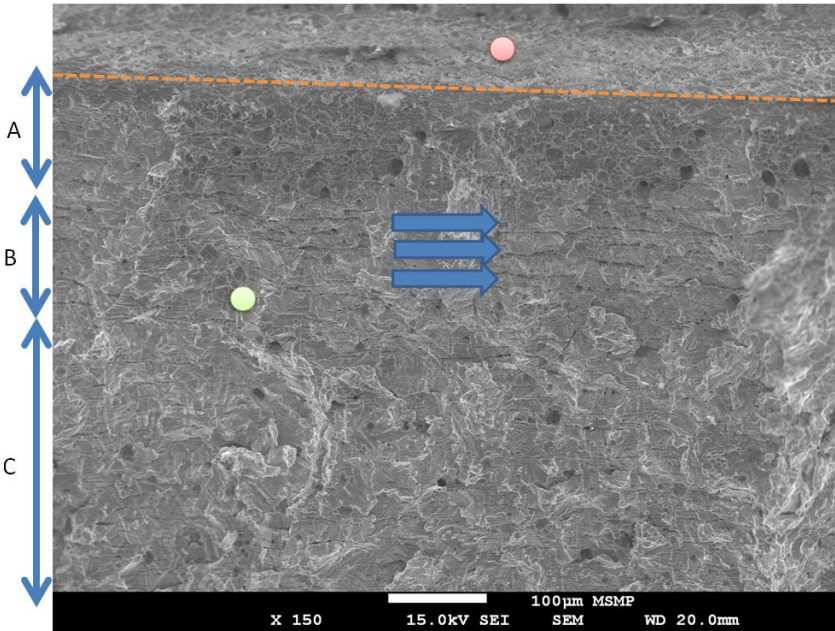
Figure 6: The crack facet of , $\epsilon = 0.16\%$, 21-day immersion SCC test.

Since the produced cracks were very well developed in the depth of the sample, characterising the crack fractography of the produced cracks was of interest. For this, the sample of R500 was chosen. One of the cracks was open such that SEM analysis can be made for its facet. Fig.6 below shows the crack facet as marked by the green circle, below the dashed line. The surface with the pink circle is the sample's upper surface.

Fig. 6 shows different corrosion regimes. Regime “A” corresponds to an aggressive corrosion after the crack propagation over the entire experiment. Following this is regime “B” where the three parallel lines indicated by the arrows in Fig.6 are traces of the step wise mode of crack propagation. This might correspond to locations of slip system activation, followed by dissolution of freshly exposed surface. This stands as evidence in favor of the FRM, as described in Fig. 1 and 2. Such results were found by [12]. The last regime is “C”, which represents the rapid propagation of SCC, where the cracks have grown to make large decohesive crack coalesce with cleavage and fluting features. Such results were found by [13,14]. Fig.6 helps identify these regimes on the cross-section. This cracking behavior is in agreement with cracking kinetics described by [15].

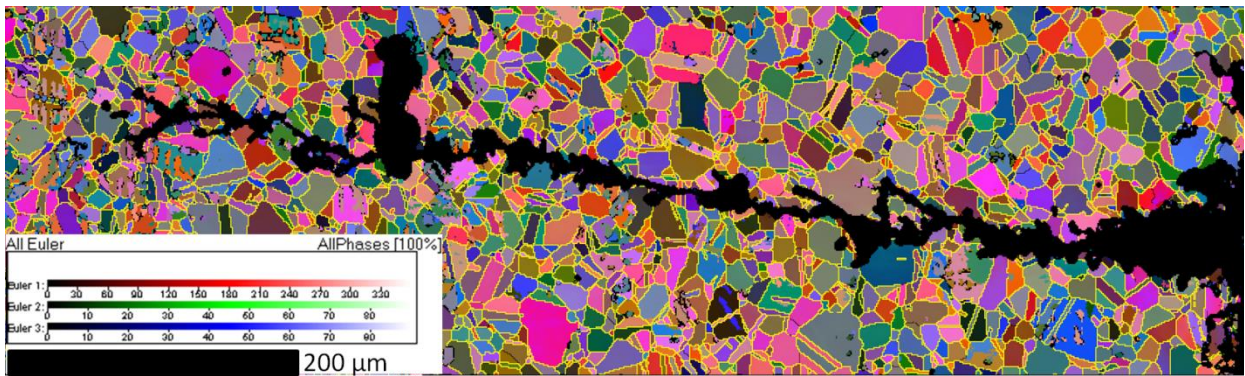
Figure 7: EBSD map of crystallographic orientation around a SCC, $\sigma = 245$ MPa sample.

Three cracks were selected to be analysed in this section. The orientation map shown in Fig.7 is one of them. This is related to $\sigma = 245$ MPa applied stress sample.

Having the EBSD map for the crystallographic orientation of the grains made it possible to analyse the cracking planes. The interest was to check if the cracking plane has any crystallographic features. Thus, the ruptured grains were isolated. From the crack path, a line is chosen representing the top view of the cracking plane. An assumption is made here is that this plane is perpendicular to the sample cross-sectional plane. To verify if this assumption is valid, step-wise polishing was

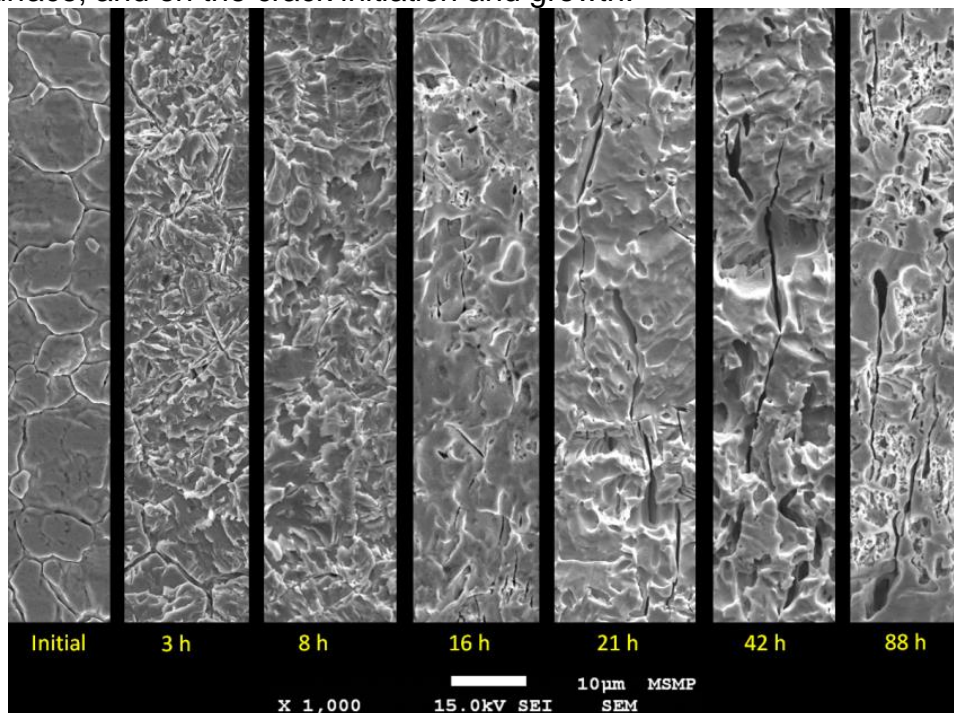
Figure 8: SCC evolution with time on the upper surface, $\sigma = 210$ MPa.

For the different tests performed here, the upper surface and cross section were observed using SEM imaging. Fig.8 shows the evolution of corrosion with time on the upper surface, and on the crack initiation and growth.

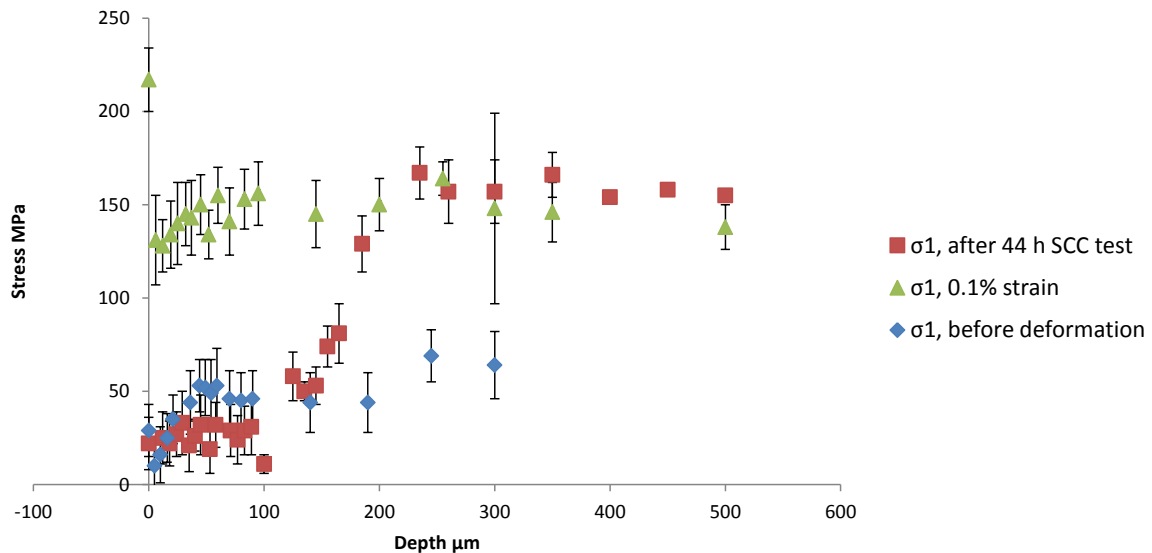
Figure 9: XRD residual – applied profile stress analysis over the sample's depth.

The XRD analysis over the sample depth profile gave the curves indicated in Fig.9. The crude metal sheet shows to have residual stresses due to manufacturing processes. The effect of the applied stress is very pronounced on the curve representing the sample after deformation.

From the obtained stress profiles, we see that the metallic sheet used in these experiments has an initial residual tensile stress. This stress is probably due to manufacturing processing, such as rolling. The average of the measured stress on the surface was 33 MPa. The sample was deformed using the support of 800 mm radius. For the deformed sample, the same measurements were made on the upper surface giving a stress value equals to 213 MPa. This value of stress represents the elastic limit of the material in hand, and it confirms the theoretical calculation made by eq.4 corresponding to this amount of deformation.

The interest was to measure the stress value after the SCC test. The average crack length for this period of SCC test is about 95 μm , and the maximum possible crack length is about 175 μm . This is directly reflected on the measured stress profile over the sample's depth. From the upper surface (depth = 0) to the point at 100 μm , the stress falls to a close value to the initial residual stress in the bulk of the material. And starting from this point, the measured stress starts to increase gradually with depth. This gradual increase stops at depth equals to 175 μm , after which the stress profile shows a platform until 500 μm depth representing the applied stress value. This is clarified in table 3.
