Hortense LAEUFFER, Brice GUIOT, Jean-Christophe WAHL, Florian LAVELLE, Christophe BOIS, Nicolas PERRY - Relationship between damage and permeability in liner-less composite tanks : experimental study at the lamina level - In: European Conference on Spacecraft Structures, Materials and Environmental Testing, France, 2016-09 - Proceedings of the European Conference on Spacecraft Structures, Materials and Environmental Testing - 2016

RELATIONSHIP BETWEEN DAMAGE AND PERMEABILITY IN LINER-LESS COMPOSITE TANKS: EXPERIMENTAL STUDY AT THE LAMINA LEVEL

ABSTRACT

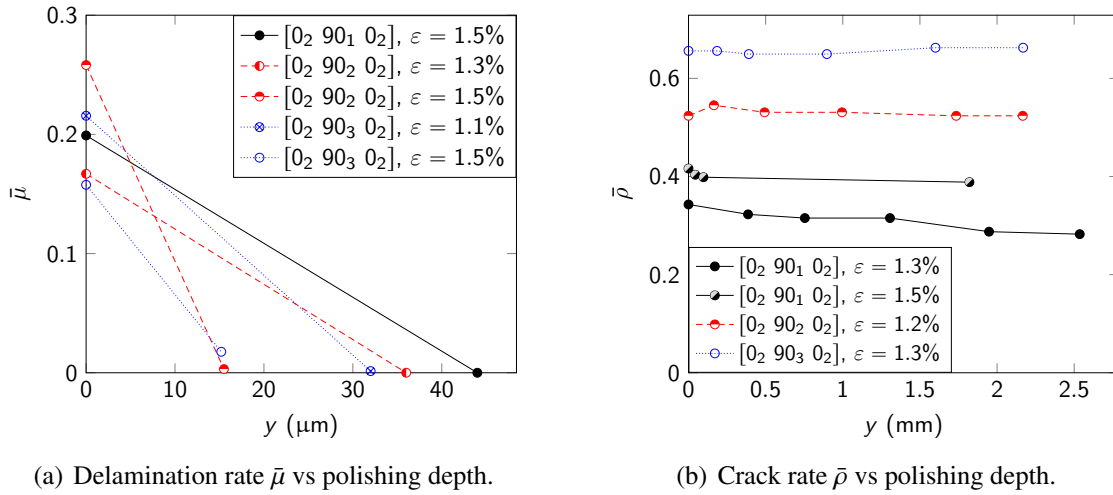
Fig. 5. Damage rates with respect to the polishing depth y after the transverse strain ε was applied.

The $[+45/-45]_{2s}$ layup was subjected to transverse strains up to $\varepsilon_{12} = 4\%$, polished and then observed. For the highest strain and after removing 1.5 mm, only a few transverse cracks remained in the central (and double) ply and in external plies. Deeper, after removing 3 mm of the surface, no crack remained at all. To exclude the eventuality of cracks being too closed to be observable, the sample was observed under loading. The results demonstrates that no transverse cracks nor micro-delamination occur in the bulk under shear load. This phenomenon can be due to the use of a toughened matrix (M21) with thermoplastic nodules. For another material, e.g. with a more fragile matrix, delamination would likely be lower in bulk than at the surface but may persist in bulk. Although no meso-damage is observable, this layup nevertheless undergoes irreversible strains and stiffness loss due to diffuse damage at the micro (fibre) scale. However, if shear loading alone does not lead to transverse cracking in this material, the shear component associated to a tensile loading will likely contribute to crack growth. This contribution may require additional testing on other layups.
