Pascal POMAREDE, Fodil MERAGHNI, Laurent PELTIER, Stéphane DELALANDE, Nico Felicien DECLERCQ - Damage Evaluation in Woven Glass Reinforced Polyamide 6.6/6 Composites Using Ultrasound Phase-Shift Analysis and X-ray Tomography - Journal of Nondestructive Evaluation - Vol. 37, p.12 - 2018

Damage Evaluation in Woven Glass Reinforced Polyamide 6.6/6 Composites Using Ultrasound Phase-Shift Analysis and X-ray Tomography

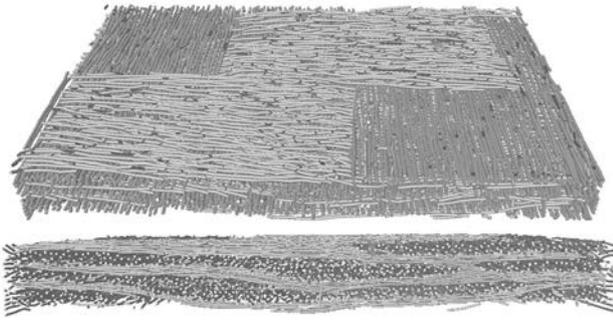
Fig. 1 Overall 3D mesostructure of the studied composite consisting of 2/2 twill weave fabric reinforced polyamide 6.6/6 matrix

The composite material considered for this study is referenced as VizilonTM SB63G1-T1.5-S3 and is manufactured by DuPont. The studied composite is produced by a thermo-compression molding process and it consists of a 2/2 twill weave glass fabric reinforced co-polyamide 6.6/6, with three plies, of 1.53 mm thick in total. The overall 3D woven fabric of the studied composite material is shown in Fig. 1. The

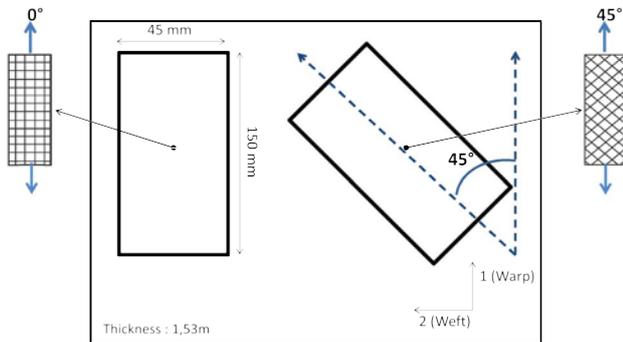
Fig. 2 Position of the samples oriented at 0° and 45° with respect to the warp direction assumed as the mold flow direction of the composite plate

weight fiber content is 63% corresponding to a fiber volume fraction of 43%. Ten samples are cut in rectangular plate of 45 mm length and 150 mm width. Four samples are cut at 45° with respect to the warp direction (mold flow direction) and six other ones are cut along the warp direction. The orientations of these two sets of samples are indicated in Fig.

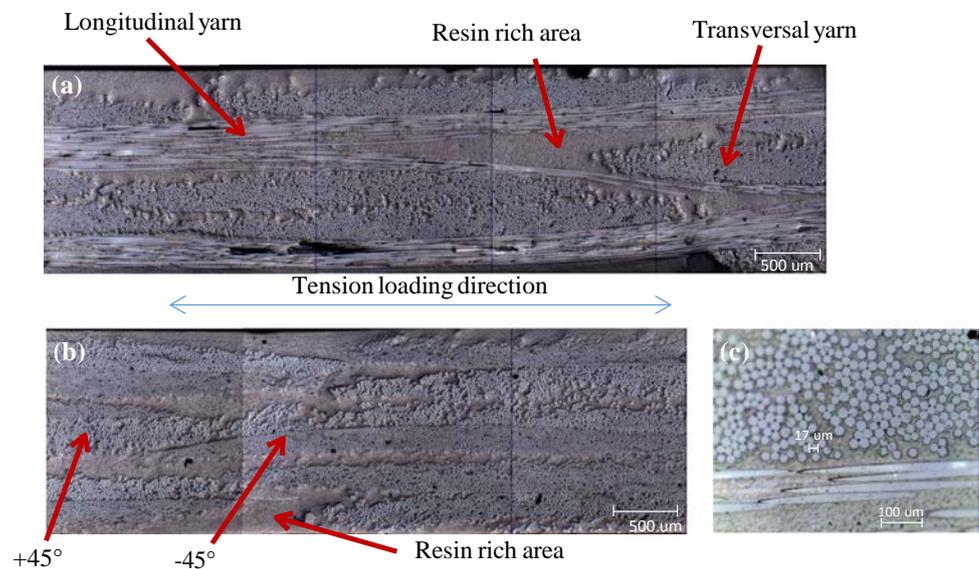
Fig. 3 Cross-sectional observation with optical microscope of the 2/2 twill weave fabric reinforced polyamide composite microstructure for samples oriented at 0° and 45°. **a** 0° sample, **b** 45° sample and **c** Zoom-in on a sample's yarns in the 0° orientation

2. The two different microstructures can be observed in the Fig. 3. All the samples are stored in a humidity chamber in order to have the same initial conditions in terms of relative humidity. The latter is set at a level of 50% for all tested composite material. Initial tensile tests are performed on the material until failure for both 0° and 45° sample configurations. The experimental stress/strain curves are normalized with respect of the tensile ultimate strength of the 0° sample configuration.

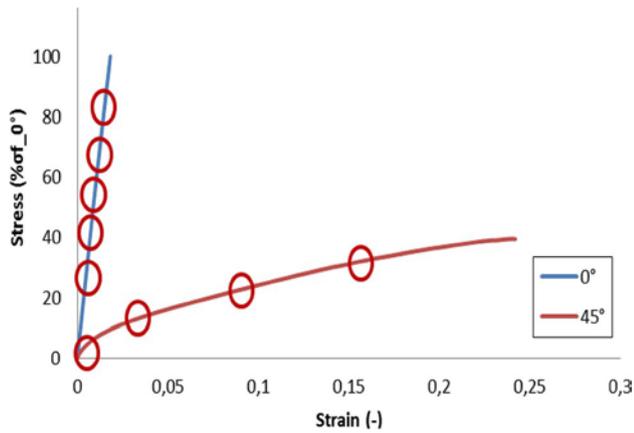
Fig. 4 Typical stress/strain responses of the 2/2 twill weave fabric reinforced polyamide composite under tension at 0° and 45° . The red circles show schematically where the tensile tests have been interrupted for both tested configurations

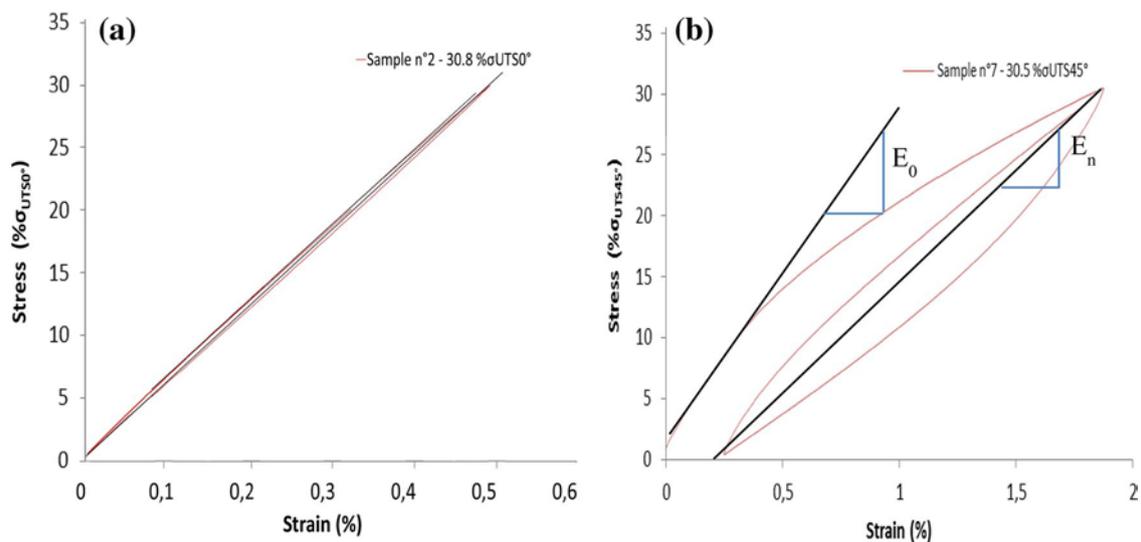
Fig. 5 Schematic representation of the elastic moduli estimation of the of E_0 and E_n for respectively **a** 0° and **b** 45° configuration samples

culated after the unloading according to a common damage measurement procedure [17]. A representation of the elastic moduli calculation is depicted in Fig. 5a, b for the two tested sample configurations.

As shown in Fig. 5, a noticeable difference is observed between the overall stress-strain responses of the two configuration samples, namely 0° and 45° . In fact, for the samples tested at 0° , the behavior in tension is mostly linear and brittle since it is governed by the fiber breakage whereas the behav-

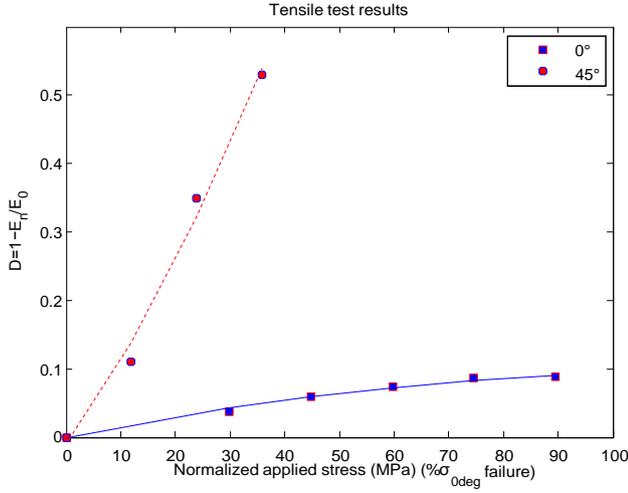
Fig. 6 Evolution of the the damage for 0° and 45° sample's configurations. The damage is estimated from the Young's modulus reduction for different applied stress levels

This is particularly clear for the evolution of the damage estimated on the elastic modulus reduction when the applied stress increases, as illustrated in Fig. 6. For the samples oriented at 45° from the warp direction, the damage D reaches a value of 0.53 close to the final failure. However, for the 0° case, it only goes up to 0.1. The values of damage for every tested sample are summarized in Table 1. This damage estimation is employed as a first reference to validate the proposed ultrasonic damage indicators detailed in further sections. Indeed, as discussed, Fig. 6 indicates a higher amount of damage induce by the loading for the 45° configuration, which could imply different damage mechanisms with different associated typical scales. In fact, to investigate the sensitivity of the ultrasonic techniques, it is necessary to consider different scales of induced damage. Hence, the typical scale of those mechanisms for the two sample configuration requires further study.

The evolution of the void volume fraction as a function of the applied stress level (Fig. 12c) exhibited a similar increase as the evolution of the macroscopic damage estimated from the Young's modulus reduction plotted in Fig. 6. Accordingly, these two quantitative estimations of the damage state, namely void volume content and Young's modulus reduction will be two actual measurements of the damage that validate the proposed new damage indicators.

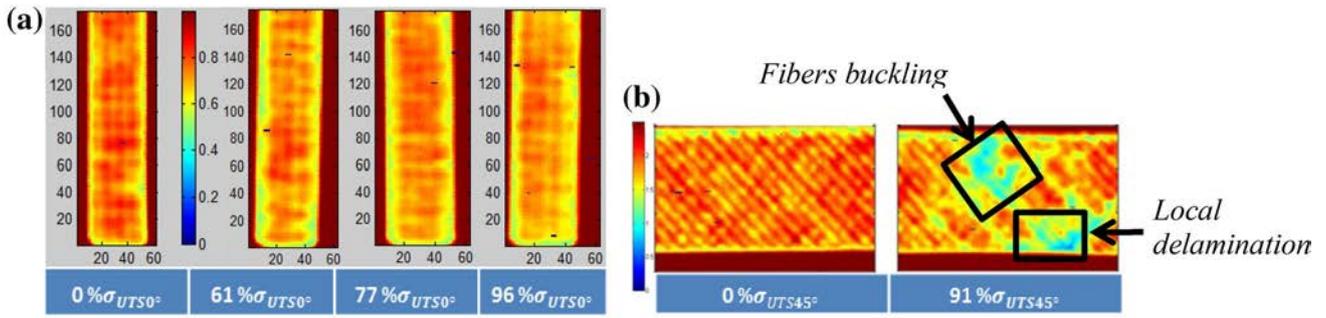
Fig. 7 Preliminary C-scan results on 2/2 twill weave fabric reinforced polyamide composite previously loaded in tension with different amplitude. **a** Samples in 0° configuration; **b** Samples in 45° configuration. For the latter, besides the large damage zones, one can easily distinguish the 45° orientation of the yarns

7a related to the samples tested at 0° from the warp direction, the attenuation of the ultrasound amplitude's signal remains low and a very slight difference, if any, was noticed when increasing the applied stress level from 0 to 92.6% σ_{UTS0} .

For the sample in 45°, the Fig. 7b shows the evolution of amplitude attenuation (C-scan images) between the unloaded state and the ultimate state level prior failure (92.6% σ_{UTS45}). Two damage zones were actually observed macroscopically and the related high attenuations in the signals were associated to the fibers buckling and the local delamination. In addition, the low signal attenuations observed at the border of the samples were clearly induced by a well-known border effect and were not caused by the mechanically induced damage.

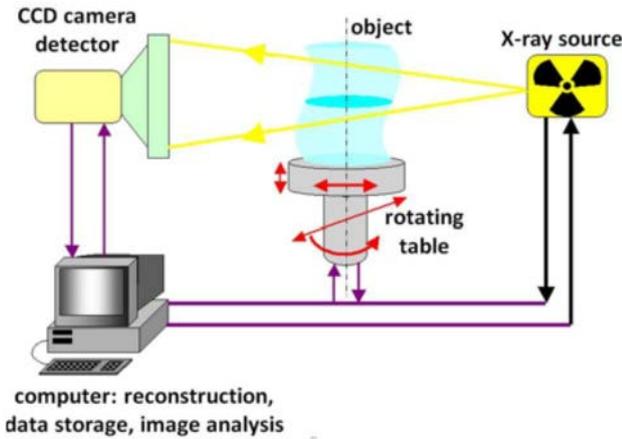
Fig. 8 Principle of the X-ray micro computed tomography techniques [22]

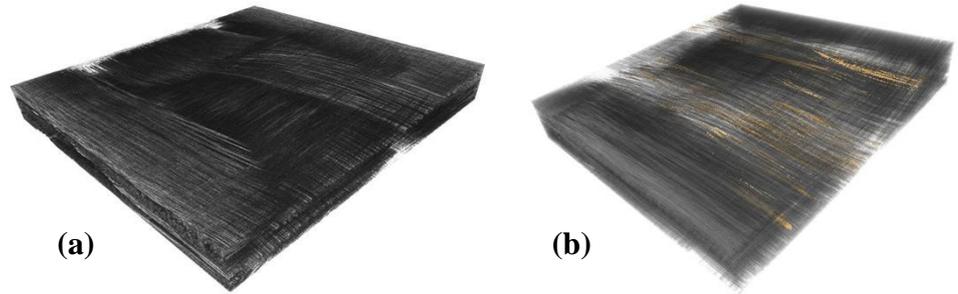
Woven 2/2 twill fabric

Fig. 9 a As received mesostructure of the 2/2 twill weave fabric obtained by 3D reconstruction prior to mechanical loading. **b** Initial voids and process-induced defects are represented by light color and their content is estimated using Avizo software segmentation (about 0.6% volume)

The matrix and the fibers of the composite are characterized by distinctive values of X-ray absorption. Hence, they can be easily separated on a grey level map. Air cannot significantly absorb X-ray. Consequently, the voids cannot be easily observed inside the composite samples, however during the image 3D-reconstruction, the voids appear as completely black volumes. A median filtering was first applied to the raw results to reduce the amount of noise in the images. A despeckle filter was then applied to remove the main part of the remaining interference noise. The different reconstructions were then segmented in three classes (void, matrix and fibers) using a grayscale thresholding. The Avizo software segmentation enables an accurate estimation of the volume fraction of each of the three phases. Figure 9 illustrates an

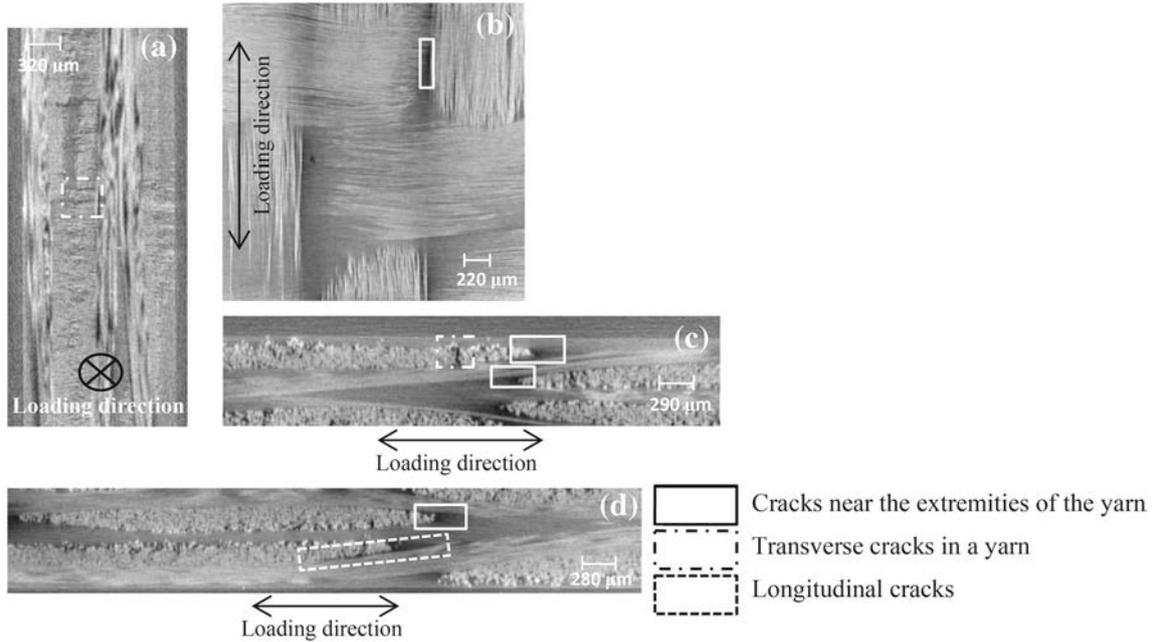
Fig. 10 Three main damage mechanisms identified for 0° sample configuration under tension loading. These main mechanisms consist in cracks near the extremities of the yarns, transverse cracks in yarns and longitudinal cracks

Some examples of damage mechanisms observed for samples in the 0° configuration are illustrated in Fig. 10. For tensile tests along the warp fiber axis, the main damage mechanisms observed were the formation of cracks near the end of the yarns (Fig. 10b, c, d), and transverse cracks inside the yarns (Fig. 10a, c), for example). Some longitudinal cracks that follow the transverse yarns very locally in the last step of damage were also observed (Fig. 10d). As the loading level increased, the number and the size of defects (cracks and voids) increased too (Tables 3, 4).

The crack inside the yarns has a characteristic thickness of 20 μm, which is of the order of magnitude of the size of the fibers. Indeed, it is worth noting that those cracks are caused by fiber/matrix debonding, which propagates perpendicularly to the loading direction from one fiber to another. The cracks at the extremities of the yarn have a typical thickness

of $50 \mu\text{m}$ for the highest damaged samples. These longitudinal cracks can then propagate along the warp yarns as shown in Fig. 10d.

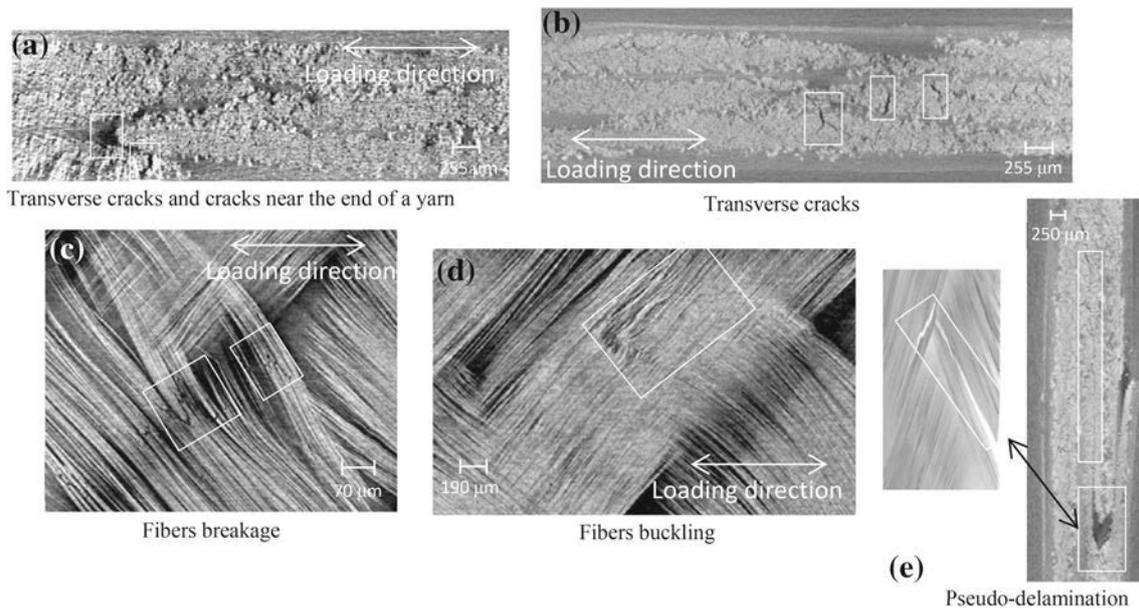
Fig. 11 The different damage mechanisms that appear when a sample in the 45° configuration is submitted to tension. These mechanisms consist in transverse cracks, cracks at the extremities of the yarns, fiber breakage, fiber buckling and yarns pseudo-delamination due to the propagation of the longitudinal cracks

For samples in the 45° configuration, all the observed mechanisms are shown in Fig. 11. Firstly, cracks at the extremities of yarns (visible in Fig. 11a) as well as cracks along the yarns were observed in Fig. 11a, b. On the $91.6\% \sigma_{UTS45^\circ}$ loaded sample many local fiber breakages were also observed, some of them were already visible in Fig. 11c for the sample tested at $61.1\% \sigma_{UTS45^\circ}$. Those defects were observed around the central region of the sample, along the loading direction, especially near the edges. In Fig. 11d, some micro buckling

of fibers was noted, more notably in the sample loaded at the highest stress level. This is due to the reorientation of fibers during the loading test. Indeed, as the load increases the angle between the fibers tends to decrease but when the tension is interrupted, the fibers cannot return to their original position because of the section reduction caused by the Poisson effect. This effect of the fibers' reorientation during off-axis loading was also observed by Vieille and Taleb [23] among others. Pseudo-delamination also appeared locally after roughly $60.1\% \sigma_{UTS45^\circ}$ of loading in some specimen, as visible in Fig. 11e. It was propagated inside a yarn and followed the fiber orientation until it reached the location where the weft and warp yarns were intertwined together. When the stress level continued to increase, the crack turned and started propagating along the direction of the other yarn.

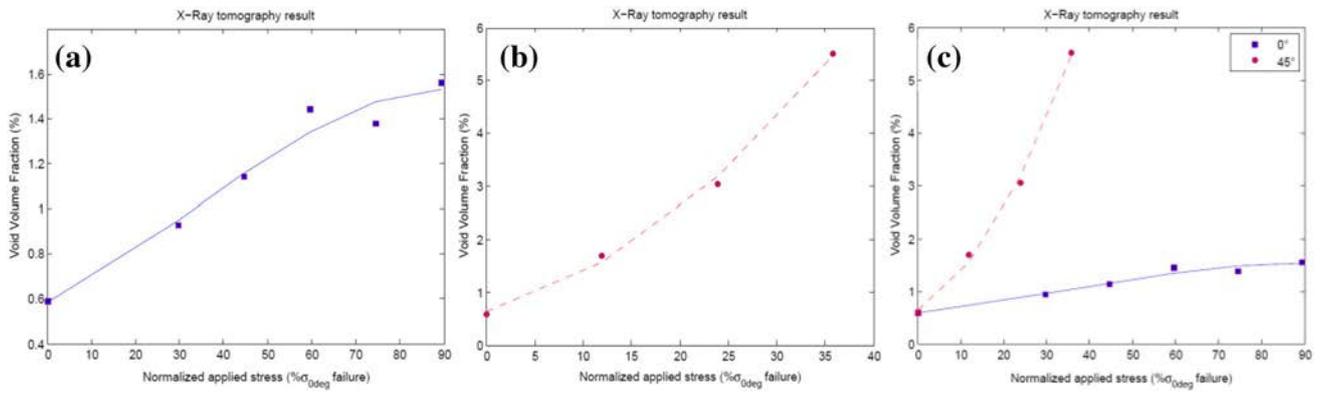
Fig. 12 Evolution of void volume fraction for **a** 0° and **b** 45° configuration of sample with increasing loading. In **c** data of both configurations are plotted for comparison purpose

The evolution of the void volume fraction is plotted for both orientations in Fig. 12. The experimental data 0° and 45° configurations are plotted as function of the stress to failure of the 0° sample (respectively Fig. 12a, b). The Fig. 12c allows an easy comparison of the two results.

The void volume fraction clearly increased with the tension loading level for both considered orientations. However, a higher growth of damage in the set of samples oriented at 45° from warp direction was observed. In fact, for the samples oriented at 0° and loaded at $92.6\% \sigma_{UTS0^\circ}$, a void volume fraction of 1.56% was measured as it can be seen on the mCT-3D reconstruction in Fig. 13. On the other hand, as shown in Fig. 14, for the sample tested at 45° for a stress level of $91.6\% \sigma_{UTS45^\circ}$, the estimated volume void content was about 5.51% . These results are in agreement with the difference in terms of the behavior between the two sample's orientations discussed in Sect. 2. Indeed, the overall response of the 45° samples was more ductile compared to the behavior of a sample tested at 0° , which exhibited a linear elastic brittle behavior.

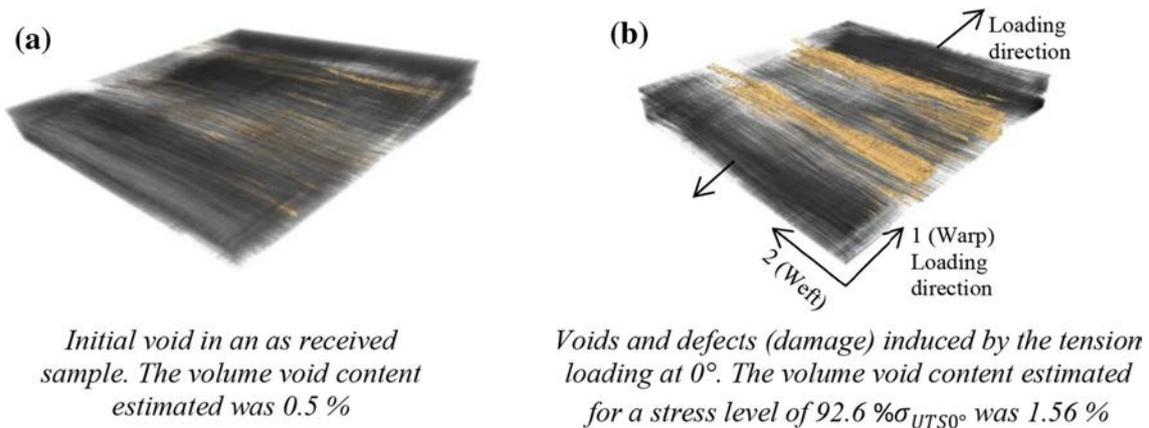
Fig. 13 mCT-3D reconstructions of composite samples in the 0° configuration respectively **a** before and **b** after tensile loading at a stress level of $92.6\% \sigma_{UTS0^\circ}$

Qualitatively, Fig. 13b shows a clear preferred orientation of the damage accumulation, which is perpendicular to the

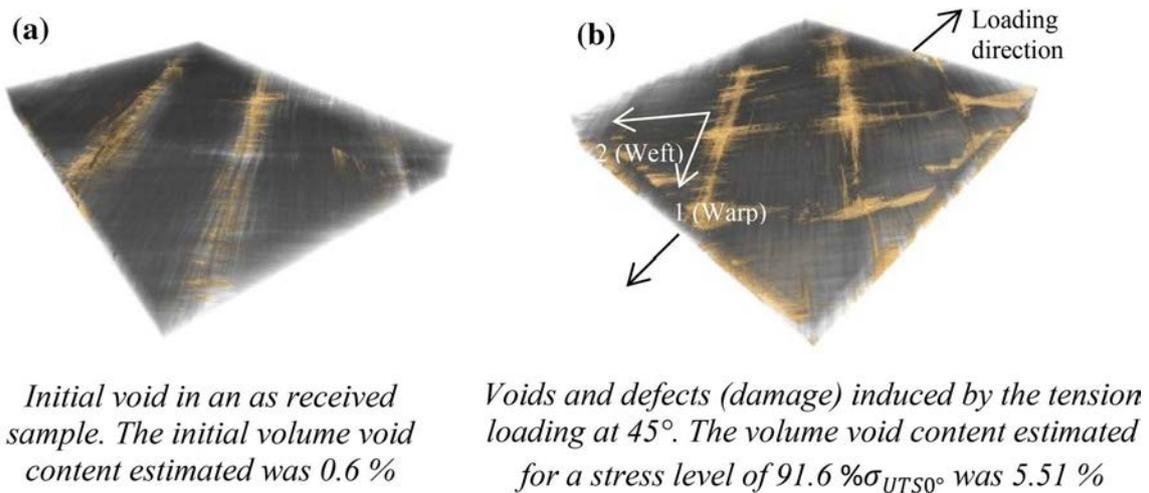
Fig. 14 mCT-3D reconstructions of composite samples in the 45° configuration respectively **a** before and **b** after tensile loading at a stress level of $91.6\% \sigma_{UTS0^\circ}$

tension loading direction for the samples oriented along the warp direction (0°). In the case of the 45° samples, the cracks grow along the two yarns direction as visible in the Fig. 14b.

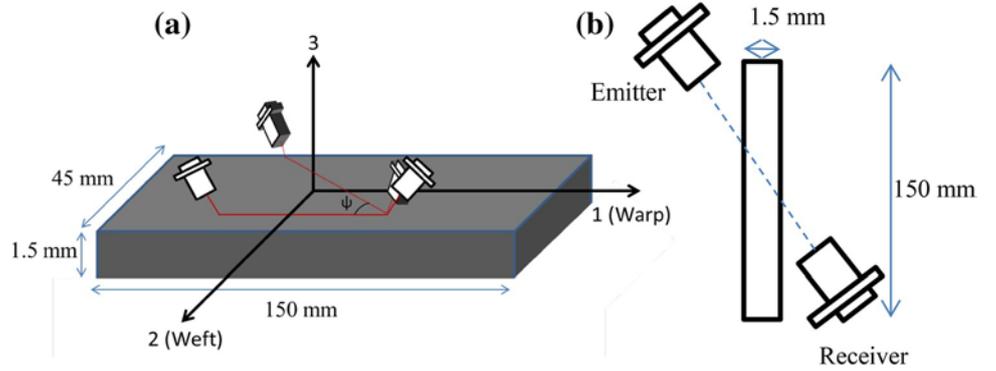
Fig. 15 Schematic representation of the two planes of interest: **a** the plane 1–2 or azimuth plane and **b** the plane 1–3

The composite is considered as orthotropic prior to loading and remains so even after the damage induced by the tensile loading. The elastic linear behavior of the composite can be described using nine stiffness components. However, considering the dimensions of the sample, only measurements in two principal planes were performed as illustrated in Fig.

15. These measurements only permitted obtaining seven out of nine stiffness components. It was observed that along the plane 1–3, quasi longitudinal and quasi transversal mode 1 can be measured. For the plane 1–2, on which guided waves propagate, the frequency and phase velocity of the transmitted signal was measured. Consequently, after comparison with the dispersion curves in Fig. 16, the mode S2 was propagating in the composite.

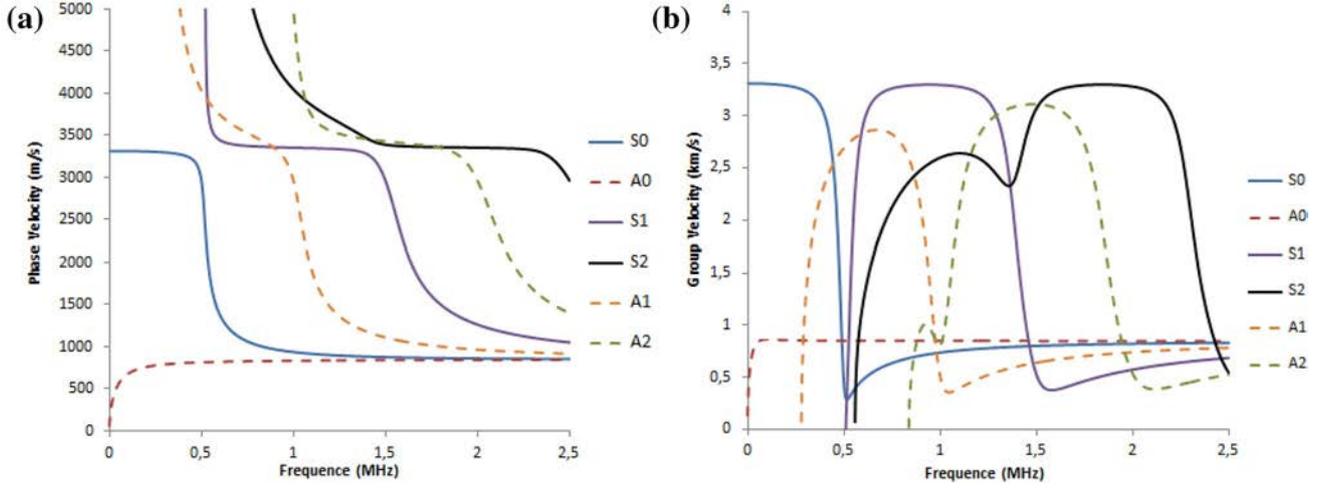
Fig. 16 Dispersion curves computed with the *Disperse software* for guided wave propagation in a 1.53mm thick studied composite along the fibers direction. **a** Phase velocities, **b** group velocities

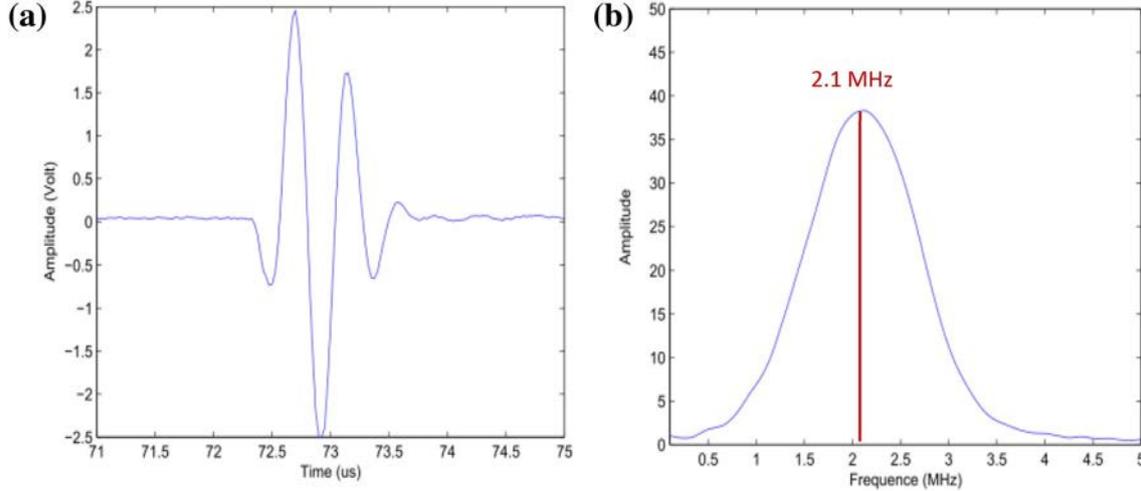
Fig. 17 a Emitted pulse signal and spectrum b for a 2.25 MHz center frequency transducer. The experimentally measured center frequency is about 2.1 MHz

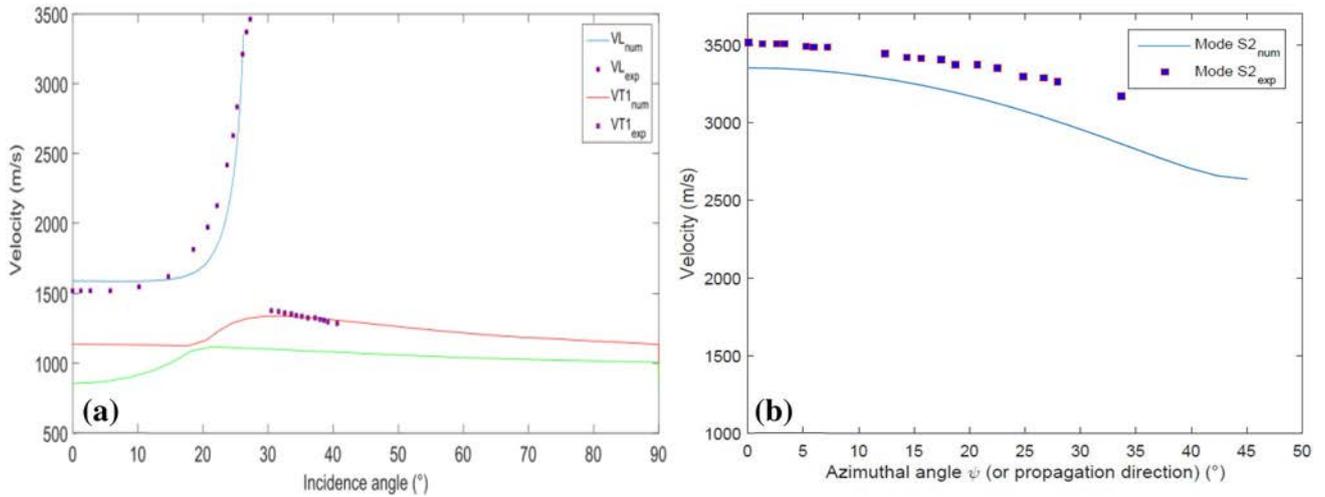
Fig. 18 Comparison of numerically and experimentally determined propagation wave velocities. The experimental values are represented by points whereas numerical values are represented in continuous line. **a** Plane 1–3; **b** Plane 1–2 or azimuth plane

Before running the optimization procedure for obtaining the stiffness constants, a computation of the expected velocity as a function of the incidence angle was performed. The quasi longitudinal, the quasi transversal 1 and the quasi transversal 2 modes propagated in the 1-3 principle plane were calculated for a refraction angle ranging from 0 to 90°. This computation was based on the stiffness matrix obtained by periodic

homogenization (Table 5). The computed velocities were compared to those obtained experimentally for the undamaged sample. The same calculation was made for Lamb wave propagation in the 1-2 planes, more particularly for the S2 mode. The comparison of experimental and analytical velocities of wave propagation is illustrated in Fig. 18. It confirms that the mode experimentally measured corresponds to the actual wave mode that was assumed to propagate in the composite material.

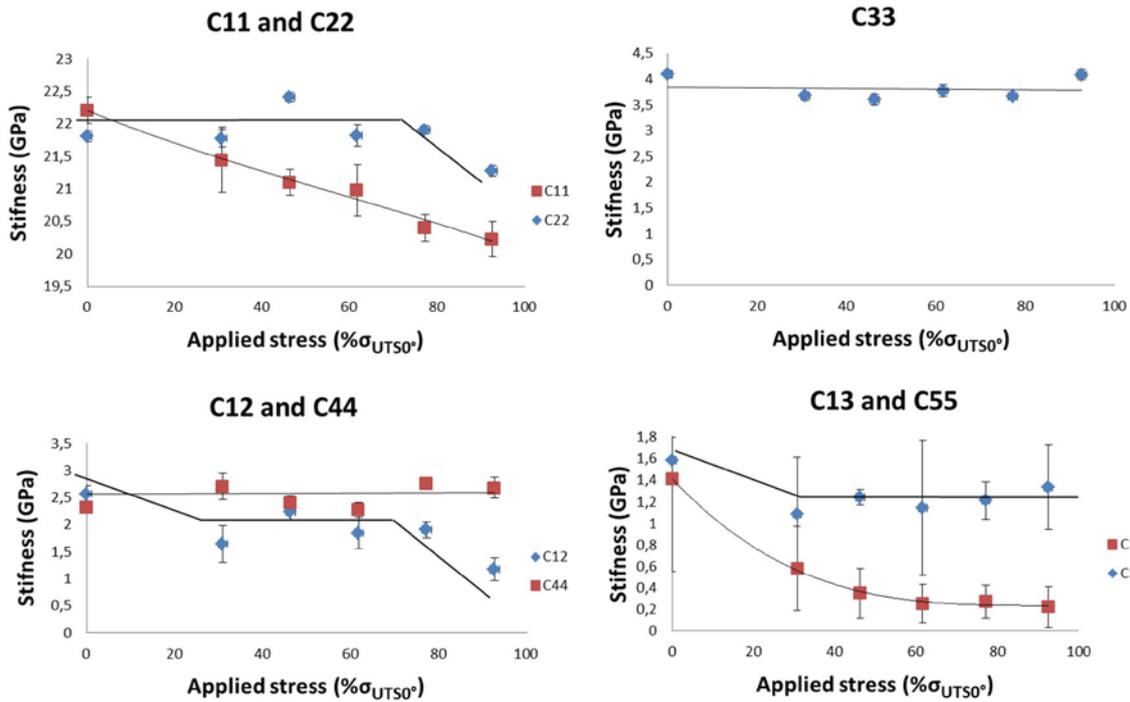
Fig. 19 Evolution of seven of the stiffness constants, function of the tensile stress, with the increase of the loading for the 0° configuration of sample with their respective confidence interval

For the undamaged sample oriented along the warp direction (0°), the experimental stiffness constants were close to the numerically obtained results as observed in Table 5. The evolution of the stiffness constants is plotted in the Fig. 19 with their respective confidence interval. Furthermore, it was noticed that the global evolution of the stiffness components was close to the results discussed by Hufenbach et al. [9]. An important decrease of the components C₁₁ and C₁₃ was noticed, whereas a smaller decrease of C₁₂ and C₅₅ and

One can then conclude that the components depending on the loading direction (direction 1), namely C_{11} and C_{13} were more affected by the damage. The component C_{12} was also impacted by the damage but at a lower extent.

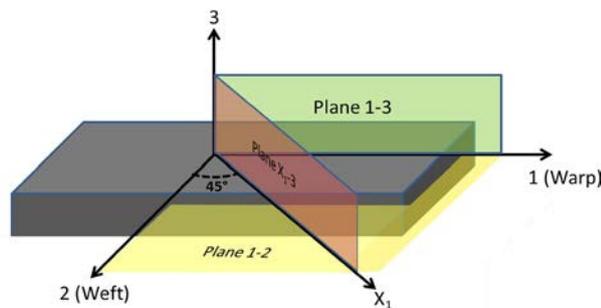
Fig. 20 Schematic representation of the different propagation planes of ultrasonic waves. For samples in the 0° configurations, the planes 1-3 and 1-2 were used. For the samples in the 45° configuration, the plane X-3 and 1-2 (or azimuth plane) were used

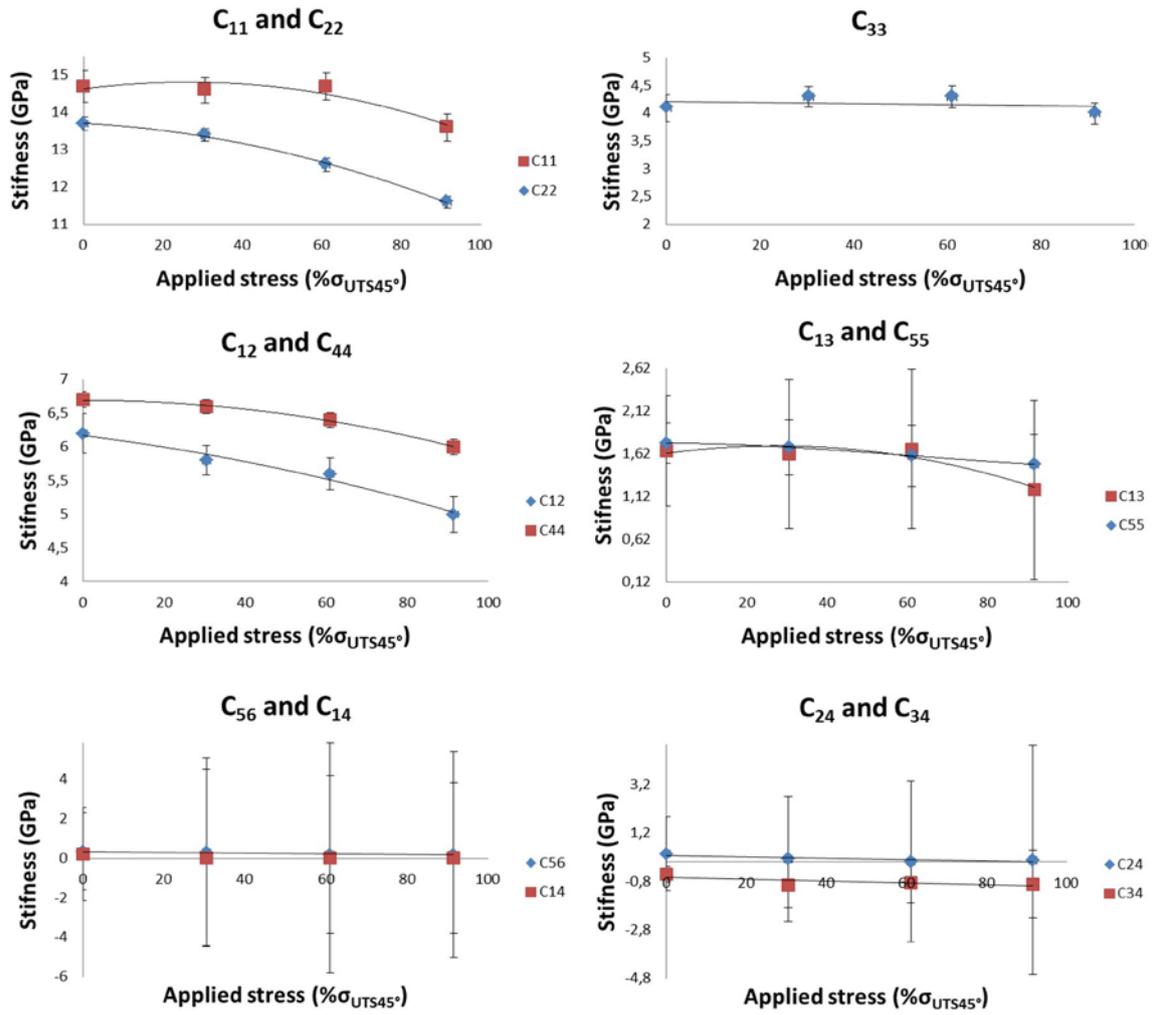
Fig. 21 Evolution of seven of the stiffness constants with the increase of the applied stress level for different 45 ° configuration of sample with their respective confidence interval

The evolution of the stiffness components is plotted in Fig. 21 with their respective confidence interval. During the first steps of the loading, the components that are a function of the loading direction (especially C_{11} and C_{13}) did not change at

all, but they dropped drastically after 61.1% σ_{UTS45° . The shear components C_{44} and C_{12} were of course impacted from the beginning of the test. The components C_{33} and C_{55} did not really change during the tensile tests. This led to a very different damage behavior compared to the other sample configurations. Some minor changes were observed for the C_{56} , C_{14} , C_{24} and C_{34} components. However, the confidence interval was very large when compared to the other stiffness components. This is explained by the lack of measurement in two additional planes as mentioned earlier. The major impact from the loading on the shearing components was clearly detected with the present method. Furthermore, this was in agreement with the damage mechanisms observed in the previous section. Indeed, it is worth recalling that the fiber buckling was caused by the reorientation of the fibers which was induced by important local shearing in the meso-structure.

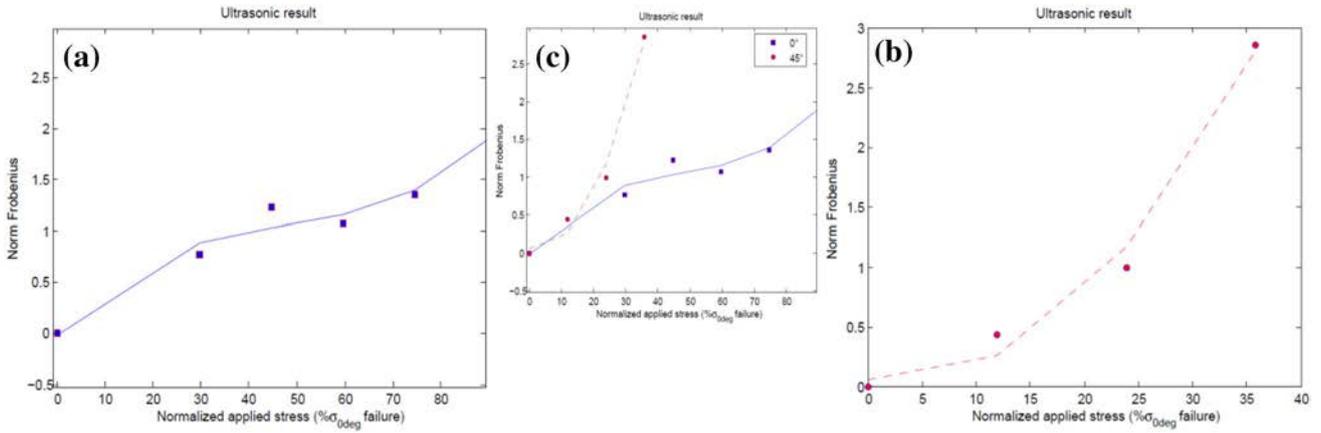
Fig. 22 Evolution of the Frobenius norm of the stiffness matrix for the two configurations of samples **a** 0° and **b** 45° function. In **c** data of both configurations are plotted for comparison purpose

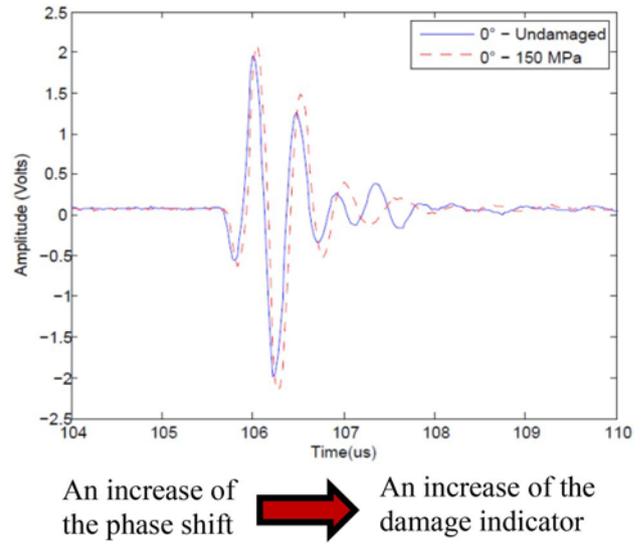
Fig. 23 Response of ultrasonic signals that propagates through the 1-3 plane, at 0° of incidence, of a 0° undamaged sample and loaded at a stress level of 150MPa

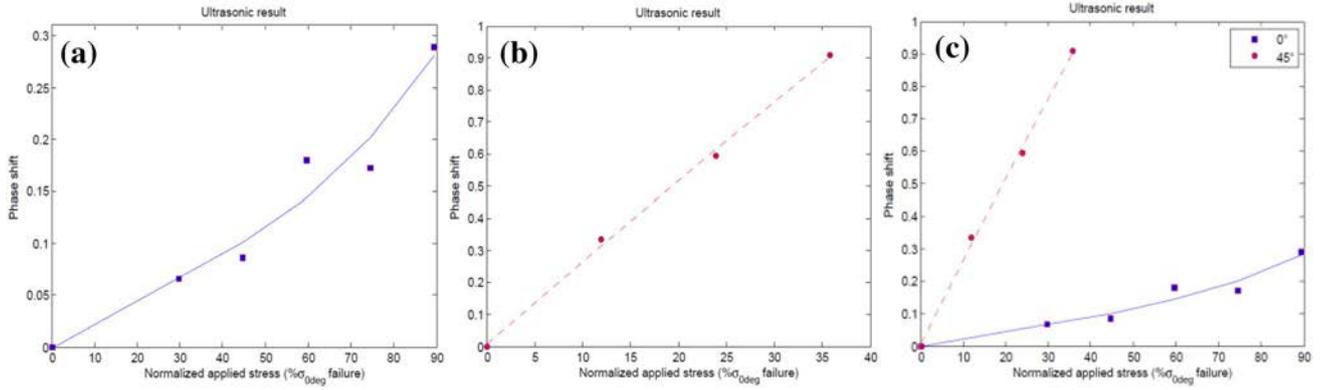
Fig. 24 Absolute phase angles evolution with increasing tensile stress to the sample for a 0° and b 45° configuration of sample. In c data of both configurations are plotted for comparison purpose

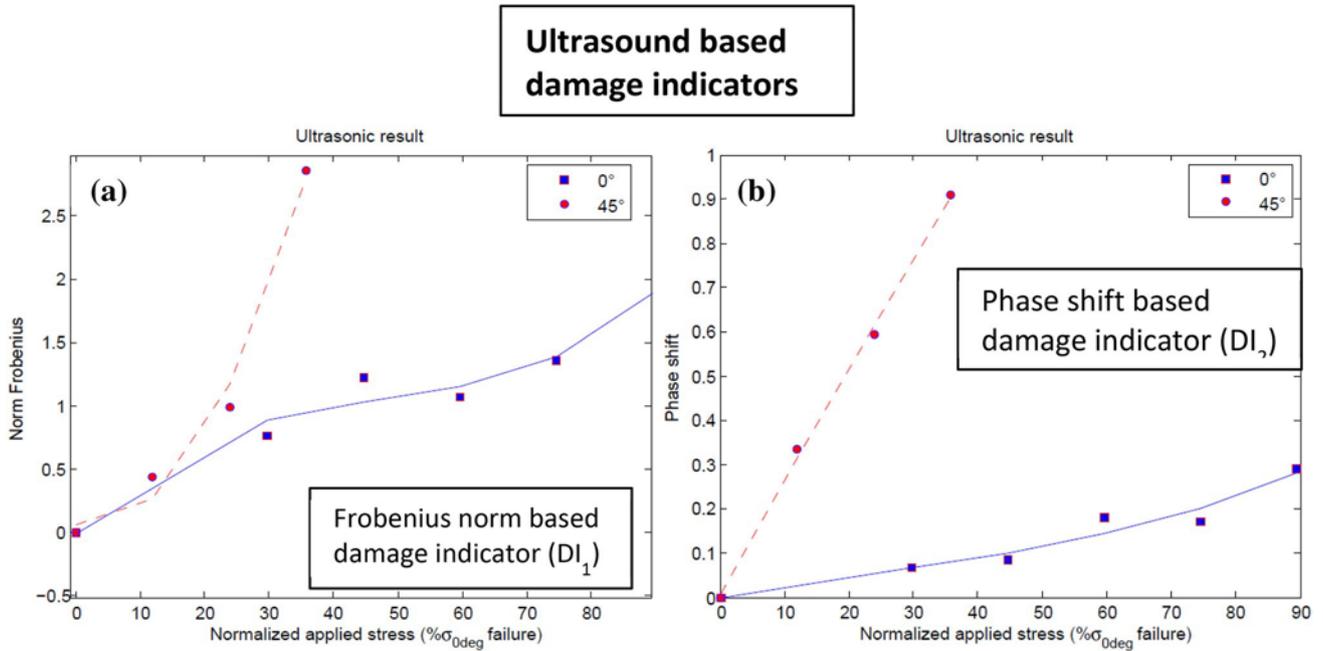
Fig. 25 Proposed ultrasonic damage indicators. a Evolution of Frobenius Norm and b Phase shift indicator. Those indicators are plotted for the sets of samples oriented at 0° and 45° from the warp direction and function of the normalized applied stress level

The two proposed ultrasound based damage indicators (DI_1 and DI_2) are respectively plotted in Fig. 25a, b. As illustrated in this figure, the evolution of the Frobenius norm for

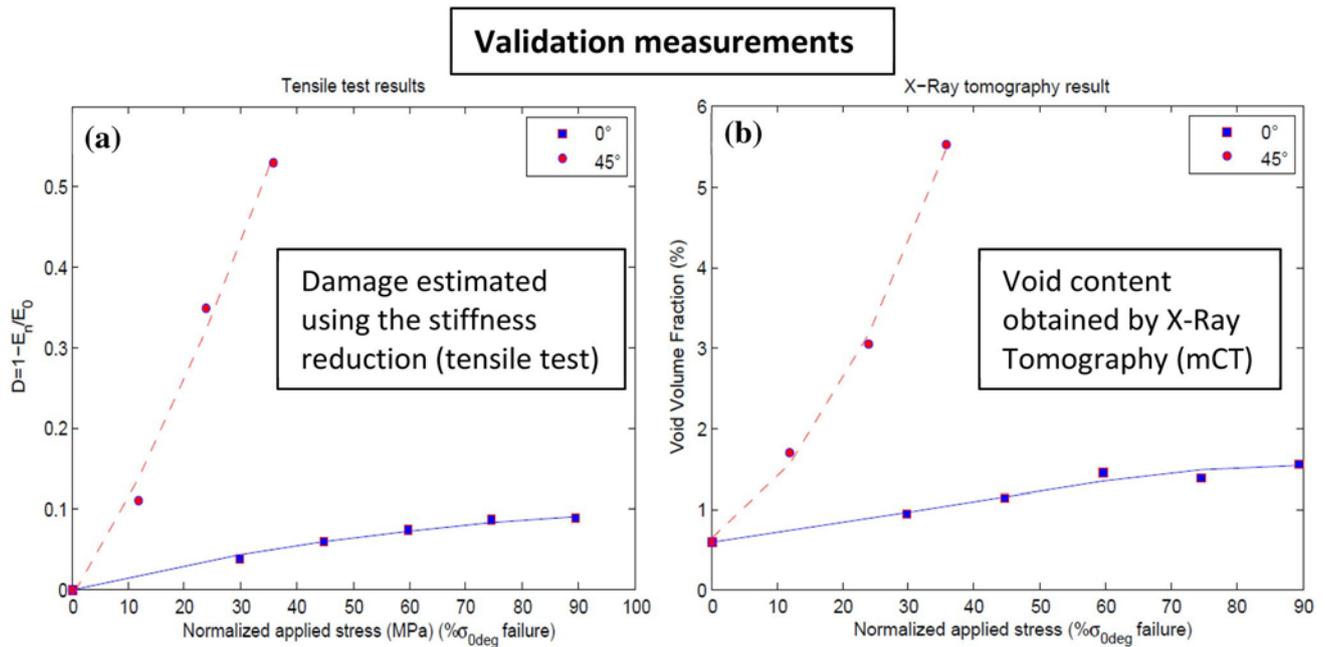
Fig. 26 Damage indicators used as validation tools. **a** Damage estimated on the elastic modulus reduction and **b** Void volume fraction. Those indicators are plotted for the sets of samples oriented at 0° and 45° from the warp direction and function of the normalized applied stress level
