Lamice DENGUIR, José OUTEIRO, Vincent VIGNAL, Rémy BESNARD, Guillaume FROMENTIN  
- On the optimization of the cutting conditions for an improved corrosion resistance of OFHC copper - In: 8th CIRP Conference on High Performance Cutting (HPC 2018), Hongrie, 2018-06-25  
- Procedia CIRP - 2018

8th CIRP Conference on High Performance Cutting (HPC 2018)

# On the optimization of the cutting conditions for an improved corrosion resistance of OFHC copper

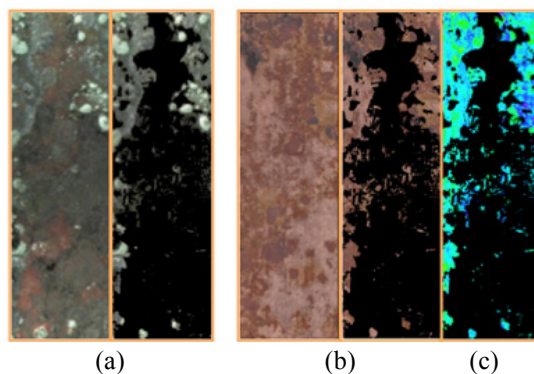
Fig. 1. Evaluation of the volume of copper dissolved by  $\text{mm}^2$  covered by atacamite.

- Isolation of green zones (covered by atacamite) starting from a photo of the oxidized surface as shown in Figure 1a.
- Starting from the image of the cleaned surface, isolating topographies of zones corresponding to those covered by green before the cleaning as shown in Figure 1b.
- Visualization of the topography corresponding only to the filtered zones as shown in Figure 1c. Level 0 corresponds to the mean plan of the freshly machined surface, before the aging test ( $R_a < 800 \text{ nm}$ ).
- The program calculated the volume of copper that has removed (valleys) under the zones previously covered with atacamite, and divided it by the green analyzed surface, which gave a mean value of the depth of the dissolved substrate.

oxidation reaction per  $\text{mm}^2$  covered by atacamite (the green color) was quantified. In fact, the oxidized surface was taken in photo by a high-resolution microscope *Keyence<sup>TM</sup>*. Then, the surface was cleaned from oxides and taken again into photo. The topography was measured by optical microscope *Alicona<sup>TM</sup>* using the variation of focal distance technique. The volume of *OFHC* copper that disappeared from the oxidized surface was calculated by treating automatically the images under *Matlab<sup>®</sup>* (cf. Figure 1) using a script developed for the study making the following tasks:

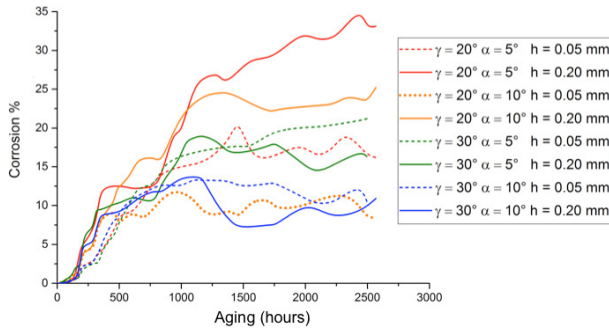
Fig. 2. Corrosion evolution under saline atmosphere for surfaces obtained by orthogonal cutting at  $V_c = 90$  m/min.

Figure 5 shows a non-negligible influence of the cutting conditions in on the evolution of the corrosion of *OFHC* copper surfaces, especially after 700 hours. under saline atmosphere. In fact, for the surfaces generated with a tool having the same rake angle of  $20^\circ$ , a raise in the uncut chip thickness accelerates the corrosion (cf. Figure 2). Nevertheless, this phenomenon is not seen when the rake angle is  $30^\circ$  where the uncut chip thickness seems to have no influence. On the other side, whatever the rake angle and the uncut chip thickness are, the raise of the flank angle from  $5^\circ$  to  $10^\circ$  shows a better influence on corrosion resistance. As observations are not enough to reveal the existing relationships between the cutting conditions and corrosion resistance, further analysis is needed to reveal their impact on the surface integrity responsible for this behavior.

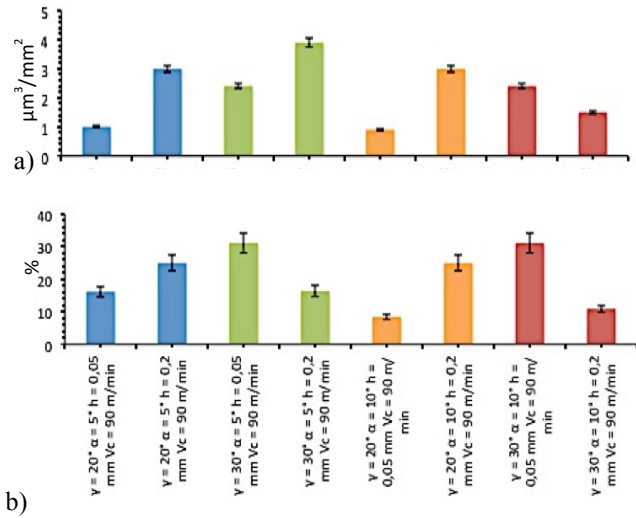
To explain degradation under the green surface, in-depth topography is measured under the oxide once it is removed. The removed volume per surface unit reflects the mean in-depth degradation under the oxide. Results are represented in Figure 3.

Fig. 3. (a) Mean in-depth degradation induced by oxidation at the end of the aging test under saline atmosphere, and (b) percentage of the oxidized surfaces at the end of the aging test under saline atmosphere.

Comparing the percentage of oxidized surface at the end of the aging test under saline atmosphere (cf. Figure 3b), the following remarks can be drawn: i) The least covered surface by atacamite is the least damaged under the green oxide ( $\gamma = 20^\circ; \alpha = 10^\circ; h = 0.05$  mm;  $V_c = 90$  m/min); ii) The most covered surface by oxides is not necessarily the one knowing the worst in-depth degradation ( $\gamma = 30^\circ; \alpha = 5^\circ; h = 0.05$  mm;  $V_c = 90$  m/min).

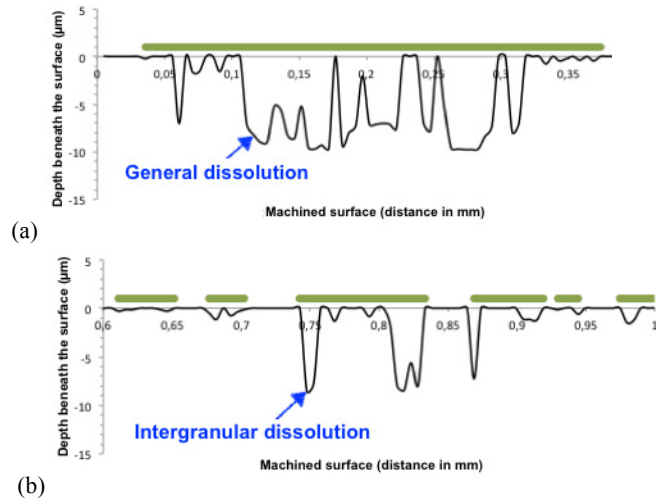
A unidirectional profile measured in the oxidized region was taken from every analyzed surface to identify the shape profile under the oxide. It was measured only under the green areas (represented by the green lines in Figure 4 as an example). The used in-depth resolution is 78 nm and the horizontal resolution is 5  $\mu\text{m}$ . According to the obtained profiles, it is remarkable that under the green areas two types of cavities can prevail: large cavities with plate valleys (corresponding to generalized dissolution, cf. Figure 4.a) and thin and deep cavities (corresponding to intergranular corrosion cf. Figure 4.b) in the borders of the green area.

Fig. 4. Profiles under the green zones for surfaces obtained by the conditions  $\gamma = 30^\circ, \alpha = 5^\circ, h = 0.2$  mm and  $V_c = 90$  m/min. Part of the analyzed profile presenting generalized dissolution (a) and intergranular corrosion (b).

The cavities depth varies under the surfaces covered by the green oxide, what witnesses a non-uniform dissolution happening on the same surface. These observations under the oxides allow the corrosion process analysis explaining the surface damage in the presence of saline atmosphere as follows [12]. Inside the droplets, copper dissolution leads to the formation of the ions  $\text{Cu}^+$  or  $\text{Cu}^{2+}$  in aqueous solution. Associated to anions  $\text{Cl}^-$  already present in the droplet, they constitute the green compound  $\text{CuCl}$ . With high chloride concentration, they can even produce the ions of  $\text{CuCl}_2^-$ . On the other side, cations  $\text{Cu}^{2+}$  can be hydrolyzed to form atacamite  $\text{Cu}_2(\text{OH})_3\text{Cl}$ . This reaction, consuming molecules of  $\text{H}_2\text{O}$ , produces protons  $\text{H}^+$ , decreasing the pH. As the droplet stagnates in the surface, the pH diminishes with the generation of atacamite. A previous study [11] has demonstrated that pH lower than the limit of copper dissolution can be rapidly reached leading to a generalized dissolution and to intergranular corrosion. The electrons issued from the dissolution reduce the oxygen inside the droplet. As the solubility of oxygen inside water is high, the cathodic reaction continues, and the dissolution evolves into cavities. Then, what makes a machined surface more active than the other just by manipulating the cutting conditions?

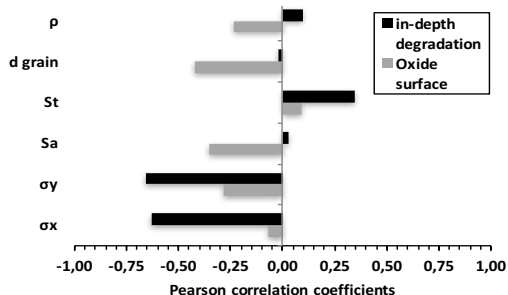
Fig. 5. Pearson correlations between the surface integrity measured parameters and the in-depth degradation and oxide surface at the end of the aging test in salt fog atmosphere.

To answer that question, the relationship between the surface integrity parameters (surface residual stresses in the cutting direction  $\sigma_x$  and in the transversal direction  $\sigma_y$ , the roughness  $S_a$  and  $S_t$  parameters, the grains size  $d_{\text{grain}}$  and the dislocations density  $\rho$ , all detailed in Table 1) and corrosion in terms of the oxide surface area and the surface in-depth degradation are evaluated using the correlation of Pearson technique. The results (cf. Figure 5) show that concerning to the area of the oxide surface is highly sensitive to the grain size  $d_{\text{grain}}$ , then to the surface roughness  $S_a$ , while in-depth degradation is mostly related to the residual stresses. In fact, the preferential dissolution starting sites are the grains boundaries and the peaks of roughness presenting micro-electrodes. So, more grains and more peaks imply greener surface. However, when it is up to the in-depth degradation, tensile stresses will play the major role in continuing and accelerating the dissolution process [12].
