Samuel RODRIGUEZ, Victor GAYOUX, Eric DUCASSE, Michel CASTAINGS, Nicolas PATTEEUW - Ultrasonic imaging of buried defects in rails - NDT&E International - Vol. 133, p.102737 - 2023

# Ultrasonic imaging of buried defects in rails

The present work addresses the ultrasonic NDT of rails, more precisely of the rail foot. The practical constraint is that transducers must be located on the rail head, whereas the region of interest is the rail foot. Thus, there is no direct acoustic path between the transducers and the region of interest. As classical delay and sum methods cannot be applied to such cases, the goal of the paper is to numerically assess the potentiality of the topological imaging method to investigate the rail foot. Three specific typical rail foot defects are investigated, namely, longitudinal vertical cracks, corrosion pits and rail injuries. Simulating eight transducers with different polarizations, the images obtained show that the detection and approximate location of the various defects are possible.

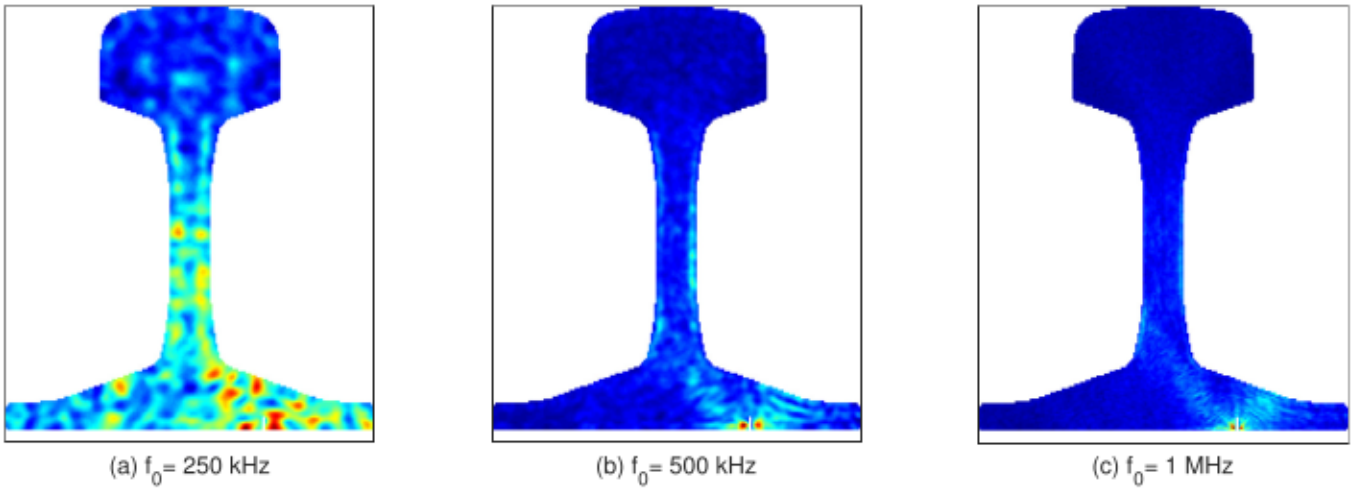
Fig. 14. Topological images of the rail section presenting a longitudinal vertical crack. The defect is represented by a white line. Each image is computed considering central frequencies of 250, 500 and 1000 kHz. The polarization is in the rail plane. The acquisition duration is 300  $\mu$ s, and the number of transducers is 16.

The influence of the central frequency of the wave packet is studied in Fig. 14 and in Fig. 15. The improvement of the images when increasing the central frequency from 250 to 500 kHz is spectacular, especially for the in-plane polarization case. A further improvement is obtained when increasing the central frequency up to 1 MHz. The sensitivity of the artifact indicator to the central frequency is plotted in Fig. 16. Increasing the central frequency clearly reduces artifacts, especially those in the web. We propose two leads to explain this

It should be noted that simulating a 3-period excitation centered at 1 MHz leads to 565 frequency steps for frequencies up to 1.86 MHz for each field computation. The images presented in Figs. 14(c) and 15(c) are defined as the mean values of 16 images, each one requiring 3 field computations. Under these conditions, it took approximately 16 days to obtain these final images using a 4-core 8-thread 3.7 GHz CPU.

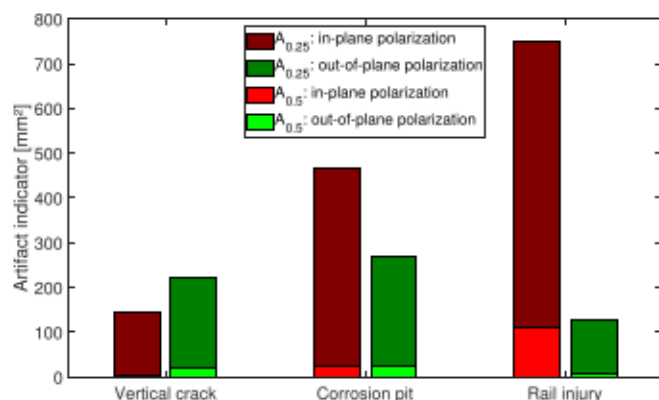
Fig. 20. Comparison of the artifact indicators of the images of the three defects under investigation.

The artifact indicators  $A_{0.25}$  and  $A_{0.5}$  are compared for each investigated defect in Fig. 20. For the studied array configurations, the out-of-plane polarization produces fewer artifacts globally. The high  $A_{0.5}$  indicator of the corrosion pit and the injury cases for the in-plane polarization indicates a higher risk of detecting absent secondary defects leading to false positive diagnoses at some locations.
