Walid KHALFAOUI, Eric VALÉRIO, Michel AUTRIC, Jean-Eric MASSE - Excimer laser treatment of ZE41 magnesium alloy for corrosion resistance and microhardness improvement - Optics and Lasers in Engineering - Vol. 48, n°9, p.926-931 - 2010

# Excimer laser treatment of ZE41 magnesium alloy for corrosion resistance and microhardness improvement

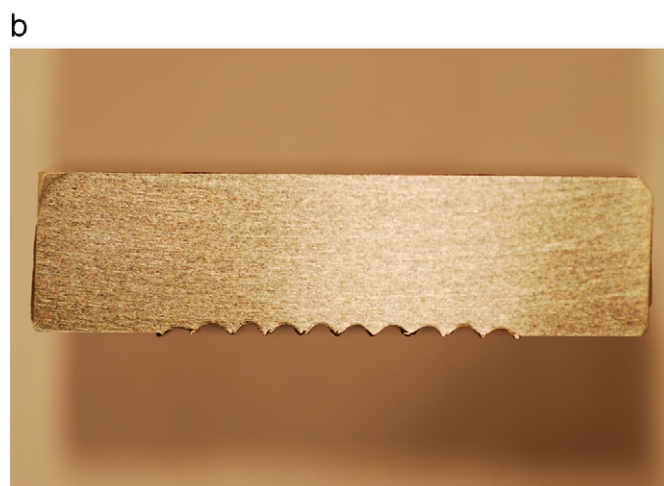
**Fig. 4.** Morphology of the irradiated surface.

After the laser surface melting treatment, the ZE41 displayed a complex rippled surface morphology. Fig. 4 shows a wavy morphology: a succession of hollows and hills can be seen on the irradiated surface of the ZE41 specimen. Each hollow corresponds to a laser beam track. Such morphology is due to several causes. The first one is loss of material by evaporation caused by the high power density ( $160 \text{ MW cm}^{-2}$ ) of the laser beam. This power density is not homogenous within the laser spot; it reaches the maximum at the centre of the beam and decreases whenever we approach the beam border. Therefore evaporation is emphasized at the centre and a hollow is created. In addition, the high power density brought by the laser pulse creates a temperature gradient around the irradiated zone. This temperature gradient induces a gradient of surface-shear stress, which increases with the distance from the irradiated surface. Consequently, the molten material is pushed away from the irradiation centre towards the beam periphery where the surface-shear stress is the highest. During laser surface melting treatment, we noticed a creation of plasma on the magnesium alloy surface. The plasma vapours' pressure drives shock waves and compresses the molten material beneath the incident laser beam, enhancing formation of the wavy topography. The irradiated surface is dark and covered with a white powder which can be wiped off. This white powder comes from ionized gas and metal from the plasma which reacts together and form solid products deposited on the magnesium surface as an extremely thin film. The dark thin layer on the irradiated surface is formed by the oxidation of the very hot laser-melted surface.

As noted in Section 3.1, the laser-melted zone displays a rippled surface morphology with several asperities, especially in laser track borders (Figs. 4 and 5). These asperities can give rise to crevice corrosion [14]. Examining the sample after 24 h of immersion in a 0.5 M NaCl solution, we find that this surface was uniformly corroded. We cannot determine whether crevice corrosion took place or not. In addition, the salt-spray test shows that, after 131 h of exposure, the laser-treated surface is intact, and devoid of any sign of crevice corrosion. Knowing that the later type of corrosion needs an incubation time, after which the corrosion process begins to develop rapidly, this incubation time may be longer than 131 h. Therefore we cannot detect it during the tests performed.
