Vanessa RODRIGUEZ, Jacob SUKUMARAN, Yeczain PEREZ DELGADO, Mariana STAIA, Alain IOST, Patrick DE BAETS - Scratch evaluation on a high performance polymer - Mechanical Engineering Letters - Vol. 9, p.76-84 - 2013

# Scratch evaluation on a high performance polymer

## Abstract

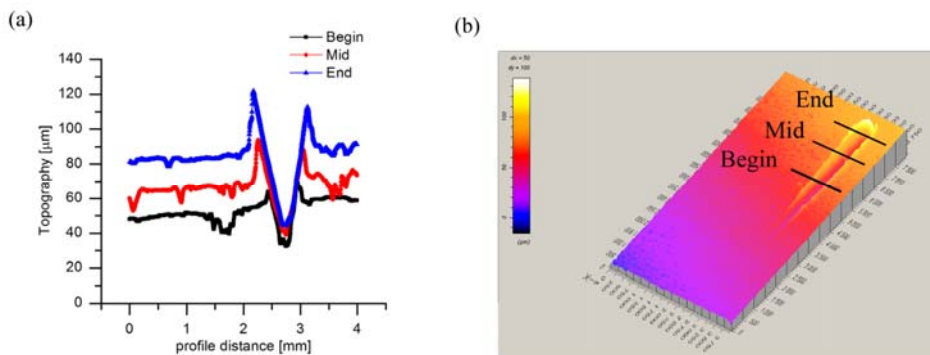
Figure 3. Profilometer results of a typical scratch on a PEEK-E02 surface: (a) depth profile with clear evidence of the scratch with different positions of the scratch; beginning, middle and end (b) 3D view of the scratch test

An evaluation of the scratch produced using profilometry leads to the profiles shown in figure 3 (a) the penetration depth with less material deformation at the beginning and a progressively increasing residual scratch towards the end of the scratch. At this position the scratch depth is also slightly deeper from the normal scratch course, due to the back-movement of the scratch head. In the figure 3(b) a corresponding a 3D view of the scratch following the original scratch direction, so that the deeper valley and the pushed-up hills at the rim of the scratch are more visible.

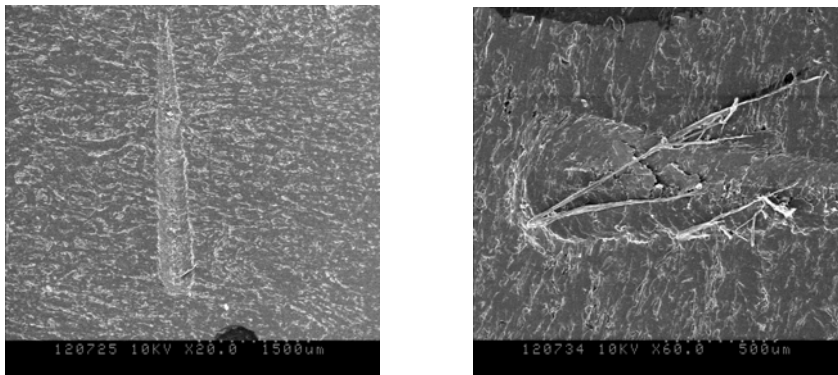
In figure 4, the sample of PEEK polymer filled with carbon fibers, graphite fibers and PTFE shows that the surface deforms with the formation of noticeable cracks, microcracks, materials removal and some detached debris particles within the scratch zone for PEEK-E02 material. In some cases depending upon the type of the materials and the severity of the contact, the material deformation can take place around the scratch tip with or without wear debris formation (Rajesh and Bijwe 2005).

*Figure 4.* The scratch surface damage observed using scanning electron micrographs on PEEK-E02 under the scratching load of 50N and scratching velocity of 10mm/min

Additionally a few analysis of scanning electron microscopy images for the PEEK-E02 polymer figure 4 and figure 7 for PEEK-S01, were performed to understand how material deformation and removal processes take place during scratching. This has indications in the understanding of abrasive wear process for polymers because abrasive wear mechanism takes places by hard asperities or loose debris particles.

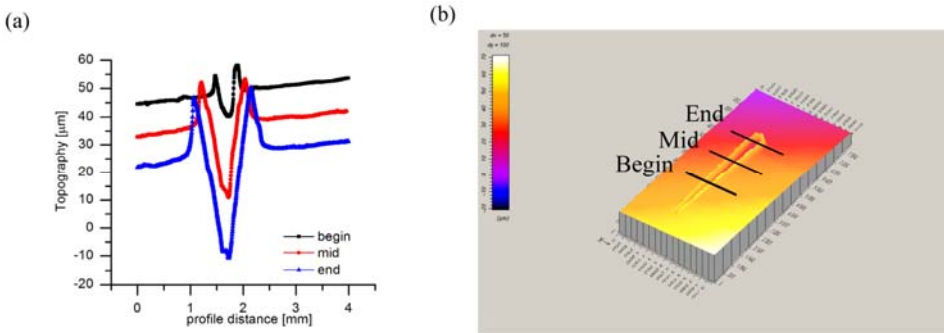
The depth profilometry allows obtaining more precise information on the remaining penetration depth during scratching test. In the figure 6 (a) we can see the variation of the penetration in the bulk of polymer for the PEEK-S01 filled with carbon fibers and graphite it can be seen how is slightly deeper and smoothly in the beginning until the end of the scratch test. And it can be notice in the figure 6 (b) the 3D images and the penetration depth and the grooves formation during the scratching test in the material tested.

Figure 6. Profilometer results of a typical scratch on a PEEK-S01 surface: (a) depth profile with clear evidence of the scratch with different positions of the scratch; beginning, middle and end (b) 3D view of the scratch test.

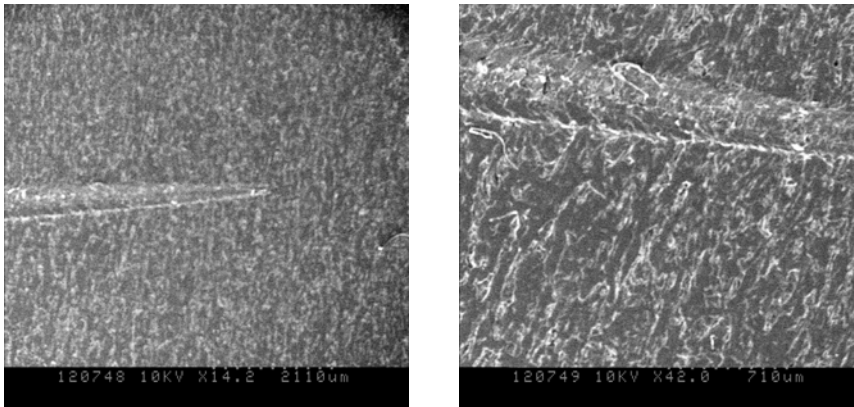
Also, by scanning electron microscopy (SEM) of the PEEK-S01 polymer in the figure 7 we can see the contour of the scratched surface when the load was further increased. The PEEK-S01 surface deforms with the formation of noticeable cracks within the scratch. A regular crack formation was seen, which can be due to surface stresses that the microstructure in the semi-crystalline polymer were subjected. Comparing SEM images of the PEEK-S01 with the

material PEEK-E02 it can be observed there is not clear formation of debris of the PEEK-S01 than in the SEM images of the PEEK-E02. A well-defined edge on the two sides of the scratch groove and a smooth scratch surface are formed after scratch pattern.

*Figure 7.* The scratch surface damage observed using scanning electron micrographs on PEEK-S01 under the scratching load of 50N and scratching velocity of 10mm/min
