Nasser Eddine BELIARDOUH, Hakan KALELI, Corinne NOUVEAU - Wear performance of duplex treated low alloyed steel against wood (beech) as static partner - Journal of the Balkan Tribological Association - Vol. 20, n°1, p.84-92 - 2014

WEAR PERFORMANCE OF DUPLEX TREATED LOW ALLOYED STEEL AGAINST WOOD (BEECH) AS STATIC PARTNER

The sliding tribological behaviour of Cr-(WC-Co) coating against wood (beech) as counterpart was investigated using a duplex treatment of low carbon steel (DIN 18CrMo4). The duplex treatment consists of LPC (low pressure carburising) + R.F magnetron co-sputtering of Cr and WC-Co. Pin on disk configurations in dry condition wear tests were performed. The wear scars of the coatings were evaluated using optical profilometry, scanning electron microscopy (SEM/EDS) and the wear mechanisms were consequently discussed. The aim of this work is to study wear mechanisms on the wood pin/disc couple. It was concluded that best behaviour was observed in the case of higher Cr content coating.

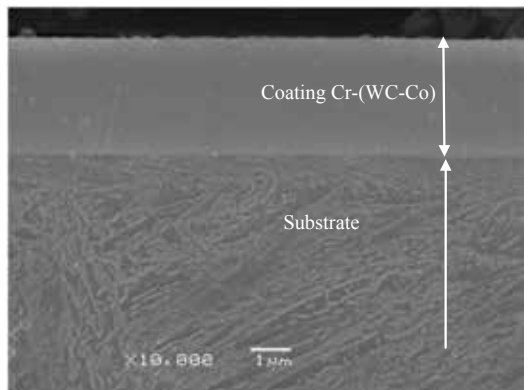
Fig. 1. SEM micrograph: cross-section view of duplex treated samples. The Cr-(WC-Co) layers developed a dense structure

Sample elaboration. The substrate used in this work was a commercial low alloy steel DIN 18CrMo4. Before thermo-chemical treatment, the samples were polished with P800 paper, ultrasonically cleaned, and finally introduced into a vacuum furnace 'BMI Furnace'. The carburising gas was ethylene (C_2H_4) and the temperature was 900°C . The total durations of the boost/diffusion stages were 120 min (carburising C1) and 105 min (carburising C2). After the carburising process, samples are in-situ quenched in a high pressure N_2 environment (500 kPa), subsequently annealed at 200°C for 120 min, and finally cooled in a 100 kPa N_2 atmosphere. The Vickers hardness values of C1-treated surface layer is $H_{v.100} = 768 \pm 5$ and the C2-treated samples yield $H_{v.100} = 654 \pm 5$. Additionally, carbon analysis of the surface layer yields 0.667 wt.% and 0.615 wt.% for C1 and C2 treatments, respectively. Both of treated C1 and C2 samples present the same hardness's value at the core of the substrate ($H_{v.100} \sim 300$) and approximately the same depth of carburised layers (550–600 μm). A standard and typical microstructure was developed after carburising process. At the top layers, the microstructure consists of martensite phase and cementite (Fe_3C) with evidently a few quantities of γ retained austenite. After that, Cr(WC-Co) coatings onto carburised surface samples were elaborated as can be seen in Fig. 1.

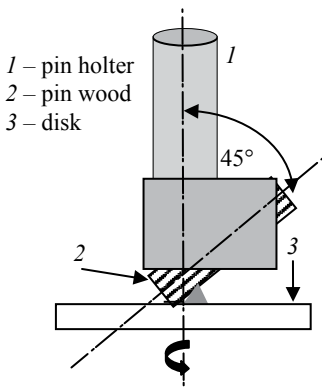
**Fig. 2.** Pin-on-disk tests**Table 2.** Parameters of experimental wear tests

Samples characterisations. Wear properties of the coatings were evaluated under dry sliding condition at room temperature using a pin-on-disk tribometer (CSM HT1000) and Tribbox 4.1.1 software. The two main standards referring to the pin-on-disk tribometer are DIN 50324 and ASTM G 99 – 95a (Ref. 7). The pin-on-disk tests were performed with the test configuration schematically illustrated in Fig. 2. The pin wood with a diameter of 6 mm is positioned at 45° on the holder and loaded against a rotating disc. Only cemented (C1 and C2) and cemented +coated (F101 and F102) samples were studied.

In order to approach real contact conditions, e.g. the wood process as peeling of beech, test parameters were chosen appropriately as listed in Table 2. A particular preparation is needed when tests are conducted with wood counterpart: the pin was cut perpendicular to fibres (length 20 mm; \varnothing of 6 mm) from a specific specimen of beech tree provided by a regional sawmill. It was then polished to remove any chips and immersed into hot water (70–75°C) for 24 h.

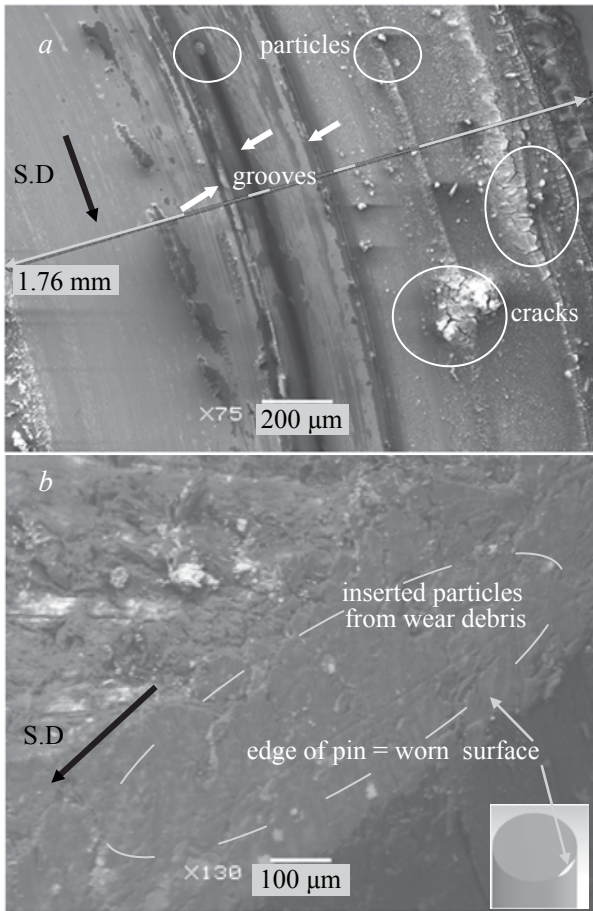
Fig. 4. Example of SEM micrographs of: wear track on disk carburized C1 (a) and the corresponding counterpart worn surface of pin wood after pin-on-disk test (b). The insert image was obtained by CATIAV5 software

Wear analysis. After a tribotest, SEM analysis of the uncoated samples surface revealed a large wear track (1.5–1.8 mm), and substantial amount of wear particles on its edges. These remarks are valuable for all samples treated C1 and C2. An example of wear track of disk seen on C1 samples is shown in Fig. 4a: inside the circular wear track, wear debris were formed. SEM micrographs show also finest and parallel grooves as result of ploughing by oxide particles (third body wear).

Moreover, the wear scar of the counter face, i.e. the edge of the pin wood became smooth as reported in Fig. 4b. Some particles (oxides) are incrustated inside the fiber of wood and a few ‘chips’ are formed at its circumference. Thus initially, at the asperity contact tips, formation of oxides film and, after reaching a critical thickness, breaking of this oxide film (cracks in Fig. 4a) occur as debris formation. Consequently the first step of wear mechanism for the cemented samples sliding against a wood pin is an oxidative wear and the second step is a mild abrasive wear mechanism.

Quantitative analysis. From the wear track profile obtained by 3D profilometry, the volume loss and wear rate of disc were calculated, for all the samples. The wear scar of the counterpart (pin wood), is an ellipse. Then major and minor semi-axes were measured by profilometry and to calculate the volume loss CATIAV5 software was used (see the inserted image in Fig. 4b). The results are presented in Fig. 7.

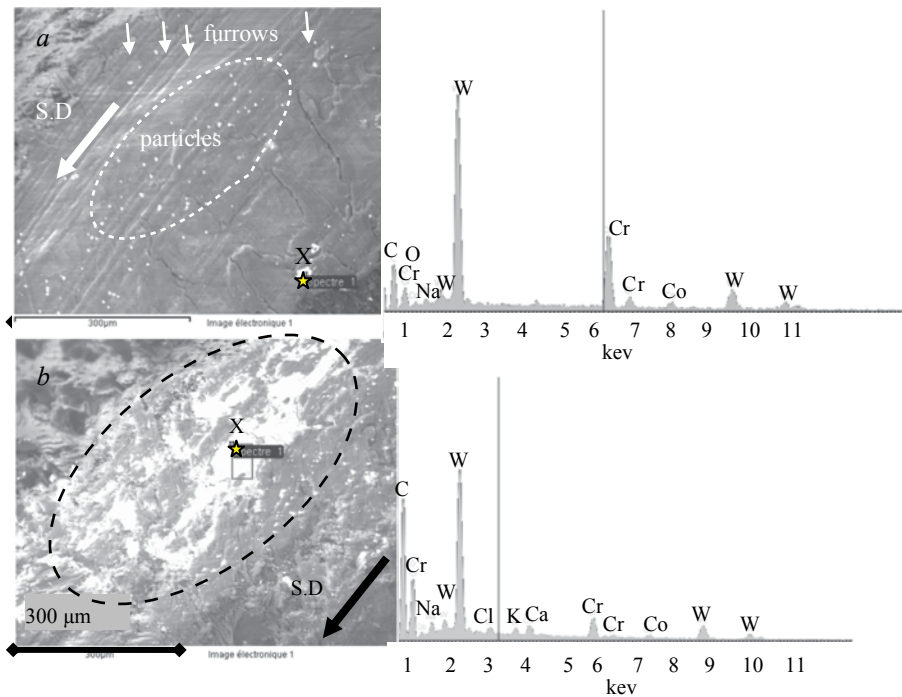
Fig. 6. Example of SEM micrographs of worn surfaces of wood pins against C1+F101 (a) and against (C1+F102) (b). EDS analysis spectra carried out the particles indicate by X

Figure 6 shows the wear scar on wood pin after 200 m sliding distance against duplex treated samples. Considerable difference exists between surface morphology of pin edge after sliding against F101 (Fig. 6a) and F102 (Fig. 6b) coatings. The wear scar of the pin in the case of the F101 coating shows few quantities of particles, dispersed on a smooth wood surface. These particles contain metallic and organic elements of wood as revealed by EDS analysis spectra. Again, no iron peak (Fe) or oxygen (O) were detected; that proves that coating is not entirely destroyed yet. Therefore, the detachment of the coating was presented in the form of wear debris. Some scratches (furrows) parallel to sliding direction are also present and are caused by particles (no oxides) between the contact surfaces. The small amount and size of the observed particles are not sufficient to cause an abrasive wear mechanism. Besides, the COF evolution curve of the F101 coating (Fig. 3), regardless the substrate, indicated that was a mild wear compared to the

F102 one. As a consequence, no evidence of abrasive wear was found. We suppose that movement of particles during sliding can be due to rotation or rolling as reported in literature⁸⁻¹⁰. The coatings are worn gradually, slowly and with continuous wear with micro-chipping of small coating fragments in connection to surface defects. The SEM micrographs of the pin worn surface sliding against F102 is shown in Fig. 6b. This part of the wear scar shows a significant amount of adhered counter material which indicates a stronger adhesion between contact surfaces. This is in agreement with the corresponding friction curve in Fig. 4, which shows significantly higher and more fluctuating values as compared with the friction curve displayed by F101 coating. The wear mechanism in this case is adhesive.
