Andriy VASIN, Yuri GOMENIUK, Audrey RUSAVSKY, Alexey N. NAZAROV, V.S. LYSENKO, Petro M. LYTVYN, O.G. GONTAR, Sergii P. STARIK, S. ASHOK, Corinne NOUVEAU - Nano- and micro-scale morphological defects in oxidized a-SiC: H thin films - physica status solidi (c) - Vol. 10, n°4, p.619-623 - 2013

Nano- and micro-scale morphological defects in oxidized a-SiC:H thin films

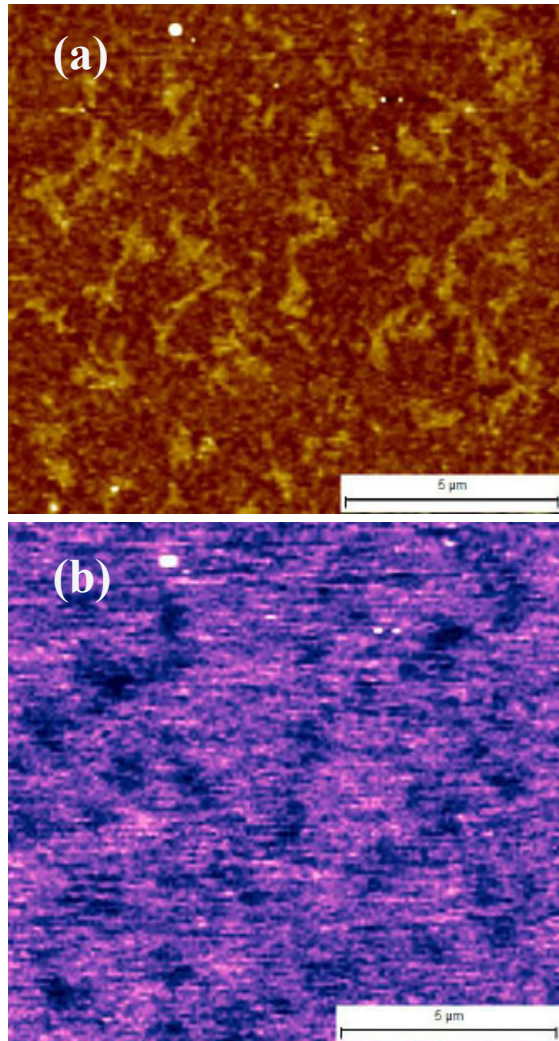
Figure 2 (a) AFM topology (contrast of height in range of 10 nm) and (b) KPFM map (contrast of surface potential in range of 30 mV) of the surface of low density a-SiC:H films after oxidation at 550 °C.

3.1 Nano-scale defects Atomic force microscopy measurements show that surface of as-deposited films is smooth and uniform. But after oxidation of the low density sample (the sample deposited at lowest discharge power, see spectrum 1 in Fig. 1) at 550 °C we observe formation of island-like inhomogeneities (Fig. 2(a)). Such morphological defects were not observed after oxidation at 650 °C. IR spectra of these samples (not presented here) do not differ significantly. The size of island-like morphological

defects ranges from several hundred nm to several μm , and islet defects protrude above the surface of the main body of the films by about 10 nm.

Kelvin probe force measurements exhibit that the surface potential of the defects is significantly lower than that of the surrounding matrix (Fig. 2(b)) indicating that electrical properties of the material is also inhomogeneous..
