Kheireddine BOUZID, BELIARDOUH NASSER EDDINE, Corinne NOUVEAU - Wear and Corrosion Resistance of CrN-based Coatings Deposited by R.F Magnetron Sputtering - Tribology in Industry - Vol. 37, n°1, p.60-65 - 2015

Wear and Corrosion Resistance of CrN-based Coatings Deposited by R.F Magnetron Sputtering

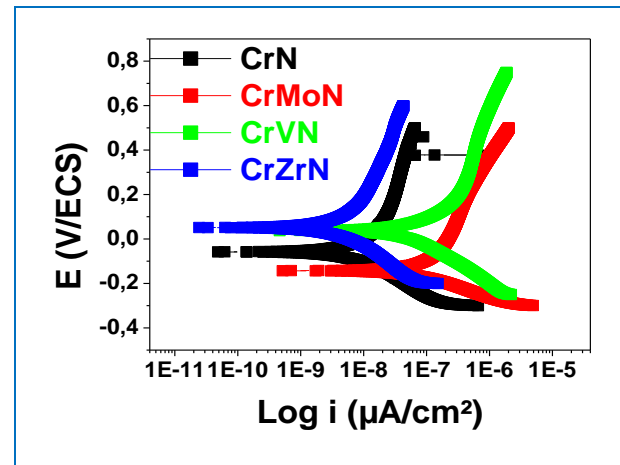
The Tafel polarization curves, shown in Fig. 1 allow finding the values of anodic and cathodic

Fig. 1. Potentiodynamic polarization curves of different samples tested.

These curves indicate that the best behavior related to the corrosion rate should be presented by the CrZrN samples because they present the lowest values of corrosion current densities (I_{corr}) as mentioned in Table 2.

Coating	I_{corr} (nA)	E_{corr} (mV)	$V_{corr} \cdot 10^{-3}$ (mm/y)
CrN	19,2	-58,5	14,22
CrZrN	10	51,4	13,97
CrMoN	136	-143	169
CrVN	67,1	37	93,82

The decrease in I_{corr} of films is a great evidence of the improvement in the corrosion resistance.

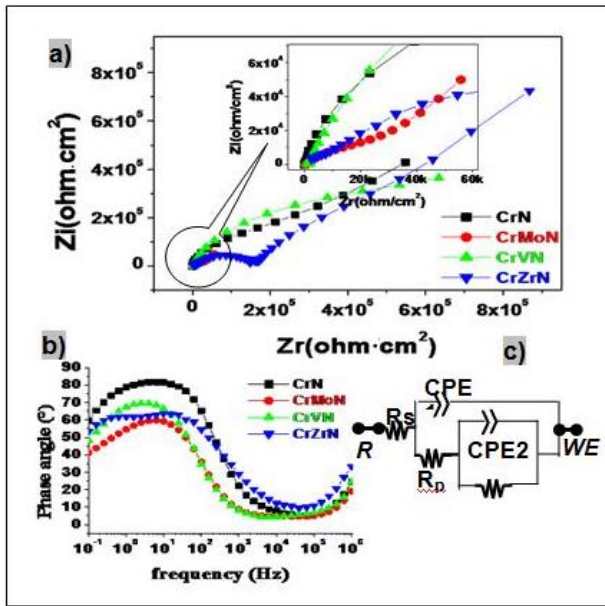
In order to investigate the corrosion performance of PVD hard coating, it was well-known that EIS has found its efficacy [6]. The different shapes of the curves in Nyquist diagrams are obtained as shown in Figure 2(a). The CrZrN coating presents the best corrosion resistance followed by the (CrVN). The CrMoN presents the lowest corrosion resistance. This result confirms the data obtained by potentiodynamic tests (Table 2). In addition, all of the Nyquist plots show two time constants, with a capacitive loop of smaller diameter followed by another capacitive loop of larger diameter. Bode plots of the phase angle as a function of the frequency shown in Fig. 2(b), confirm that the Nyquist's data.

Fig. 2 AC impedance measurements of the coated samples (a) Nyquist impedance diagrams (insert image shows the Nyquist plots at high frequencies), (b) Bode plots and (c) the equivalent circuit model.

From the above mentioned result, it is confirmed that there are effectively two time constants in the experimental frequency bandwidth. Consequently the EIS data indicates the existence of two different interfacial reactions which can be related to the coating/solution interface and substrate/solution interface respectively.

The experimental results are interpreted via developing typical impedance models for electrode surfaces and curve-fitting on the basis of an equivalent circuit using Zview impedance program. A circuit model was proposed to ascribe two sub-electrochemical interfaces generally used in such case [7].

The equivalent circuit (Fig. 2 (c)) consists of the following elements: R_s corresponds to the solution resistance of the electrolyte test between the working electrode (WE), and reference electrode (RE). CPE1 and R_{po} elements are used in parallel to replace the coating dielectrics properties. CPE2 and R_{ct} in parallel are adapted to describe charge transfer at the coating/substrate interface. Results of fitting values obtained by equivalent circuit simulation of different coating configurations indicate that the CrZrN coating has lower CPE1 value and higher charge transfer resistance. On the other hand, the total polarization resistance

The R_p of CrZrN was around 48.10^3 K Ω thus multiplying by factor 04 (four) the R_p value of CrN ($12,15.10^3$ K Ω) indicating their high corrosion resistance. The R_p values for CrVN and CrMoN are 3.10^3 K Ω and $48,23$ K Ω , respectively. These results showed a good agreement with the Tafel potentiodynamic polarization measurements.

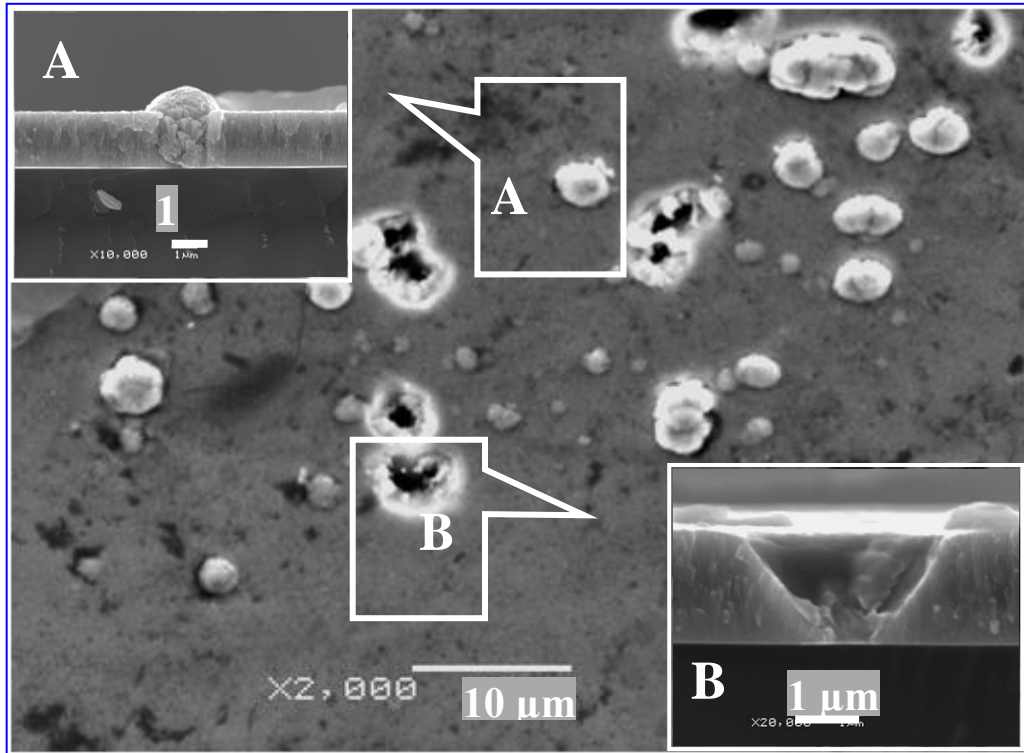
Figure 3 presents an example of the surface morphology of the CrZrN coating after 24 h of immersion and potentiodynamic test measurements in a 0,3 wt. % NaCl solution. SEM images can prove that selective corrosion occurs at growth defect sites. According to Lewis et al [10], a droplet is compositionally metal rich and nitrogen deficient; this defect is anodic with respect to both surrounding coating. It is obvious from Fig. 3, that the corrosive attack occurs with the ejection of droplets (insert image A in Fig. 3) from the coatings which creates a crater (insert image B) at its surface, resulting in direct contact with the substrate.

Fig. 3. SEM micrographs of CrZrN surface. Corrosion damage after potentiodynamic polarisation test; Insert images: cross section view (A) showing droplet and crater in (B).

When compared to similar CrN based coatings, as reported in other works [7-9], our study indicates that all of coatings present better behavior against aggressive chloride ions (Cl⁻). It can be concluded that the different electrochemical behavior may be associated with their different surface defect densities. Our results confirm the remarkable resistance against corrosion in NaCl solution, of CrZrN obtained by Zhang *et al.* [11]. The authors conclude that the additions of Zr into CrN coatings improved their chemical inertness and the corrosion mechanism was due to the slight pitting corrosions, which were mainly localized in the growth defects.

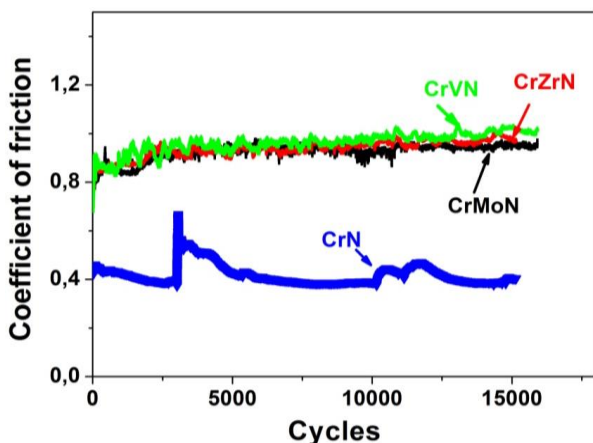
The objective of the second part of this work was to analyze the surface states of the coated samples in terms of the friction coefficient (μ) evolution during dry sliding against WC balls. Fig. 4 shows the variation in the friction coefficient as a function of the number of sliding cycles. It can be seen, at the start of test, the CrN curve shows a running-in period, characterized by an initial transient state followed by a sudden friction coefficient increase and a final gradual-steady state about 0,4.

Fig. 4. Coefficient Of Friction evolution vs cycles of coated samples.

The friction behavior of CrN against WC balls was in agreement with results obtained by other researchers [12-13] although the experimental conditions are not exactly the same.

However, the friction coefficients behavior for ternary CrN-based coatings (CrZrN, CrMoN, and CrVN) in combination with WC balls present similar features: in both cases, the friction coefficient increased rapidly at the start of the test to a maximum value of about 0,85-0,9. Thus, the wear of ternary CrN based coatings was visibly higher than the wear of CrN.

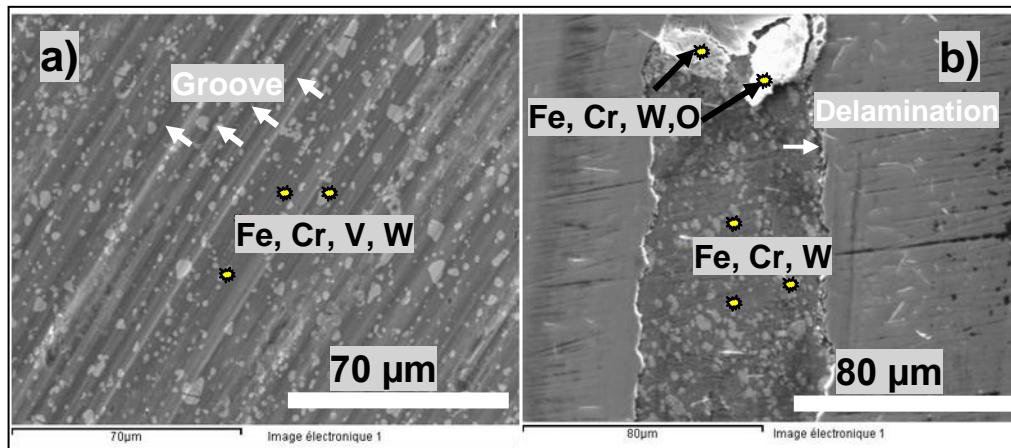
Figure 5 shows the wear scar of CrN and CrVN coatings as an example of SEM observations. The main difference is the fact that plowed grooves along the sliding direction are found on the wear tracks of CrVN, as well as CrMoN and CrZrN as presented in Fig. 5(a).

Fig. 5. SEM micrographs of wear track observed on (a) CrVN and (b) CrN when sliding against WC balls.

The wear scar of the tested ternary coatings shows abrasive marks, pits and excess wear debris. Consequently, the three-body abrasive wear was the dominant wear mechanism as reported by M.S. Priyan *et al.* [14].

No grooves and no scratches are shown inside the CrN wear scar. EDX analysis of wear tracks of ternary nitride coatings reveals the presence of coating's elements (Cr, V, Mo, Zr, N), elements of substrate (Fe) and elements of the counterpart (W). The presence of tungsten is a sign of an adhesive wear. On another hand, absence of oxygen (O) indicates that the wear track is free of oxide. Consequently, the wear mechanism of the ternary coatings seems to be a combination of abrasive and adhesive wear.

In the contrary, SEM investigations of the worn surface of CrN, Figure 5(b), reveal the presence of oxygen (O), in the middle of the wear scar. Consequently the CrN coating suffers a combination of adhesive and delamination wear. It can be noticed that the presence of debris (wear product) inside de wear track can act as a solid lubricant by rolling, and thus reducing the friction. We consider that is the reason why CrN presents lower COF evolution than other ones.
