Henri BAILLERES, Jean-Claude BUTAUD, Robert MCGAVIN, Louis DENAUD - Experimental approach of coconut peeling process - In: 22nd International Wood Machining Seminar, Canada, 2015-07-14 - 22nd International Wood Machining Seminar - Volume 2 - 2015

# EXPERIMENTAL APPROACH OF COCONUT PEELING PROCESS

## ABSTRACT

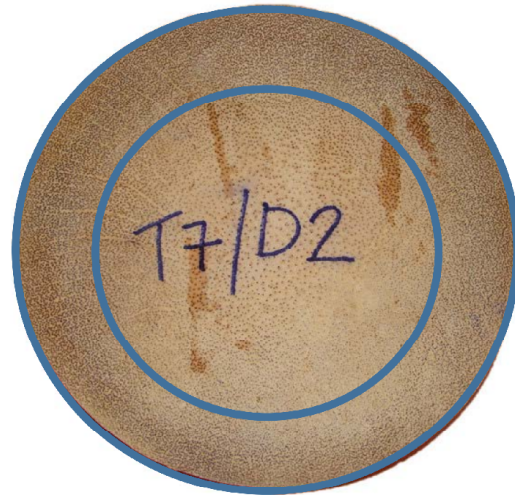
**Figure 1:** Coconut disc showing that the most valuable area for high density veneer production lies between the blue circles

The fibrovascular bundle architecture follows an interlocked helix formation as it ascends the trunk. The specific architecture of cocowood has been described as a triple helix structure (2, 3, 4). Unlike the dicotyledonous trees traditionally used by the forest products industry, coconut palm (*Cocos nucifera* L.) is a monocotyledon. Due to the huge variation in cocowood's density, production of high-quality veneers from the external part of coconut palm logs appears to be the most attractive way to use this resource (Figure 1). However, the unique structure of cocowood requires tight control of peeling parameters.
