Henri BAILLERES, Jean-Claude BUTAUD, Robert MCGAVIN, Louis DENAUD - Experimental approach of coconut peeling process - In: 22nd International Wood Machining Seminar, Canada, 2015-07-14 - 22nd International Wood Machining Seminar - Volume 2 - 2015

# EXPERIMENTAL APPROACH OF COCONUT PEELING PROCESS

**Henri Bailleres<sup>1</sup>, Louis Denaud<sup>2</sup>, Jean Claude Butaud<sup>2</sup>, Robert L. McGavin<sup>1</sup>**

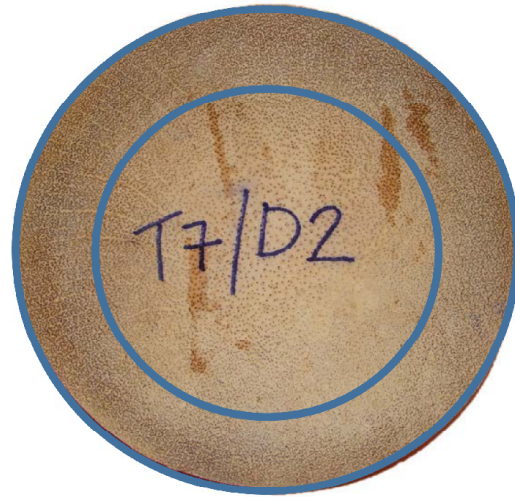
**Figure 1:** Coconut disc showing that the most valuable area for high density veneer production lies between the blue circles

The fibrovascular bundle architecture follows an interlocked helix formation as it ascends the trunk. The specific architecture of cocowood has been described as a triple helix structure (2, 3, 4). Unlike the dicotyledonous trees traditionally used by the forest products industry, coconut palm (*Cocos nucifera* L.) is a monocotyledon. Due to the huge variation in cocowood's density, production of high-quality veneers from the external part of coconut palm logs appears to be the most attractive way to use this resource (Figure 1). However, the unique structure of cocowood requires tight control of peeling parameters.
