# MICRO-MECHANISMS OF FATIGUE IN SHORT GLASS FIBER REINFORCED POLYAMIDE 66: A MULTI-SCALE EXPERIMENTAL ANALYSIS

B. Esmaeillou <sup>a</sup>, J. Fitoussi<sup>a\*</sup>, F. Meraghni<sup>b</sup>, A. Tcharkhtchi<sup>a</sup>

**Keywords:** polyamide composite, fatigue behavior, damage mechanisms

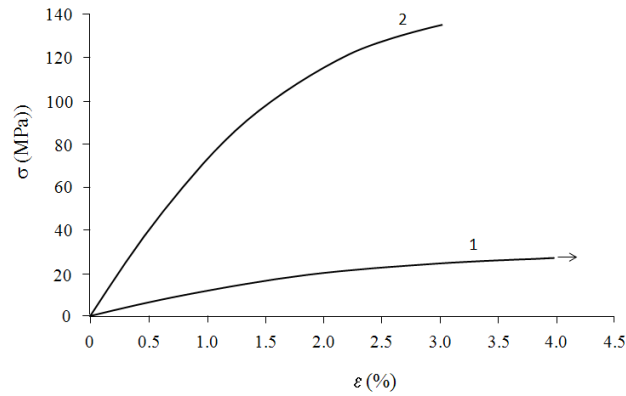
**Figure 1.** Strain-stress curves of tensile tests performed at room temperature on the neat PA66 matrix (1) and the P66/GF30 composite (2). Strain is measure by means of an extensometer

Figure 1 compares the results of tensile tests performed on the pure PA66 and on the composite PA66/GF30 at room temperature. The presence of the strongly oriented glass fibers leads to an increased modulus and a low value of strain to failure (3%). For the pure PA66 matrix the strain to failure occurs after a necking and can reach up to 200%. One can also observe a non-linear behavior beginning up to 30% of the ultimate stress. The first

nonlinearity in the composite behavior corresponds to the non-linear behavior of the matrix since the important loss of ductility is due to damage mechanisms occurring at the microscopic scale.

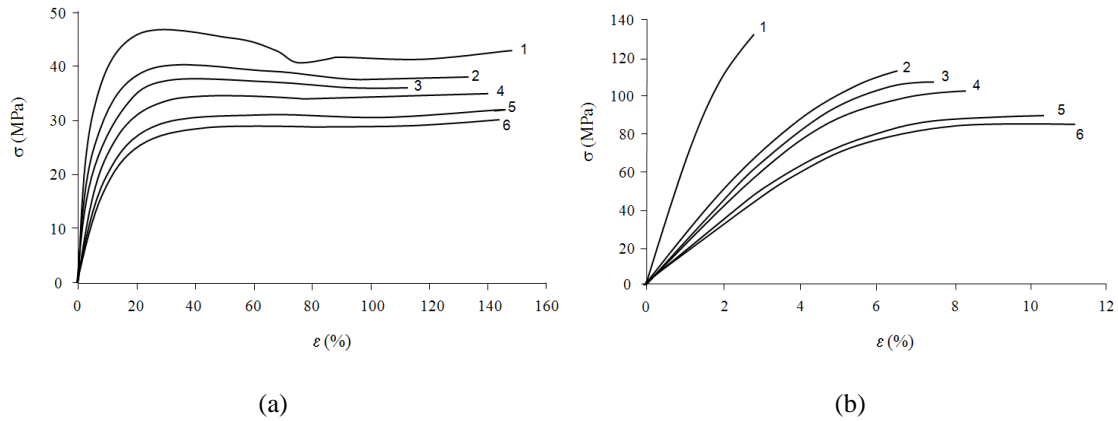
**Figure 2.** Stress-strain curves of pure PA66 (a) and PA66/GF (b) at various temperatures 25°C (1), 35°C (2), 45°C (3), 55°C (4), 75°C (5) and 90°C (6).

In order to evaluate the influence of the temperature on the pure PA66 matrix behavior, tensile tests have been performed on both PA66 and PA66/GF in a weathering (environmental) chamber at various temperatures ranging from 25°C to 90°C (figure 2). The strain was obtained using the temporal derivative of the displacement measured by a LVDT displacement sensor. Because of the limitation of chamber height, the test on pure matrix has been stopped before fracture. It can be seen in figure 2 that the mechanical properties are significantly affected by temperature especially when the temperature is higher than Tg.

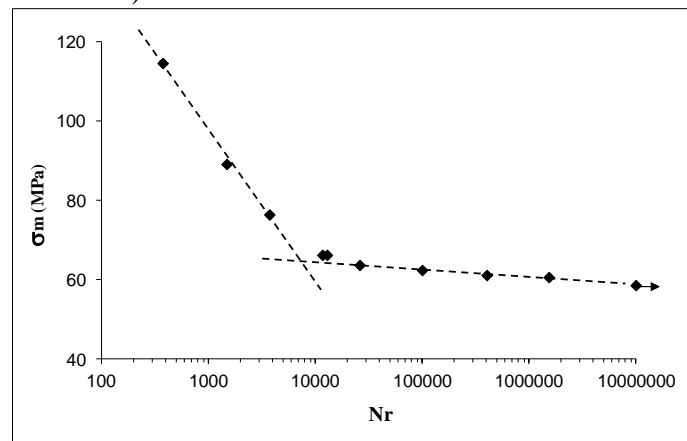
**Figure 3.** Wohler curve obtained from TTF tests performed at room temperature in tension-tension for a frequency of 20Hz and  $R=0.1$ .

Tension-tension fatigue tests (TTF) have been performed at room temperature for a frequency of 20Hz. The minimum applied stress is always chosen to be equal to 10% of the maximum applied stress (load ratio  $R = 0.1$ ). The aim of this work being to analyze the main mechanisms and fatigue regimes, only one TTF specimen was tested for each of the nine chosen applied maximum stress levels mentioned in section 1.2. From these TTF tests one can build the Wöhler curve given on figure 3.

This Wöhler curve is obtained for the studied material molded according to the specific injection conditions assuring an homogeneous distribution of the fibers through the thickness of the sample as mentioned above in section 1.1. As it can be noticed, the fatigue life is about  $10^5$  cycles for a maximum applied stress equal to 62 MPa. It reaches about  $10^6$  cycles for a maximum applied stress of 60 MPa. So, a variation of only 2 MPa leads to a fatigue life 10 times higher. It is worth noting that a pseudo-endurance limit can be reached for a stress level of 58 MPa. It corresponds to a state where no macroscopic failure on the specimen was noticed or detected until  $10^7$  cycles. However, at this level of stress local damage mechanisms can occur.

Basically, this Wöhler curve presents two different domains: higher (from 67 to 114 MPa) and lower values (from 58 to 64 MPa) of applied maximum stress. It can be noticed that the maximum stress,  $\sigma_m$ , in each of these domains can be approximated by a linear function of  $N_r$ . These two domains are separated by a transition zone around 65 MPa (intermediate maximum applied stress level).

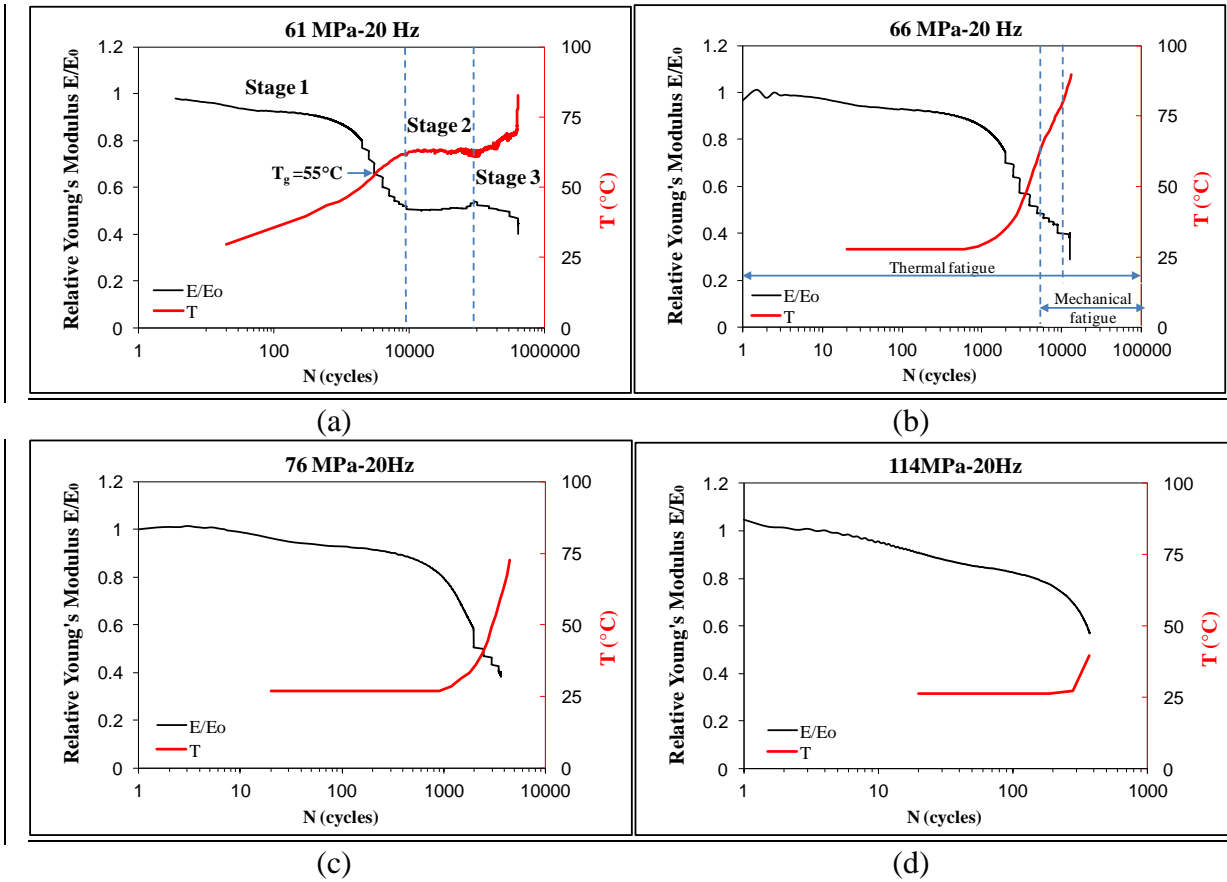
**Figure 4.** TTF curves : Evolution of the relative Young's modulus ( $E/E_0$ ) and temperature versus the number of cycles for different maximum applied stress.

The evolution of the relative Young's modulus and the temperature has been analyzed as a function of the number of cycles. Figure 4(a) shows these results obtained for a low maximum applied stress (61 MPa)

The evolution of the relative Young's modulus and of the temperature during a fatigue test shows three stages (see figure 4(a)):

- 1) Stage 1 is characterized by a rapid decrease of the relative Young's modulus according to two regimes. Simultaneously, the temperature rises due to self-heating. This stage corresponds to the setting up of a thermal regime. One can notice that during this stage, the temperature exceeds the glass transition temperature ( $T_g = 55^\circ\text{C}$ ).
- 2) Stage 2 is characterized by a plateau for both Young's modulus and temperature. During this stage, the thermal regime is established and characterized by a stable value of the temperature (up to  $63^\circ$ ) during a range of cycle from  $10^4$  to  $10^5$ .
- 3) Stage 3 is characterized by a new decrease of the Young's modulus simultaneously with a new increase of the temperature until final rupture is observed.

It is worth noting that the duration of this stage corresponds to 75% of the fatigue life ( $3 \cdot 10^5$  cycles for a fatigue life of  $4 \cdot 10^5$  cycles). It can be assumed that during this final stage, occurring after the stabilization of the temperature, damage mechanisms become predominant. An accumulation of a diffuse damage over the whole volume of the specimen is then developed.

For intermediate level of stress (figure 4(b)) corresponding to the knee point in the Wohler curve shows an inflexion point : stage 2 (stable thermal regime) tend to disappear and stage 3

(damage) remains relatively short. Indeed, one observe that the stage 2 becomes very confined for intermediate level of stress (figure 4(b)) and both stage 2 and 3 completely disappear for higher stress level (figure 4(c) and 4(d)).

This results lead to consider the influence of two main phenomenon : thermal fatigue characterized by temperature rise due to self heating and mechanical fatigue due to damage development. In the case of low applied stress level (under 63MPa), thermal fatigue appears to be the predominant phenomenon during stage 1 (elevation of temperature) and stage 2 (stabilized thermal regime) since stage 3 is mostly governed by mechanical fatigue induced by damage accumulation.

The inflexion point observed in figure 4(b) is the result of the competition between thermal fatigue and mechanical fatigue. Indeed, due to the early contribution of the damage (from 5000 cycles), the stabilized thermal regime observed for the lower stress level (stage 2 in figure 4(a)) do not succeed to take place. The application of a higher stress level tends to produce a continuously increase of the temperature mainly due to self-heating and an emerging damage. For intermediate value of the maximum applied stress level, although the effect of the damage persists, thermal fatigue tends to become predominant. For the highest values of the maximum applied stress (higher domain of the Whöler curve) fatigue response is mainly governed by thermal fatigue (self-heating). No damage stage is observed. However, one can note that self-heating is also limited when the stress level increases. Indeed, applying a high level of stress leads to a rapid failure.

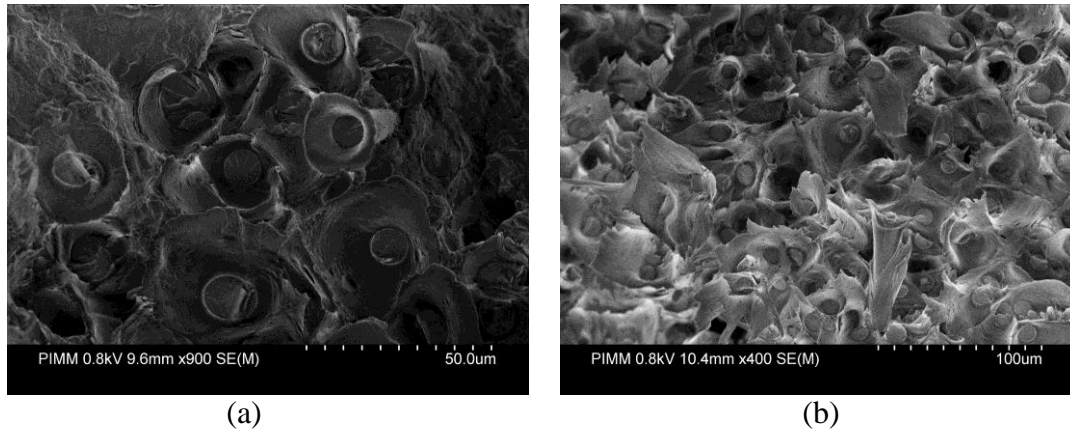
**Figure 5.** Apparition of micro-ductile areas around the fibers: (a) in the case of tension-tension fatigue test, (b) in the case of a tensile test performed at 90°C.

In order to determine the microscopic mechanisms at the origin of the fatigue behavior, SEM observations have been performed on the fracture surfaces of fatigue specimens. Micro-ductile areas have been observed around the fibers (figure 5)). This phenomenon have also been observed in the case of high strain rate loading performed on thermoplastic composites [6]. These local deformations are distributed over the whole observed fracture surfaces and are mainly due to stress concentration around the fibers leading to a more intensive self-heating localized around the fiber-matrix interface.

During a fatigue test, the presence of the fiber creates heterogeneous stress and strain fields enhancing locally self-heating due to cyclic variations of the applied stress. Consequently, the cyclic variations are more intensive around the fiber. The average temperature consecutive to self-heating is higher around the fiber. This temperature gradient leads to a more clear failure in fatigue (figure 5(a)) than in the case of the tensile test performed at 90°C (figure 5(b)).

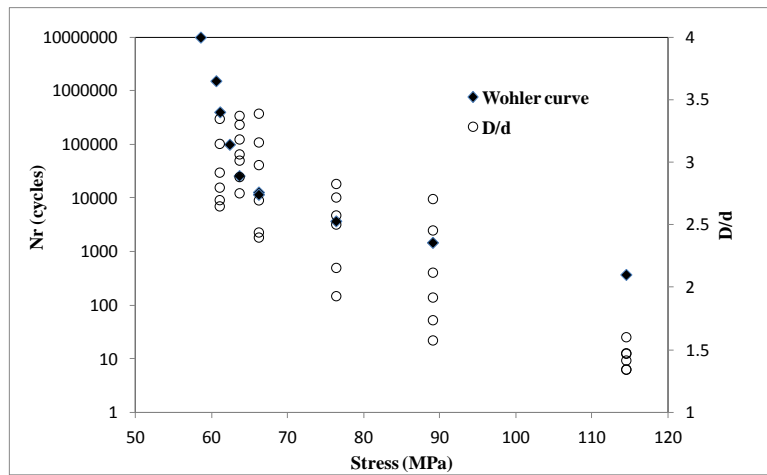
**Figure 6.** Evolution of the size of the micro-ductile areas as a function of the maximum applied stress.

Image analysis have been performed on the fracture surfaces.  $D$  is defined to be the diameter of the locally deformed area and  $d$  corresponds to the diameter of the considered fiber. In order to understand the influence of this local effect on the fatigue life, a statistical quantitative analysis relating the size of these micro-ductile areas to the maximum applied stress is proposed hereafter. Each measurement of  $D$  corresponds to average of 4 values. The evolution of the ratio  $D/d$  is plotted in figure 6 as a function of the maximum applied stress together with the number of cycle at rupture. The micro-ductile areas are observed for

maximum applied stresses ranging from 61 to 114 MPa. In this range,  $D/d$  decreases with the maximum applied stress.

When the composite is submitted to lower applied loads the whole specimen is firstly submitted to a quit uniform temperature consecutive to self-heating. However, at the microscopic scale, due to the concentration of stress, the micro-ductile zone around the fibers keep on developing (average  $D/d$  up to 3) over the whole volume of the specimen. Note that in this case, around 80% of the fracture surfaces show micro-ductile zones.
