Pascal POMAREDE, Fodil MERAGHNI, Laurent PELTIER, Stéphane DELALANDE, Nico Felicien DECLERCQ - Damage Evaluation in Woven Glass Reinforced Polyamide 6.6/6 Composites Using Ultrasound Phase-Shift Analysis and X-ray Tomography - Journal of Nondestructive Evaluation - Vol. 37, p.12 - 2018

Damage Evaluation in Woven Glass Reinforced Polyamide 6.6/6 Composites Using Ultrasound Phase-Shift Analysis and X-ray Tomography

Abstract

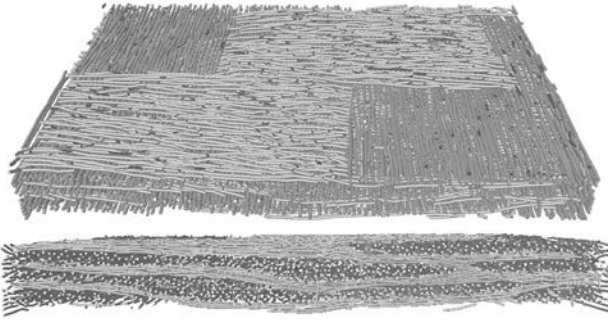
Fig. 1 Overall 3D mesostructure of the studied composite consisting of 2/2 twill weave fabric reinforced polyamide 6.6/6 matrix

The composite material considered for this study is referenced as VizilonTM SB63G1-T1.5-S3 and is manufactured by DuPont. The studied composite is produced by a thermo-compression molding process and it consists of a 2/2 twill weave glass fabric reinforced co-polyamide 6.6/6, with three plies, of 1.53 mm thick in total. The overall 3D woven fabric of the studied composite material is shown in Fig. 1. The

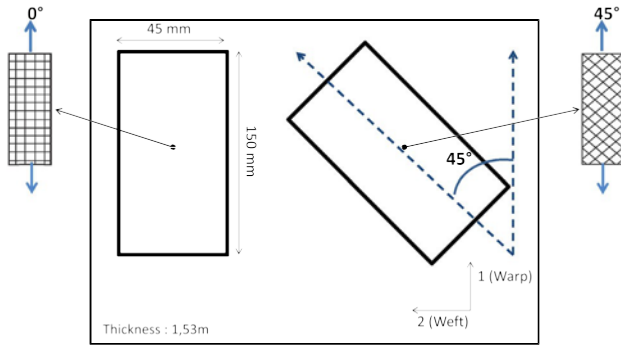
Fig. 2 Position of the samples oriented at 0° and 45° with respect to the warp direction assumed as the mold flow direction of the composite plate

weight fiber content is 63% corresponding to a fiber volume fraction of 43%. Ten samples are cut in rectangular plate of 45 mm length and 150 mm width. Four samples are cut at 45° with respect to the warp direction (mold flow direction) and six other ones are cut along the warp direction. The orientations of these two sets of samples are indicated in Fig.

2. The two different microstructures can be observed in the Fig. 3. All the samples are stored in a humidity chamber in order to have the same initial conditions in terms of relative humidity. The latter is set at a level of 50% for all tested composite material. Initial tensile tests are performed on the material until failure for both 0° and 45° sample configurations. The experimental stress/strain curves are normalized with respect of the tensile ultimate strength of the 0° sample configuration.

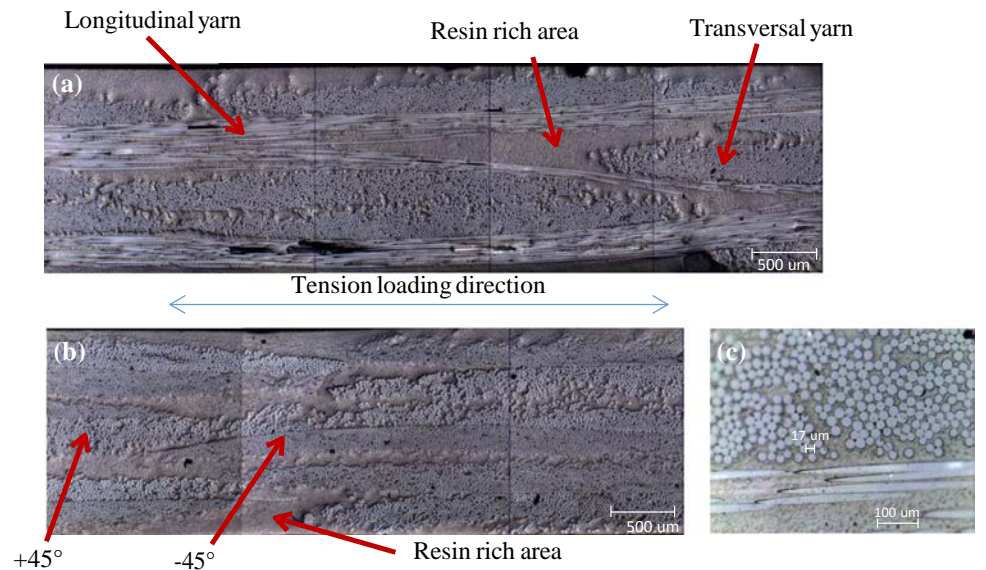
Fig. 3 Cross-sectional observation with optical microscope of the 2/2 twill weave fabric reinforced polyamide composite microstructure for samples oriented at 0° and 45°. **a** 0° sample, **b** 45° sample and **c** Zoom-in on a sample's yarns in the 0° orientation

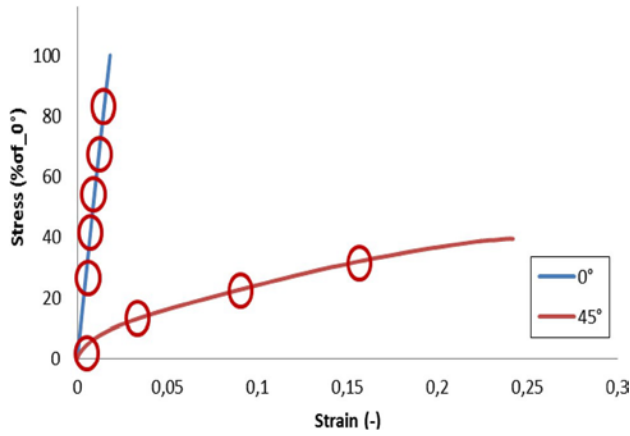
Fig. 4 Typical stress/strain responses of the 2/2 twill weave fabric reinforced polyamide composite under tension at 0° and 45° . The red circles show schematically where the tensile tests have been interrupted for both tested configurations

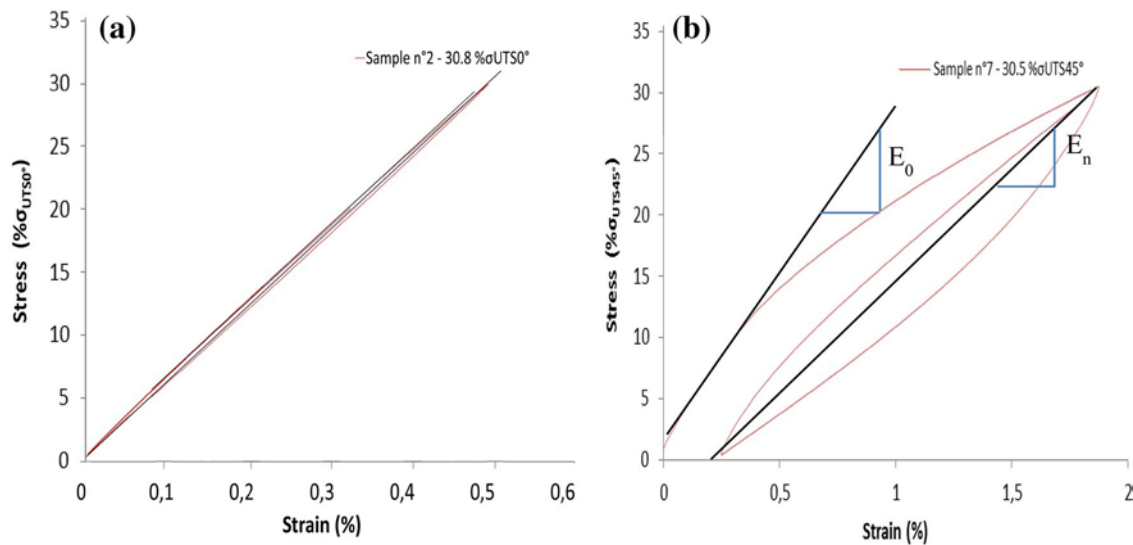
Fig. 5 Schematic representation of the elastic moduli estimation of the of E_0 and E_n for respectively **a** 0° and **b** 45° configuration samples

culated after the unloading according to a common damage measurement procedure [17]. A representation of the elastic moduli calculation is depicted in Fig. 5a, b for the two tested sample configurations.

As shown in Fig. 5, a noticeable difference is observed between the overall stress-strain responses of the two configuration samples, namely 0° and 45° . In fact, for the samples tested at 0° , the behavior in tension is mostly linear and brittle since it is governed by the fiber breakage whereas the behav-

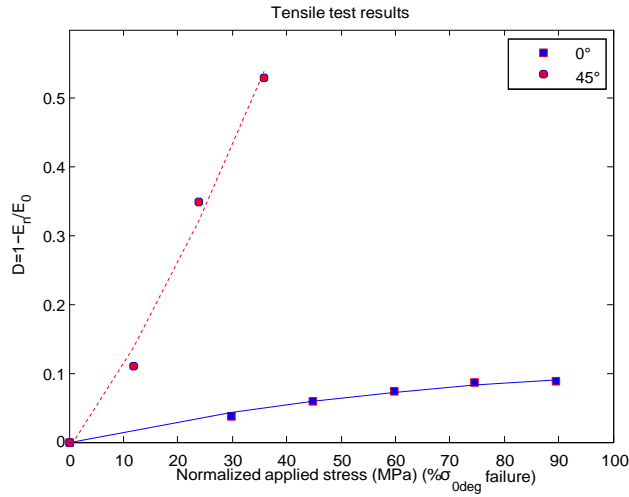
Fig. 6 Evolution of the the damage for 0° and 45° sample's configurations. The damage is estimated from the Young's modulus reduction for different applied stress levels

This is particularly clear for the evolution of the damage estimated on the elastic modulus reduction when the applied stress increases, as illustrated in Fig. 6. For the samples oriented at 45° from the warp direction, the damage D reaches a value of 0.53 close to the final failure. However, for the 0° case, it only goes up to 0.1. The values of damage for every tested sample are summarized in Table 1. This damage estimation is employed as a first reference to validate the proposed ultrasonic damage indicators detailed in further sections. Indeed, as discussed, Fig. 6 indicates a higher amount of damage induce by the loading for the 45° configuration, which could imply different damage mechanisms with different associated typical scales. In fact, to investigate the sensitivity of the ultrasonic techniques, it is necessary to consider different scales of induced damage. Hence, the typical scale of those mechanisms for the two sample configuration requires further study.

The evolution of the void volume fraction as a function of the applied stress level (Fig. 12c) exhibited a similar increase as the evolution of the macroscopic damage estimated from the Young's modulus reduction plotted in Fig. 6. Accordingly, these two quantitative estimations of the damage state, namely void volume content and Young's modulus reduction will be two actual measurements of the damage that validate the proposed new damage indicators.

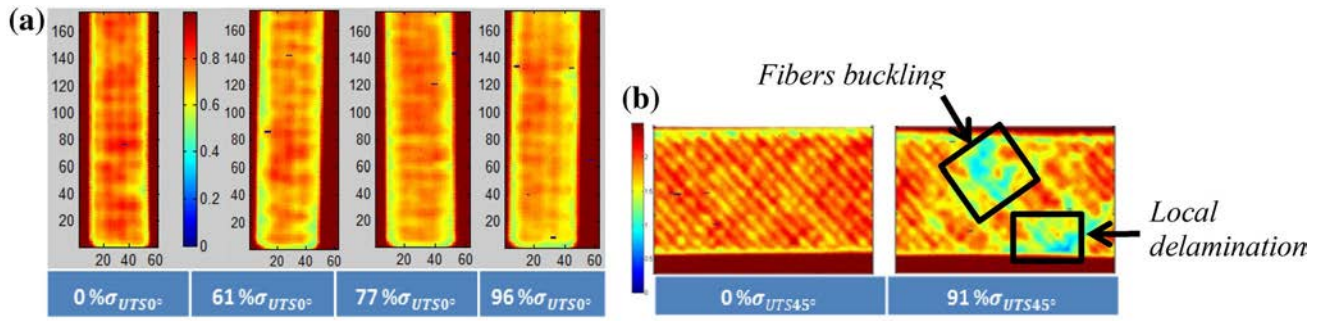
Fig. 7 Preliminary C-scan results on 2/2 twill weave fabric reinforced polyamide composite previously loaded in tension with different amplitude. **a** Samples in 0° configuration; **b** Samples in 45° configuration. For the latter, besides the large damage zones, one can easily distinguish the 45° orientation of the yarns

7a related to the samples tested at 0° from the warp direction, the attenuation of the ultrasound amplitude's signal remains low and a very slight difference, if any, was noticed when increasing the applied stress level from 0 to 92.6% σ_{UTS0} .

For the sample in 45°, the Fig. 7b shows the evolution of amplitude attenuation (C-scan images) between the unloaded state and the ultimate state level prior failure (92.6% σ_{UTS45}). Two damage zones were actually observed macroscopically and the related high attenuations in the signals were associated to the fibers buckling and the local delamination. In addition, the low signal attenuations observed at the border of the samples were clearly induced by a well-known border effect and were not caused by the mechanically induced damage.

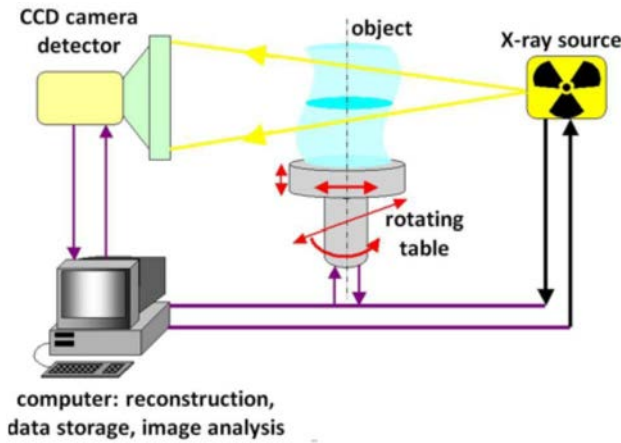
Fig. 8 Principle of the X-ray micro computed tomography techniques [22]

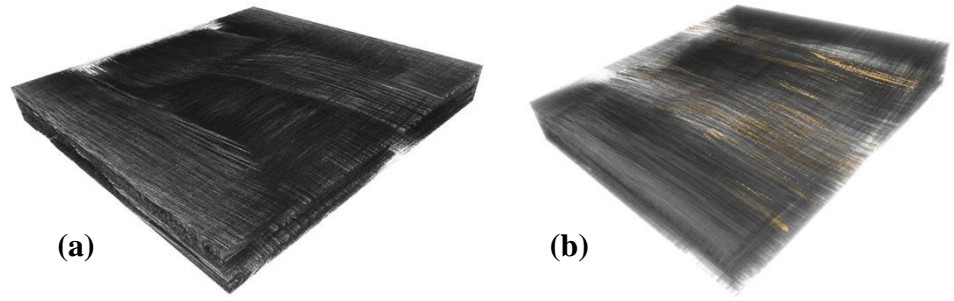
Fig. 9 **a** As received mesostructure of the 2/2 twill weave fabric composite obtained by 3D reconstruction prior to mechanical loading. **b** Initial voids and process-induced defects are represented by light color and their content is estimated using Avizo software segmentation (about 0.6% volume)

The matrix and the fibers of the composite are characterized by distinctive values of X-ray absorption. Hence, they can be easily separated on a grey level map. Air cannot significantly absorb X-ray. Consequently, the voids cannot be easily observed inside the composite samples, however during the image 3D-reconstruction, the voids appear as completely black volumes. A median filtering was first applied to the raw results to reduce the amount of noise in the images. A despeckle filter was then applied to remove the main part of the remaining interference noise. The different reconstructions were then segmented in three classes (void, matrix and fibers) using a grayscale thresholding. The Avizo software segmentation enables an accurate estimation of the volume fraction of each of the three phases. Figure 9 illustrates an

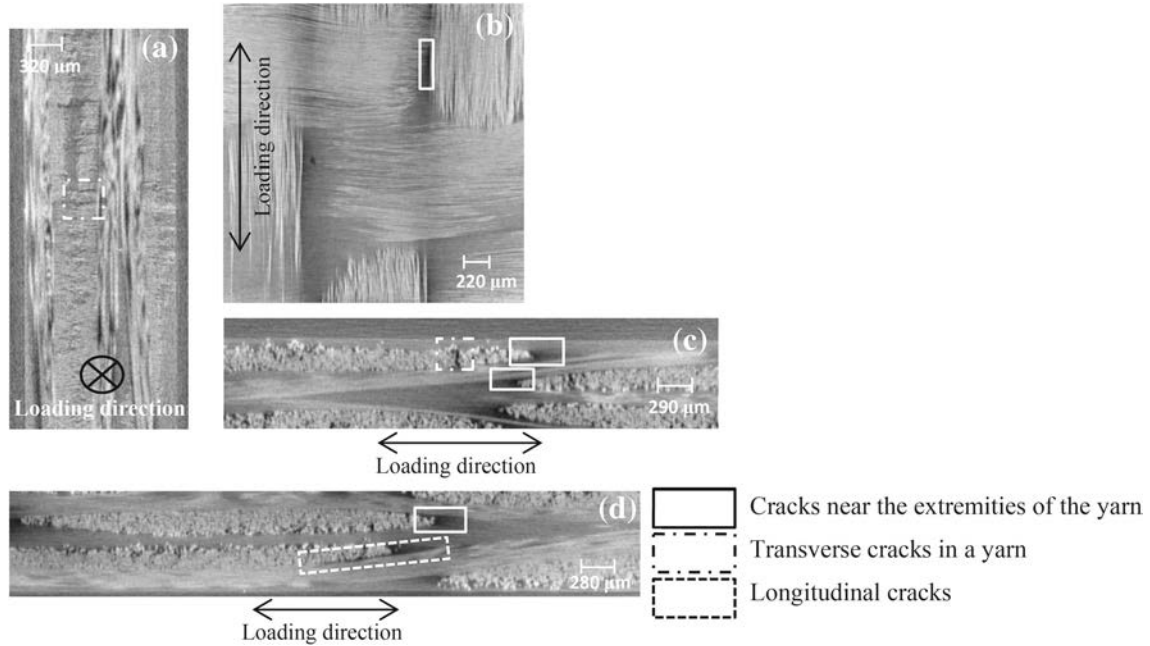
Fig. 10 Three main damage mechanisms identified for 0° sample configuration under tension loading. These main mechanisms consist in cracks near the extremities of the yarns, transverse cracks in yarns and longitudinal cracks

Some examples of damage mechanisms observed for samples in the 0° configuration are illustrated in Fig. 10. For tensile tests along the warp fiber axis, the main damage mechanisms observed were the formation of cracks near the end of the yarns (Fig. 10b, c, d), and transverse cracks inside the yarns (Fig. 10a, c), for example). Some longitudinal cracks that follow the transverse yarns very locally in the last step of damage were also observed (Fig. 10d). As the loading level increased, the number and the size of defects (cracks and voids) increased too (Tables 3, 4).

The crack inside the yarns has a characteristic thickness of $20 \mu\text{m}$, which is of the order of magnitude of the size of the fibers. Indeed, it is worth noting that those cracks are caused by fiber/matrix debonding, which propagates perpendicularly to the loading direction from one fiber to another. The cracks at the extremities of the yarn have a typical thickness

of 50 μm for the highest damaged samples. These longitudinal cracks can then propagate along the warp yarns as shown in Fig. 10d.

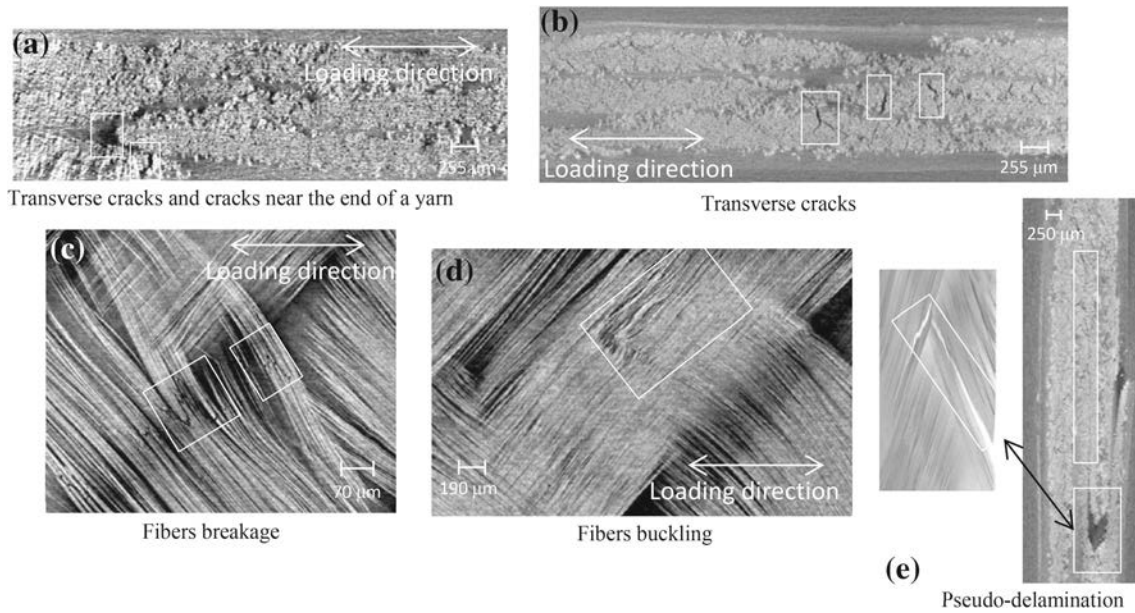
Fig. 11 The different damage mechanisms that appear when a sample in the 45° configuration is submitted to tension. These mechanisms consist in transverse cracks, cracks at the extremities of the yarns, fiber breakage, fiber buckling and yarns pseudo-delamination due to the propagation of the longitudinal cracks

For samples in the 45° configuration, all the observed mechanisms are shown in Fig. 11. Firstly, cracks at the extremities of yarns (visible in Fig. 11a) as well as cracks along the yarns were observed in Fig. 11a, b. On the 91.6% σ_{UTS45° loaded sample many local fiber breakages were also observed, some of them were already visible in Fig. 11c for the sample tested at 61.1% σ_{UTS45° . Those defects were observed around the central region of the sample, along the loading direction, especially near the edges. In Fig. 11d, some micro buckling

of fibers was noted, more notably in the sample loaded at the highest stress level. This is due to the reorientation of fibers during the loading test. Indeed, as the load increases the angle between the fibers tends to decrease but when the tension is interrupted, the fibers cannot return to their original position because of the section reduction caused by the Poisson effect. This effect of the fibers' reorientation during off-axis loading was also observed by Vieille and Taleb [23] among others. Pseudo-delamination also appeared locally after roughly $60.1\% \sigma_{UTS45^\circ}$ of loading in some specimen, as visible in Fig. 11e. It was propagated inside a yarn and followed the fiber orientation until it reached the location where the weft and warp yarns were intertwined together. When the stress level continued to increase, the crack turned and started propagating along the direction of the other yarn.

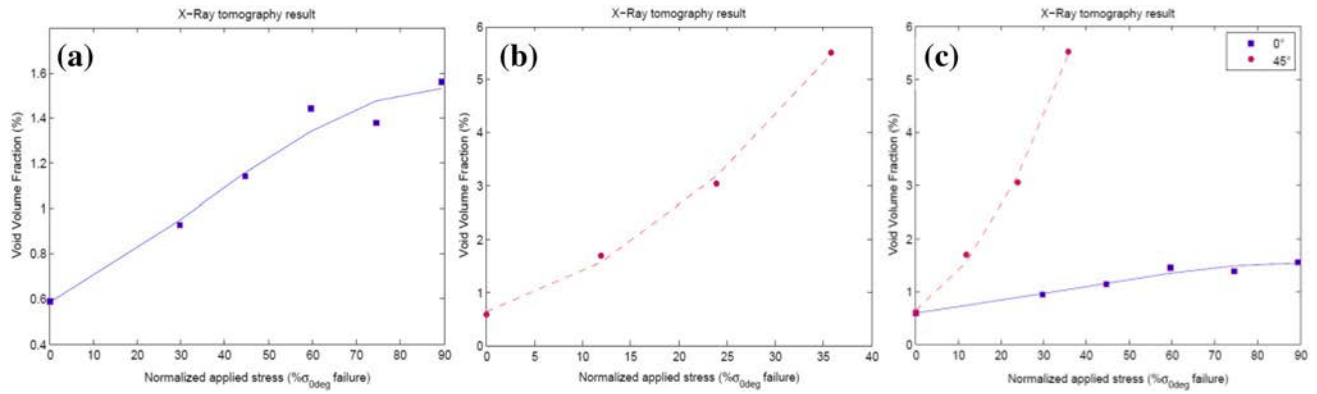
Fig. 12 Evolution of void volume fraction for **a** 0° and **b** 45° configuration of sample with increasing loading. In **c** data of both configurations are plotted for comparison purpose

The evolution of the void volume fraction is plotted for both orientations in Fig. 12. The experimental data 0° and 45° configurations are plotted as function of the stress to failure of the 0° sample (respectively Fig. 12a, b). The Fig. 12c allows an easy comparison of the two results.

The void volume fraction clearly increased with the tension loading level for both considered orientations. However, a higher growth of damage in the set of samples oriented at 45° from warp direction was observed. In fact, for the samples oriented at 0° and loaded at $92.6\% \sigma_{UTS0^\circ}$, a void volume fraction of 1.56% was measured as it can be seen on the mCT-3D reconstruction in Fig. 13. On the other hand, as shown in Fig. 14, for the sample tested at 45° for a stress level of $91.6\% \sigma_{UTS45^\circ}$, the estimated volume void content was about 5.51% . These results are in agreement with the difference in terms of the behavior between the two sample's orientations discussed in Sect. 2. Indeed, the overall response of the 45° samples was more ductile compared to the behavior of a sample tested at 0° , which exhibited a linear elastic brittle behavior.

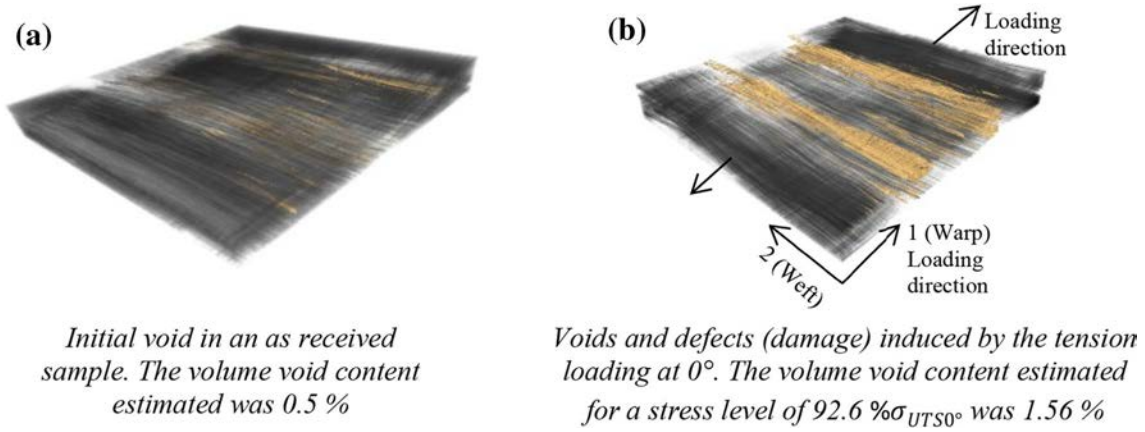
Fig. 13 mCT-3D reconstructions of composite samples in the 0° configuration respectively **a** before and **b** after tensile loading at a stress level of 92.6% σ_{UTS0°

Qualitatively, Fig. 13b shows a clear preferred orientation of the damage accumulation, which is perpendicular to the

tension loading direction for the samples oriented along the warp direction (0°). In the case of the 45° samples, the cracks grow along the two yarns direction as visible in the Fig. 14b.

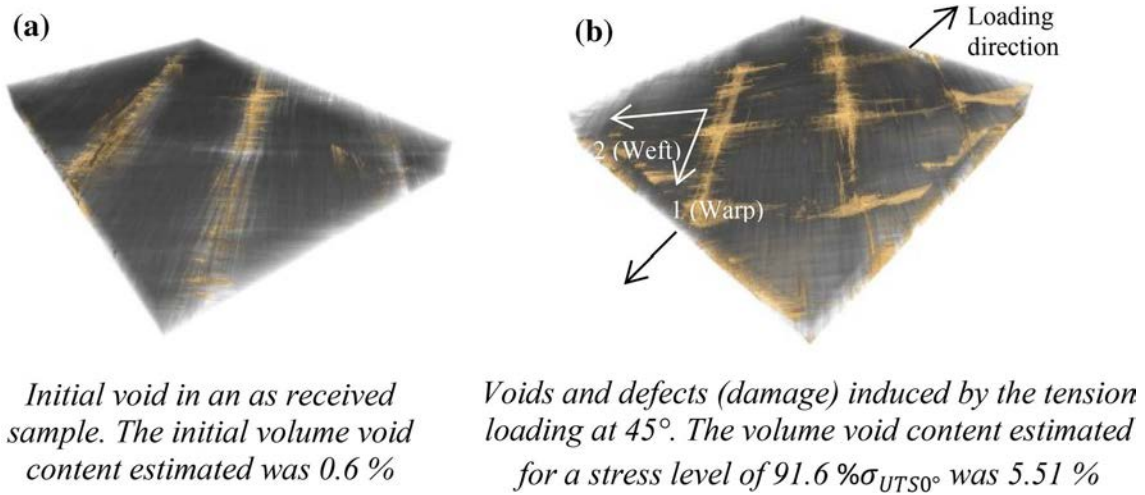
Fig. 14 mCT-3D reconstructions of composite samples in the 45° configuration respectively **a** before and **b** after tensile loading at a stress level of 91.6% σ_{UTS0°

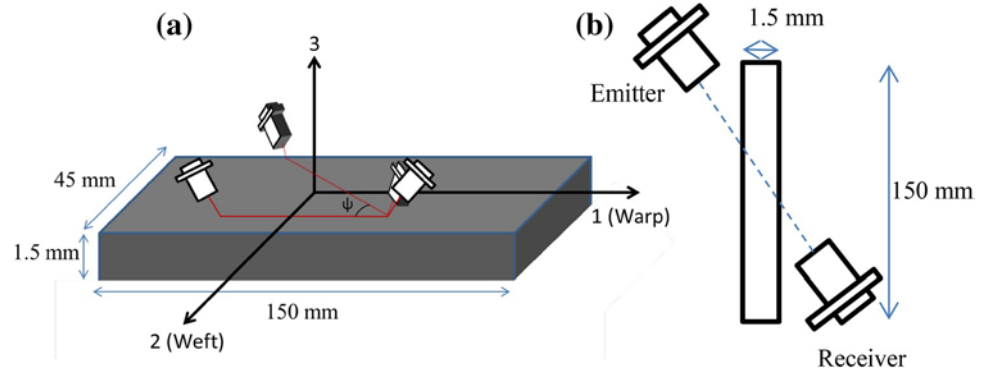
Fig. 15 Schematic representation of the two planes of interest: **a** the plane 1–2 or azimuth plane and **b** the plane 1–3

The composite is considered as orthotropic prior to loading and remains so even after the damage induced by the tensile loading. The elastic linear behavior of the composite can be described using nine stiffness components. However, considering the dimensions of the sample, only measurements in two principal planes were performed as illustrated in Fig.

15. These measurements only permitted obtaining seven out of nine stiffness components. It was observed that along the plane 1–3, quasi longitudinal and quasi transversal mode 1 can be measured. For the plane 1–2, on which guided waves propagate, the frequency and phase velocity of the transmitted signal was measured. Consequently, after comparison with the dispersion curves in Fig. 16, the mode S2 was propagating in the composite.

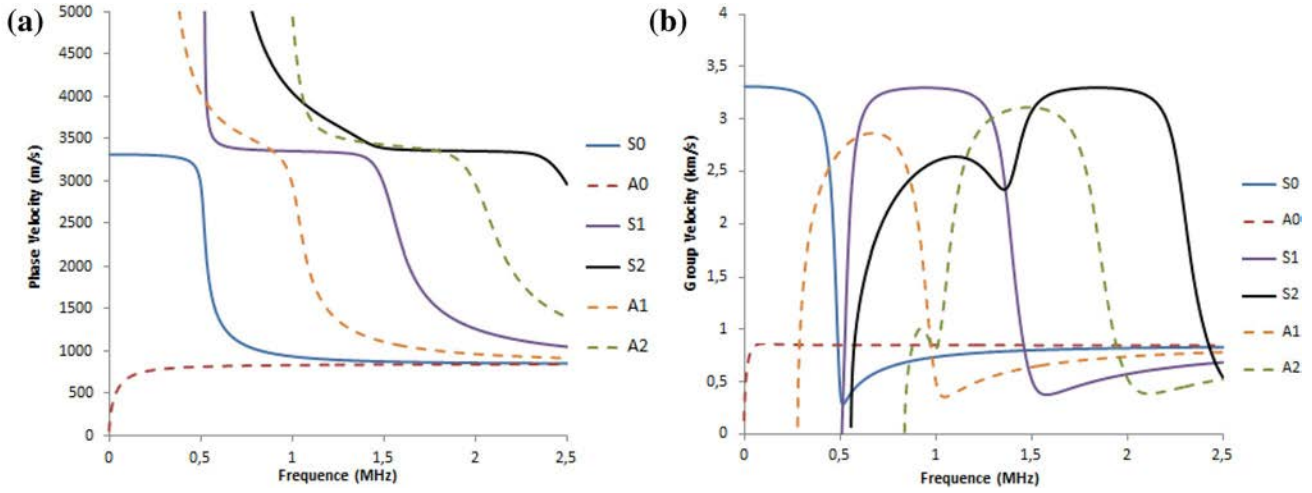
Fig. 16 Dispersion curves computed with the *Disperse software* for guided wave propagation in a 1.53mm thick studied composite along the fibers direction. **a** Phase velocities, **b** group velocities

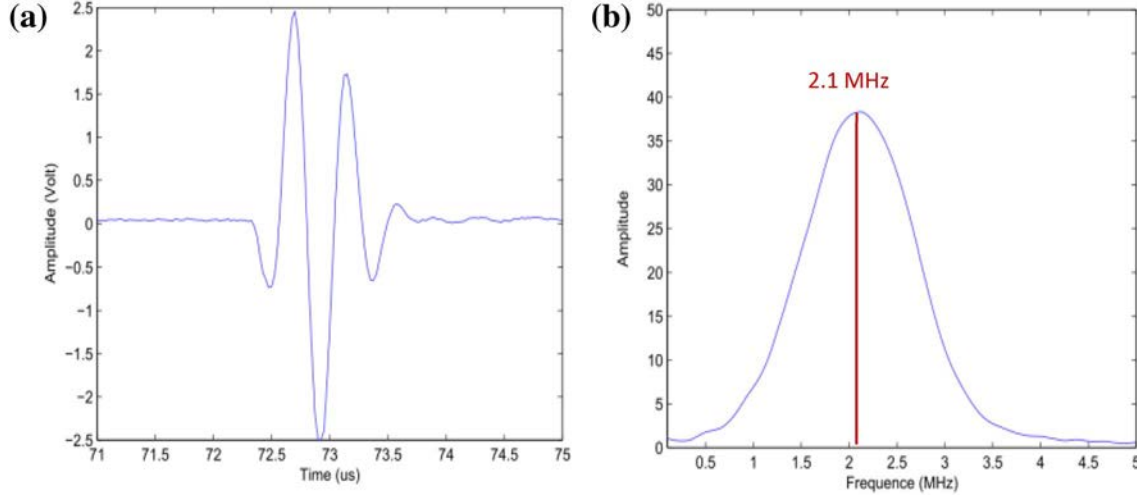
Fig. 17 **a** Emitted pulse signal and spectrum **b** for a 2.25 MHz center frequency transducer. The experimentally measured center frequency is about 2.1 MHz

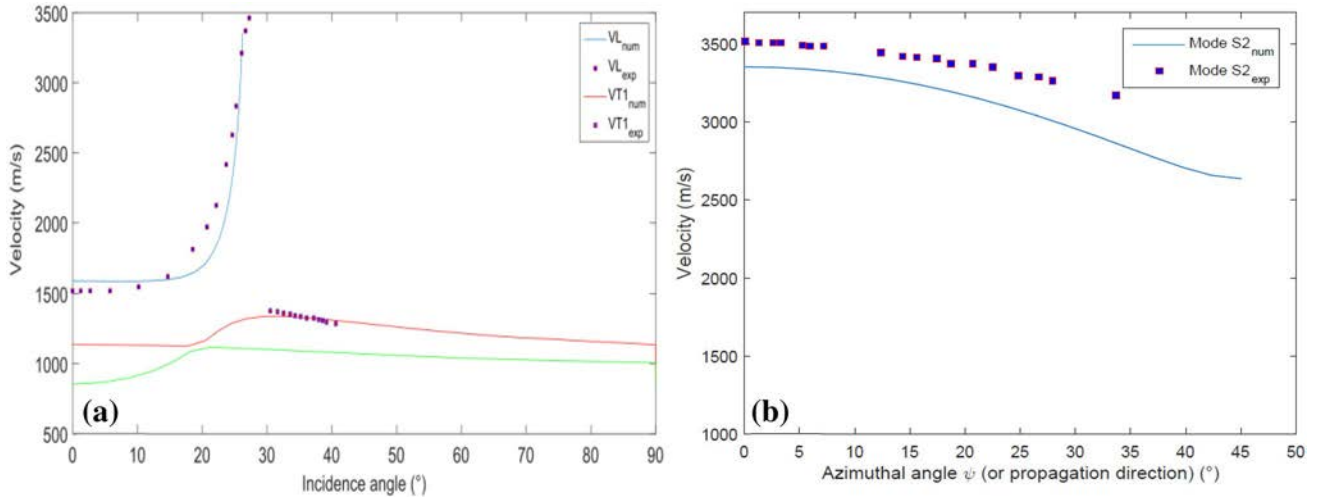
Fig. 18 Comparison of numerically and experimentally determined propagation wave velocities. The experimental values are represented by points whereas numerical values are represented in continuous line. **a** Plane 1–3; **b** Plane 1–2 or azimuth plane

Before running the optimization procedure for obtaining the stiffness constants, a computation of the expected velocity as a function of the incidence angle was performed. The quasi longitudinal, the quasi transversal 1 and the quasi transversal 2 modes propagated in the 1-3 principle plane were calculated for a refraction angle ranging from 0 to 90°. This computation was based on the stiffness matrix obtained by periodic

homogenization (Table 5). The computed velocities were compared to those obtained experimentally for the undamaged sample. The same calculation was made for Lamb wave propagation in the 1-2 planes, more particularly for the S2 mode. The comparison of experimental and analytical velocities of wave propagation is illustrated in Fig. 18. It confirms that the mode experimentally measured corresponds to the actual wave mode that was assumed to propagate in the composite material.

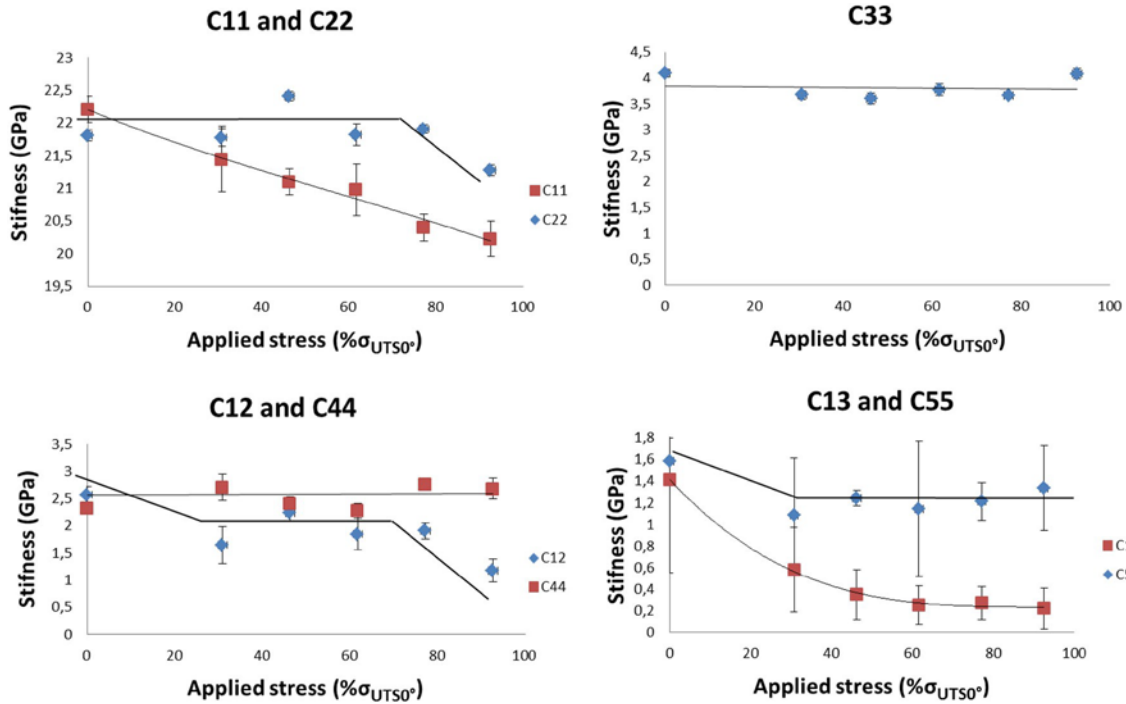
Fig. 19 Evolution of seven of the stiffness constants, function of the tensile stress, with the increase of the loading for the 0° configuration of sample with their respective confidence interval

For the undamaged sample oriented along the warp direction (0°), the experimental stiffness constants were close to the numerically obtained results as observed in Table 5. The evolution of the stiffness constants is plotted in the Fig. 19 with their respective confidence interval. Furthermore, it was noticed that the global evolution of the stiffness components was close to the results discussed by Hufenbach et al. [9]. An important decrease of the components C₁₁ and C₁₃ was noticed, whereas a smaller decrease of C₁₂ and C₅₅ and

One can then conclude that the components depending on the loading direction (direction 1), namely C_{11} and C_{13} were more affected by the damage. The component C_{12} was also impacted by the damage but at a lower extent.

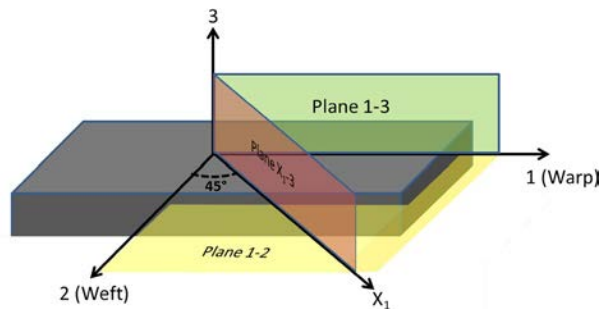
Fig. 20 Schematic representation of the different propagation planes of ultrasonic waves. For samples in the 0° configurations, the planes 1-3 and 1-2 were used. For the samples in the 45° configuration, the plane X-3 and 1-2 (or azimuth plane) were used

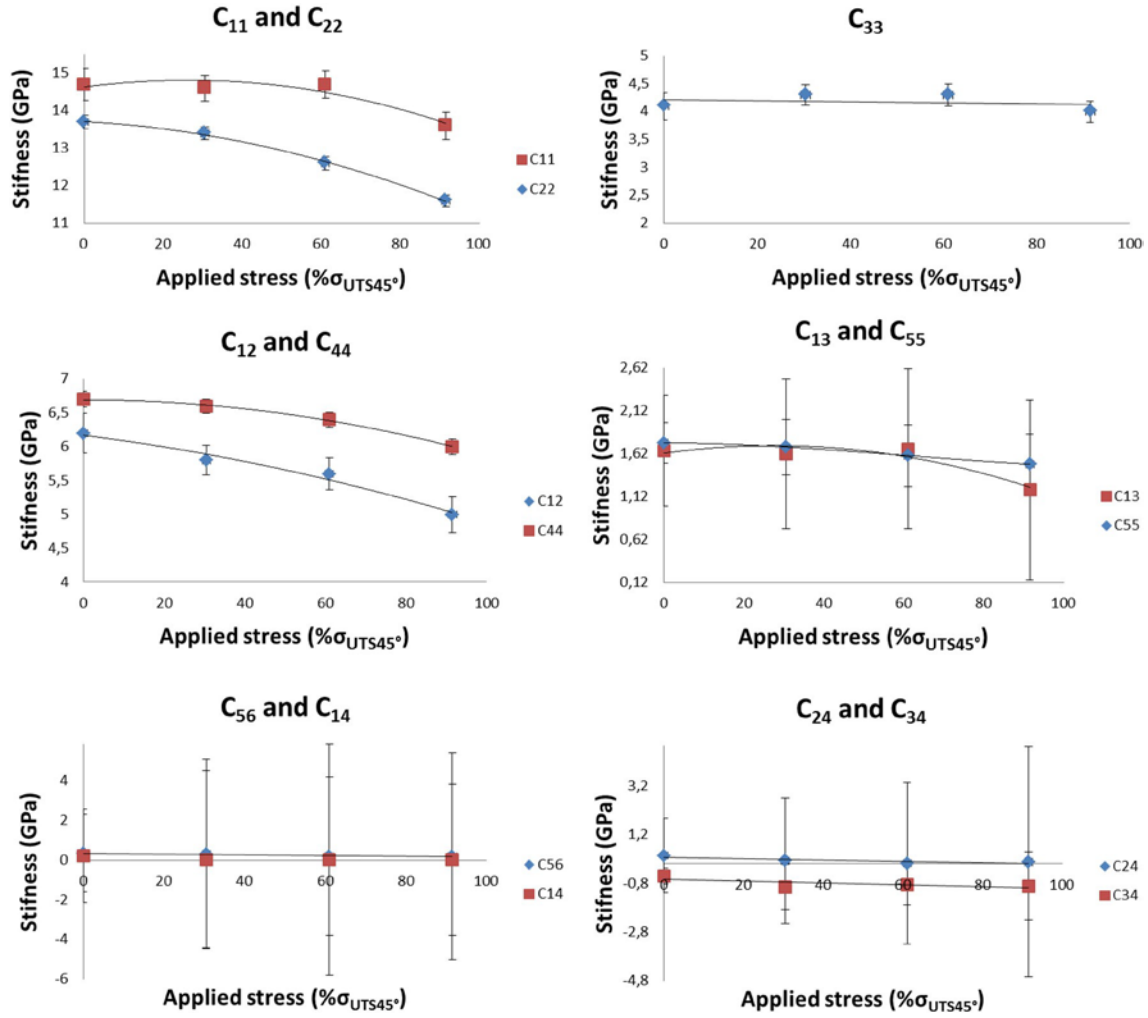
Fig. 21 Evolution of seven of the stiffness constants with the increase of the applied stress level for different 45 ° configuration of sample with their respective confidence interval

The evolution of the stiffness components is plotted in Fig. 21 with their respective confidence interval. During the first steps of the loading, the components that are a function of the loading direction (especially C_{11} and C_{13}) did not change at

all, but they dropped drastically after 61.1% σ_{UTS45° . The shear components C_{44} and C_{12} were of course impacted from the beginning of the test. The components C_{33} and C_{55} did not really change during the tensile tests. This led to a very different damage behavior compared to the other sample configurations. Some minor changes were observed for the C_{56} , C_{14} , C_{24} and C_{34} components. However, the confidence interval was very large when compared to the other stiffness components. This is explained by the lack of measurement in two additional planes as mentioned earlier. The major impact from the loading on the shearing components was clearly detected with the present method. Furthermore, this was in agreement with the damage mechanisms observed in the previous section. Indeed, it is worth recalling that the fiber buckling was caused by the reorientation of the fibers which was induced by important local shearing in the meso-structure.

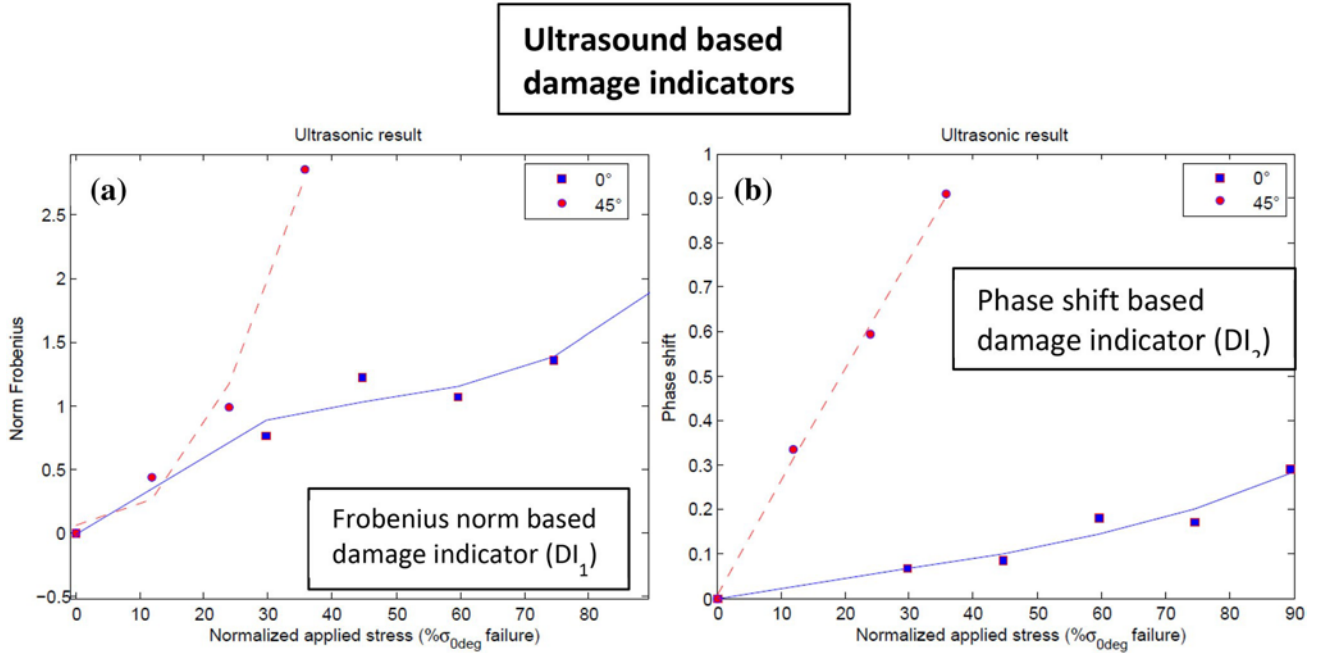
Fig. 25 Proposed ultrasonic damage indicators. **a** Evolution of Frobenius Norm and **b** Phase shift indicator. Those indicators are plotted for the sets of samples oriented at 0° and 45° from the warp direction and function of the normalized applied stress level

The two proposed ultrasound based damage indicators (DI₁ and DI₂) are respectively plotted in Fig. 25a, b. As illustrated in this figure, the evolution of the Frobenius norm for
