8th CIRP Conference on High Performance Cutting (HPC 2018)

On the optimization of the cutting conditions for an improved corrosion resistance of OFHC copper

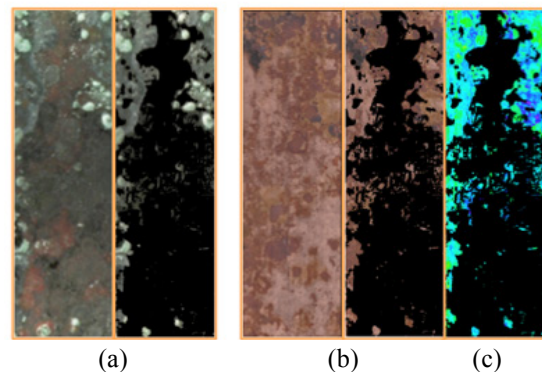
Fig. 1. Evaluation of the volume of copper dissolved by mm^2 covered by atacamite.

oxidation reaction per mm^2 covered by atacamite (the green color) was quantified. In fact, the oxidized surface was taken in photo by a high-resolution microscope *KeyenceTM*. Then, the surface was cleaned from oxides and taken again into photo. The topography was measured by optical microscope *AliconaTM* using the variation of focal distance technique. The volume of *OFHC* copper that disappeared from the oxidized surface was calculated by treating automatically the images under *Matlab[®]* (cf. Figure 1) using a script developed for the study making the following tasks:

- Isolation of green zones (covered by atacamite) starting from a photo of the oxidized surface as shown in Figure 1a.
- Starting from the image of the cleaned surface, isolating topographies of zones corresponding to those covered by green before the cleaning as shown in Figure 1b.
- Visualization of the topography corresponding only to the filtered zones as shown in Figure 1c. Level 0 corresponds to the mean plan of the freshly machined surface, before the aging test ($R_a < 800\text{ nm}$).
- The program calculated the volume of copper that has removed (valleys) under the zones previously covered with atacamite, and divided it by the green analyzed surface, which gave a mean value of the depth of the dissolved substrate.
