High temperature strain heterogeneities tracking within hole-specimens of FV566 turbine steel via digital image correlation

Jianguang Bao ^{a,b,*}, Adil Benaarbia ^{c*}, Siyuan Bao ^d, Xiaofeng Guo ^a, Yonghong Wang ^{d*}, Wei Sun ^a

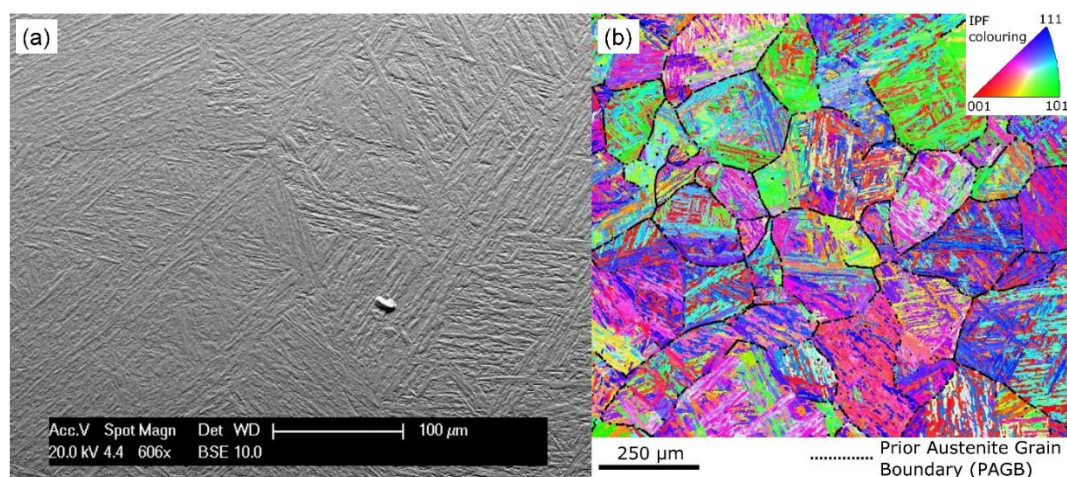
Fig. 1. (a) Backscattered electron image and (b) an EBSD orientation map of the as received FV566 material. The prior austenite grain boundaries are highlighted in black using 23°-41° misorientation angles.

Fig.1a presents the microstructure of the FV566 steel after heat treatment with the average grain size of 30 μm . After tempering, a typical tempered martensitic microstructure in the as-received material can be seen in Fig.1b [33]. Prior austenite grains (PAGs), packets, blocks, sub-blocks and laths, were involved, as has been noticed in [34]. Also, according to the Kurdjumov-Sachs orientation relationship with the parental austenitic phases [35], the PAGs in the as-received material are less than 300 μm in size with the misorientation in a range of 23° - 41°. Sub-blocks and laths have the average misorientation angles of 1.8° and 8.3°, respectfully.

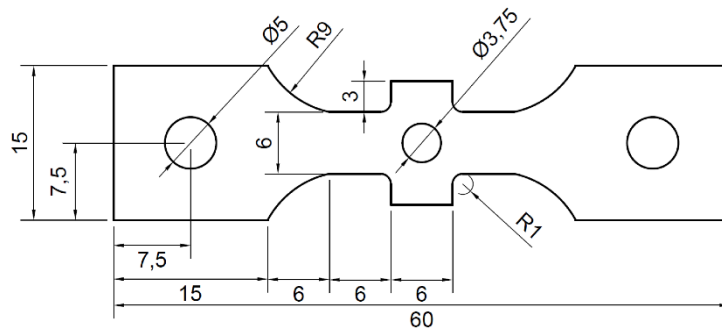
Fig. 2. Specimen configuration (All dimensions are in mm, the thickness is set at 2 mm).

Many structural components possess geometrical features such as holes, corners or gaps that are necessitated by design to accommodate fasteners, joints, or for weight reduction. Under the influence of combined thermal and mechanical loads, such stress concentration sites may become initiation sites of void nucleation and fracture [30]. The local strain fields can be highly inhomogeneous in such biaxial, or in general triaxial, stress states [36]. Hence, specimens with a hole of $\varnothing 3.75$ mm at the central part and symmetrical protrusions of 3 mm on both extremities were designed and tested under high temperature tensile loading. The holes of $\varnothing 5$ mm on both sides were machined to satisfy the loading pins' requirement. Dimensions of the specimen are shown in Fig. 2.

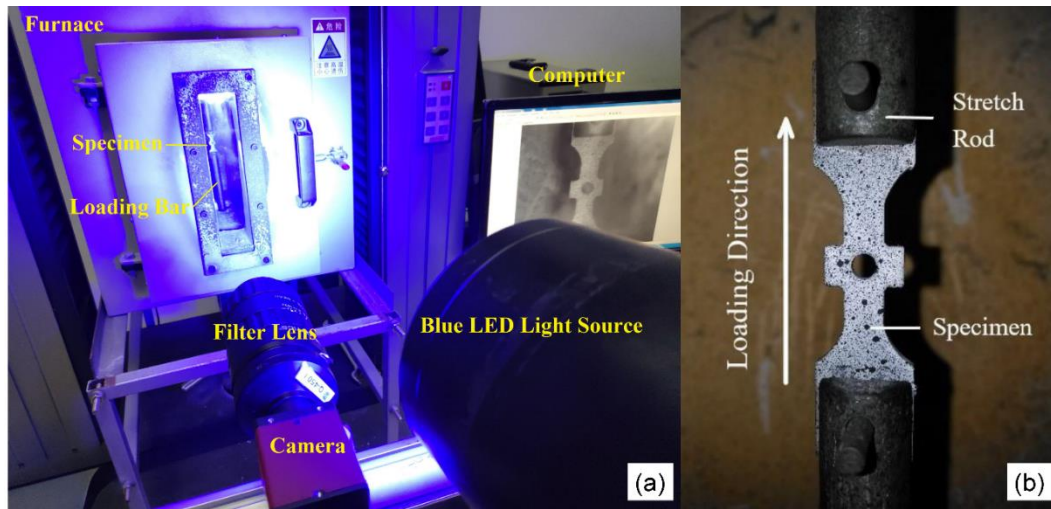
Fig. 3. (a) The experimental setup showing the digital camera used for the DIC measurements, a high temperature furnace, a narrow band pass filter lens of 441 nm \pm 10 nm bandwidth and a monochromatic light source with the wavelength of 440 nm \pm 20 nm. (b) The test specimen sprayed with a black/white speckle.

Different techniques are available in the literature to generate the high temperature resistance speckle for DIC [38]. In order to increase the contrast between the speckle pattern and the background, the specimens were first covered with white inks and then, after a drying process, the black ink speckle pattern was sprayed. The pretreatment was necessary for a better adhesion of spray painting for high temperature environments. The gauge part was first ground with coarse grind paper to increase its surface roughness. After cleaned the grease on the surface and rinsed with water, the specimens with white painting were placed in a furnace for 2 hours at 200°C in order to make the white paint solidified completely. The same procedure was repeated for the black one. Furthermore, the white uniform ink layer serves to avoid "shiny" surface, sensitive to the light reflection [39]. The example of obtained speckle pattern for the test specimens is presented in Fig. 3b.

The experimental setup is shown in Fig. 3. It consists of a high temperature furnace equipped with a glass window, a charged-coupled-device (CCD) camera (AVT Stingray F-504B), a band-pass filter (441 nm \pm 10 nm), a blue LED light source and a stretching machine. The

furnace was employed to monitor the test temperature up to 600 °C. The detector of the camera was operated with a 2452 by 2056 pixels window size and 19 μm pixel size. The camera was positioned on a tripod approximately 1 m from the specimen surface. It was fixed and kept perpendicular to the gauge part during the loading in order to collect reliable visible images. The camera frame rate was set at 4 frames per second to obtain enough sampled data while the integration time was set at 50 ms. The blue LED light source with a wavelength of 440 nm \pm 20 nm was used to provide quasi-monochromatic illuminations.

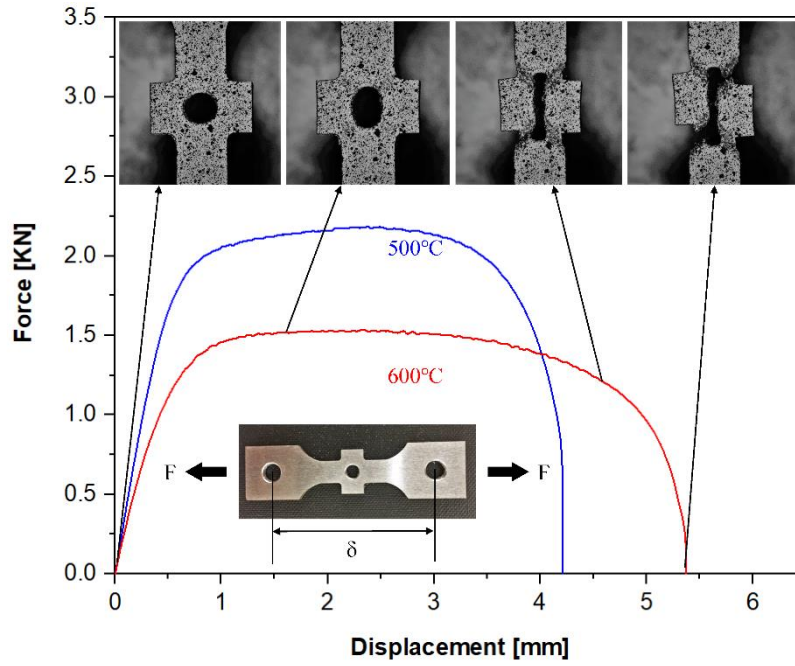
Fig. 4. The F (force) vs. δ (displacement) curve of the test specimens under both 500 °C and 600 °C temperatures, along with four images captured by the digital camera at different stages of the test.

The tensile responses (force vs displacement) of the investigated specimens for both 500 °C and 600 °C test temperatures are given in Fig. 4. The results show a maximum reachable load increases for low temperatures (the ultimate force decreases by about 30% when going from 500 °C to 600 °C). Also, the tensile strength at 500 °C was higher than that at 600 °C, showing a noticeable temperature dependence effect. A macroscopic structural softening, highlighted by a displacement of necking lips, is also observed followed by a broad plateau. This ductile behavior is more pronounced for the high test temperature conditions, exhibiting the fracture displacements of ~ 4.2 mm and ~ 5.4 mm for 500 °C and 600 °C, respectively.

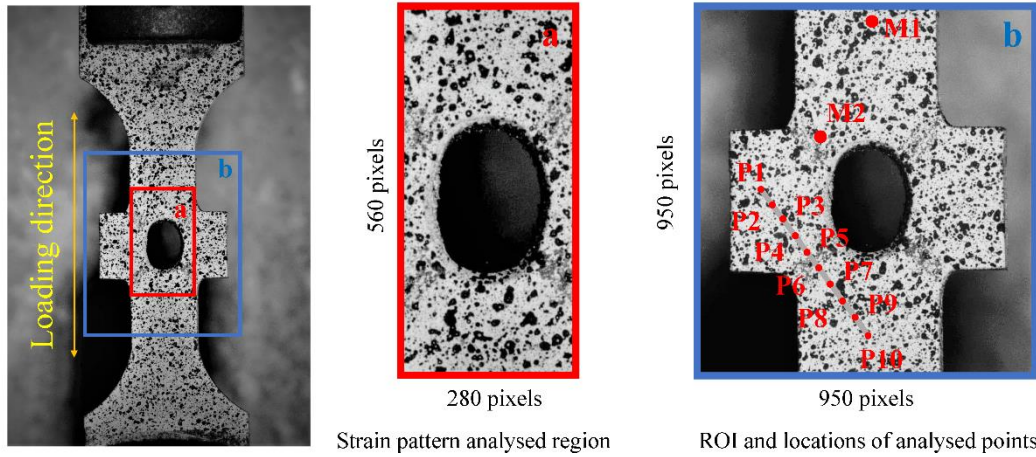
Fig. 5. Subfigures highlighting the region of interest, region for strain pattern analysis and locations of points of interest for the local kinematic analysis.

The kinematic assessments were analyzed in terms of the mean logarithmic strain components. The objective was to track the possible development of strain localization zones throughout the tensile test. The local mechanical response of the test specimens at the region of interest (ROI) was thus evaluated (see Fig.5). Dantec Dynamics software was used to post-process the visible images and assess the strain maps. Note that a preload of 100 N was performed prior to the tensile test in order to eliminate the superfluous load and strain resulted from the vacuum and thermal expansion. A subset of 41×41 pixels and a grid step of 17 pixels were used to evaluate the strain tensor at each point of interest. Cubic B-spline interpolations with normalized squared differences criterion were chosen. An area corresponding to a hole of $\varnothing 3.75$ mm at the ROI and symmetrical protrusions of 3mm on both extremities, with a size of 300000 pixels (Approximately 820 subsets per specimen), was chosen as the ROI (see Fig. 5).

Selected points $\{M_k\}_{k=1,2}$ were considered for the time dependent strain analysis (see Fig. 5b). Figs. 9a and b depict the temporal evolution at both 500 °C and 600 °C test temperatures of the selected longitudinal and transverse strain components, ϵ_{xx} and ϵ_{yy} , respectively. It can be seen that at the beginning of the tests, all strain components had very small magnitudes. After 300s, the absolute strain values at M_2 started to increase rapidly with time, while those at M_1 seemed to slightly evolve throughout the test. Indeed, Fig. 9a shows that the transverse strain curves at both temperatures were almost identical. Fig. 9b shows that the orders of magnitude of the longitudinal component for M_1 were smaller compared to those of M_2 ,

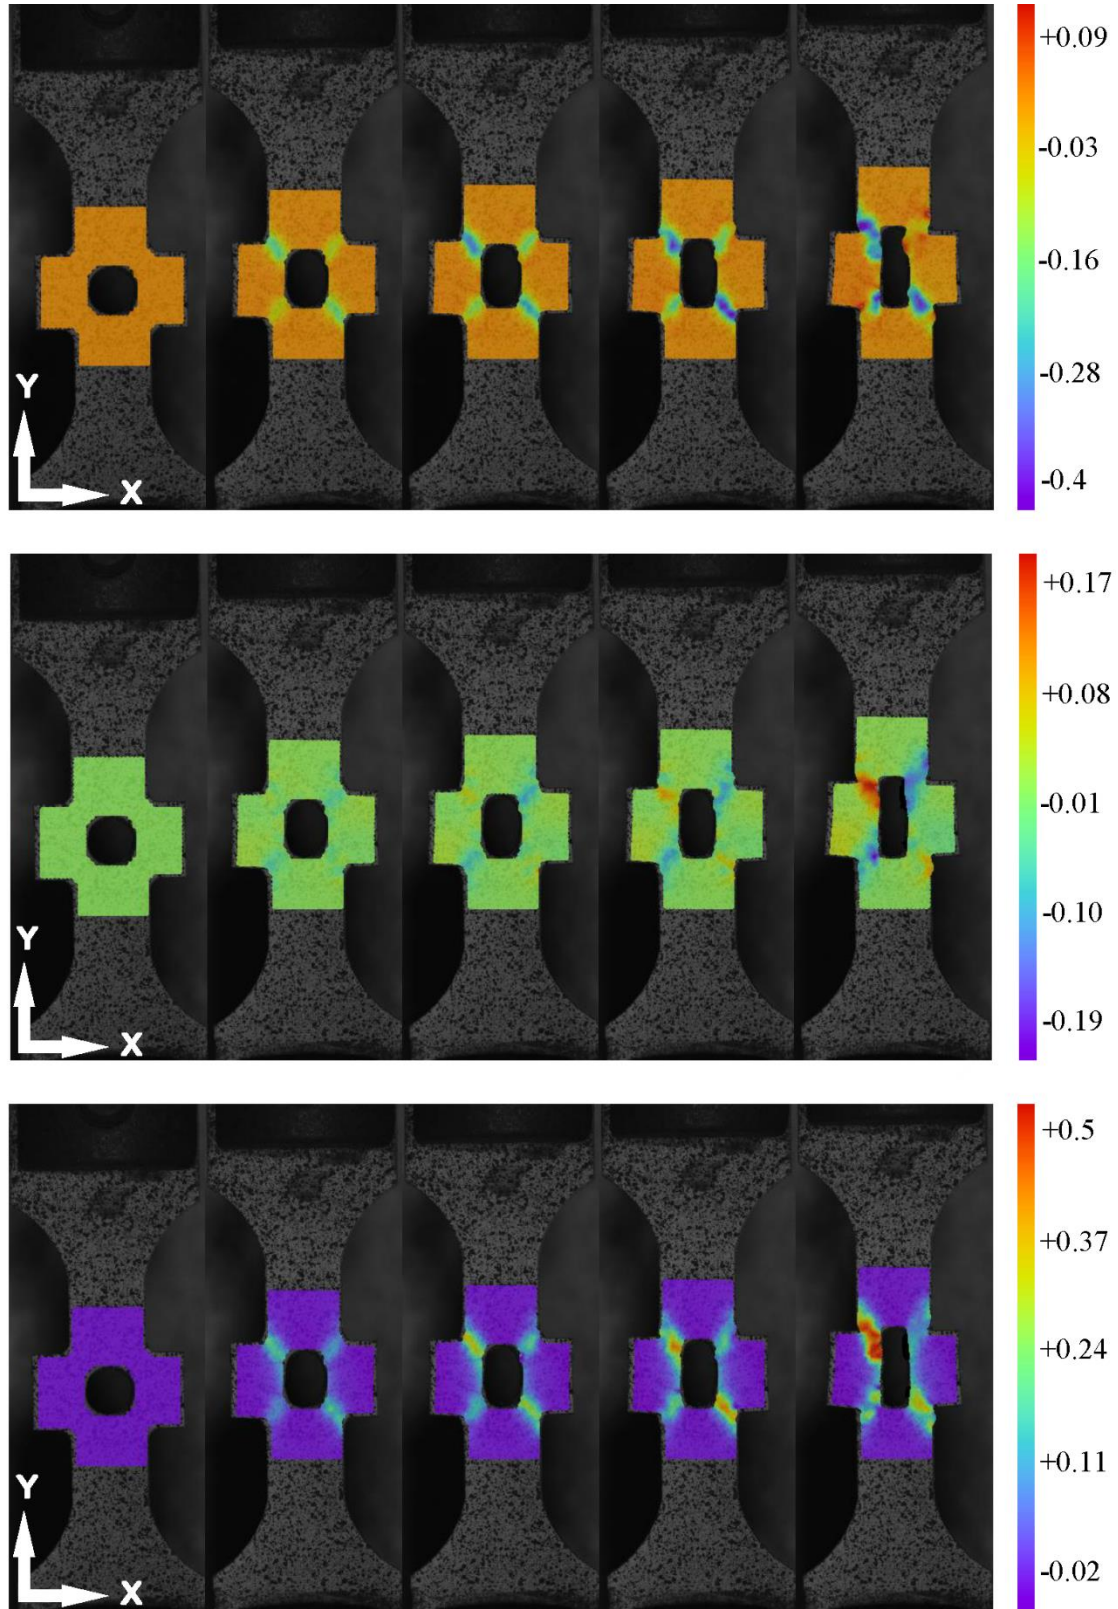
Fig. 6. 2D maps of the transverse strain, ϵ_{xx} (top), shear strain, ϵ_{xy} (middle), and longitudinal strain, ϵ_{yy} (bottom) at: the very beginning of the test ($\tau_1=0s$), intermediate times ($\tau_2=810s$, $\tau_3=1060s$ and $\tau_4=1310s$) and the last stage before the macroscopic fracture ($\tau_5=1877s$). These results were extracted from measurements performed under the 500 °C test temperature.

Fig. 6 and Fig. 7 show the full-field strain maps for the investigated FV566 tensile specimens at both 500 °C and 600 °C test temperatures, selected at different specimen life stages (τ_1 , τ_2 , τ_3 , τ_4 , τ_5). The spatial resolution was set at 20 μm per pixel. The results show a precocious and gradual development of strain localization zones. These zones were clearly visible for all the strain components (longitudinal, ϵ_{yy} , transverse, ϵ_{xx} , and shear, ϵ_{xy} , components). For 500 °C condition, at the very beginning of the loading, the spatial heterogeneities were less visible as indicated at τ_1 . These heterogeneities started to intensify at the following life stages till the macroscopic failure (see Fig. 6). It is worth noting that the painting near the strain concentration zones (where the hole is located) eroded due to the high temperature and large displacement exhibited by the test specimens. This results in inaccurate strain estimate at the last stages before the macroscopic fracture. Note that most of the observed hotspots were located around the specimen hole at the ROI due to the geometry singularity. Nevertheless, the strain field contours show that the strain concentrations were not perfectly symmetric. For the transverse strain, the top-left and the bottom-right sides of the hole were slightly intensive than these on the top-right and the bottom-left sides. However, at the instant τ_5 , some of strain localization zones were significantly less intensive than others. This is probably caused by inhomogeneous features of the investigated specimen and/or the inaccuracy of the measurements. The spatial distributions of the longitudinal strain component on the top-left side of the hole were more intensive than these on the bottom-right side. From a statistical point of view, the absolute values of both the minimum and maximum longitudinal strain were almost the same at the

very beginning of the loading, highlighting the homogeneous character of the investigated gauge part. However, with the increase of the load, the absolute value of the minimum longitudinal strain was about thousand-fold lower than the maximum longitudinal strain. For the shear component, the spatial strain concentrations were mostly located on the top-left and top-right sides of the hole. As expected, the localization patterns seemed to progress preferably according to 45° angle (with a shape of “X” letter). At 600 °C (see Fig. 7), the strain localizations for the transverse and longitudinal components showed similar patterns as those obtained for the 500 °C condition while the higher values of the shear strain were appeared at top-right and bottom-left side with a shape of “/” from where sample fractured finally.

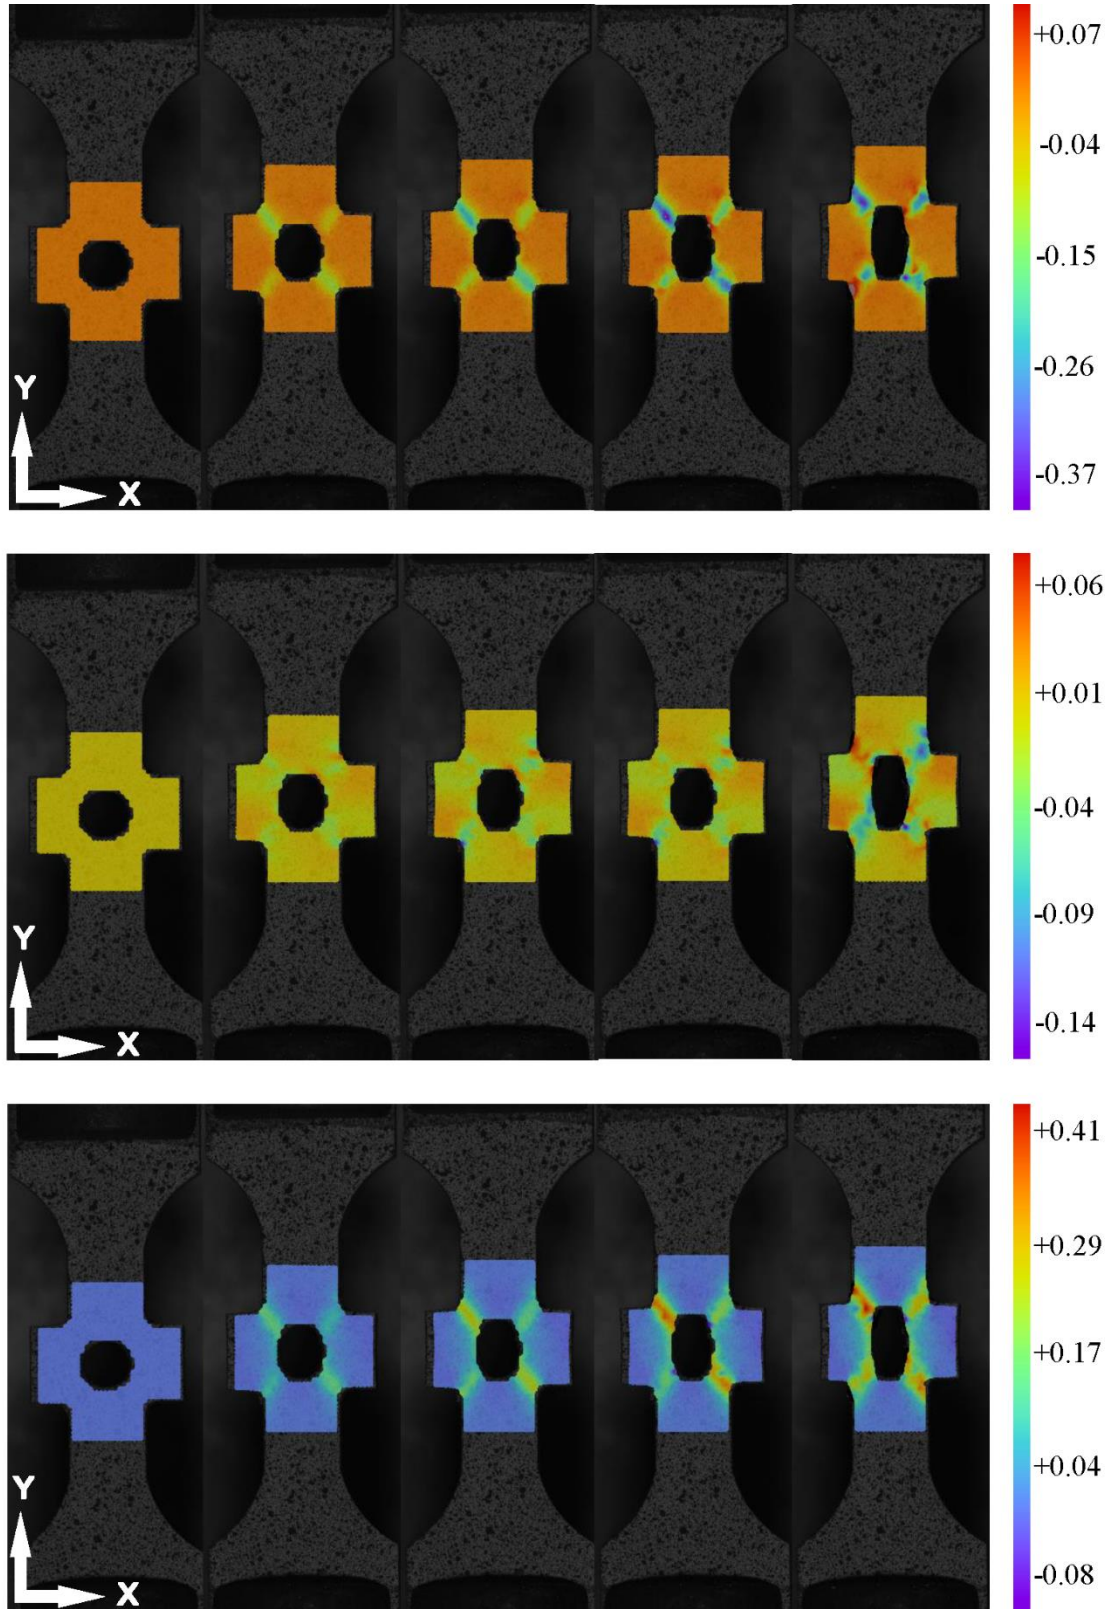
Fig. 7. 2D maps of the transverse strain, ϵ_{xx} (top), shear strain, ϵ_{xy} (middle), and longitudinal strain, ϵ_{yy} (bottom) at: the very beginning of the test ($\tau_1=0s$), intermediate times ($\tau_2=810s$, $\tau_3=1060s$ and $\tau_4=1310s$) and the last stage before the macroscopic fracture ($\tau_5=1709s$). These results were extracted from measurements performed under the 600 °C test temperature.

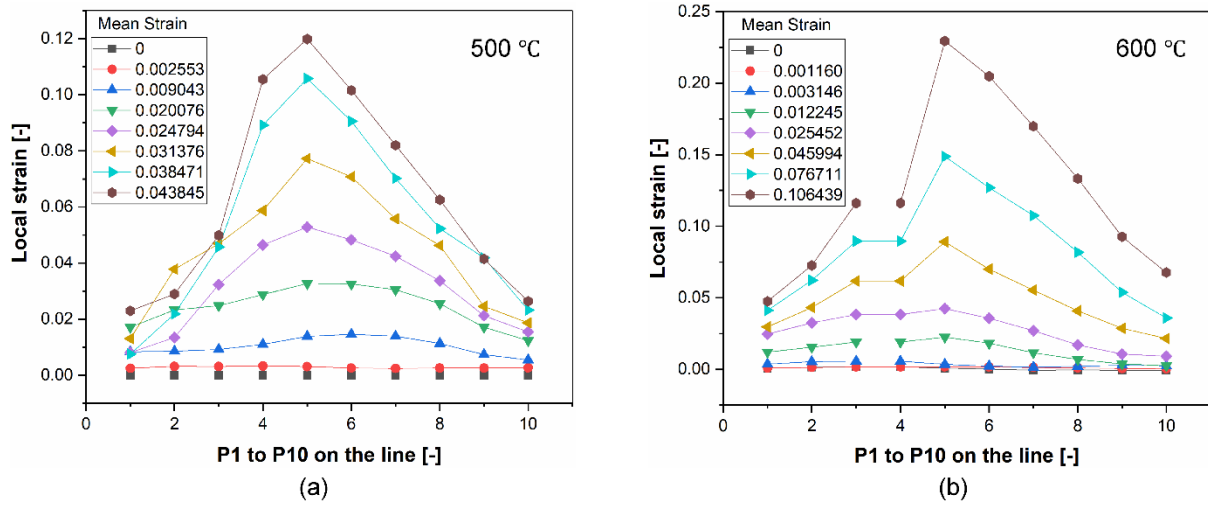
Fig. 8. Spatial-temporal distributions of the longitudinal strain component extracted at the selected points $\{P_i\}_{i=1,\dots,10}$.

Fig. 8 depicts the local spatial profiles of the longitudinal strain component, selected at different life stages (corresponding to different average strain values on the total line) and different location points $\{P_i\}_{i=1,\dots,10}$ (see Fig. 5b), from which a strain concentration zone is activated. At the very beginning of the loading, the strain distribution on the selected points was uniform. Then, strain concentrations started to appear for both temperatures when the local maximum strain magnitude reached 0.01. As expected, the local strain magnitude for both P5 and P6 was higher compared to that of the other location points. This is due to the fact that these points (where the peak of strain is occurred) are located close to the regions where the strain heterogeneities are more pronounced. The necking is especially driven by these high strain concentrations as it is highlighted in Fig. 4.

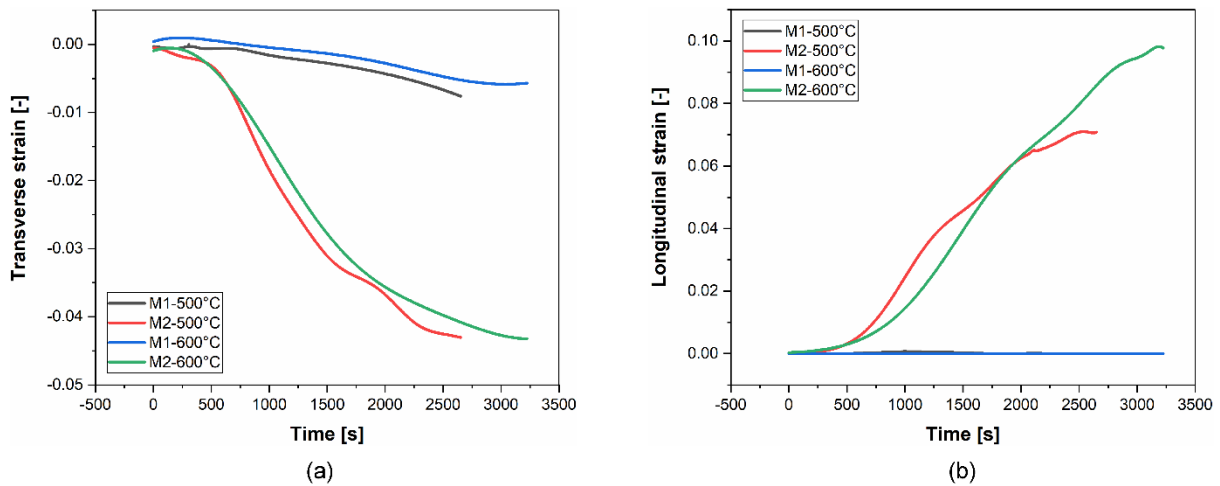
Fig. 9. (a) True transverse strain curves, and (b) true longitudinal strain curves with respect to the test time at M₁ and M₂.

which were almost identical to the true principle strains under both test temperatures. This allows to suggest that the longitudinal strain component significantly contributed to the ductile failure of the specimen. The maximum longitudinal strain value at 600 °C was around 0.1, while this value reached 0.07 at 500 °C, highlighting the effect of temperature on the ductile damage evolution of the FV566 steel under investigation.

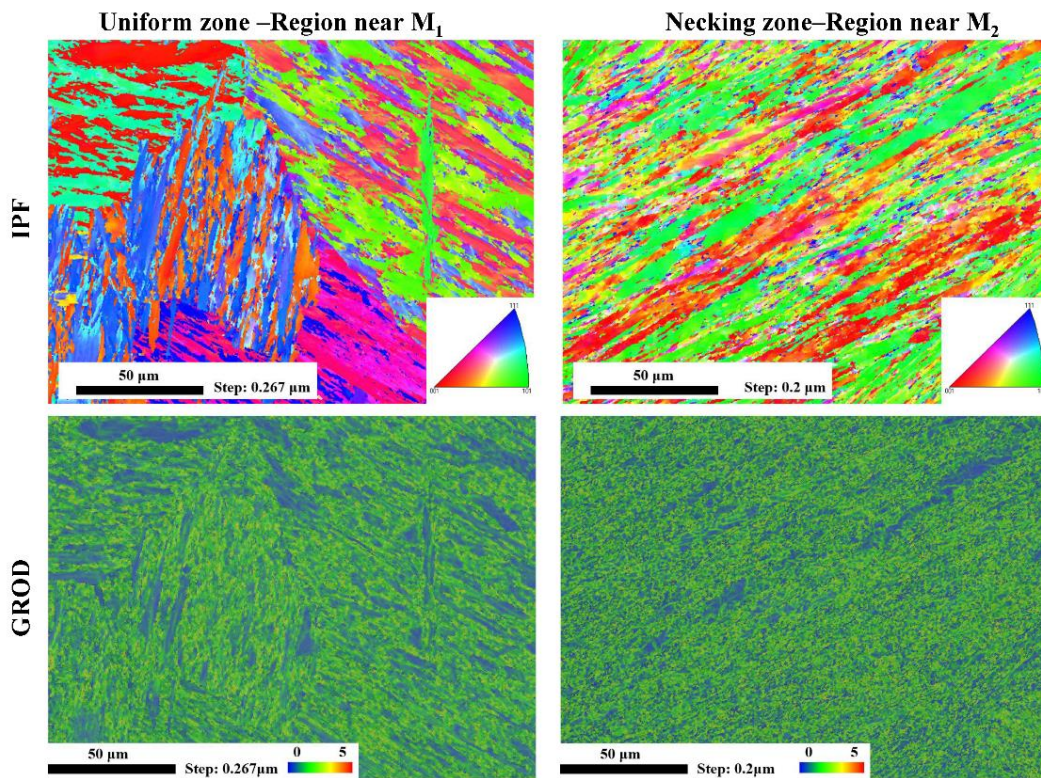
Fig. 10. EBSD results of the uniform M_1 (left) and necked M_2 (right) zones extracted from 600 °C test fractured sample.

Two areas from the ruptured surface, close to the DIC time dependent analysis regions (i.e. M₁ and M₂) were further investigated to highlight the microstructure evolution. Extensive EBSD examination has been conducted and the results are presented in Fig. 10. The inverse pole figure (IPF) images show that the pre-existing martensitic microstructure was significantly distorted along the principal loading direction, accompanied with the formation of a finer martensitic substructure. In addition, the presence of sub-block boundaries at 5 to 6 degrees in the as-received material as well as the variation of sub-block boundaries and the frequency of the low angles boundaries are highlighted in Fig. 11. The findings suggest that the dislocation slip could be the dominant deformation mechanism for the material, since dislocation slip activated by the high temperature and tensile loading may generate a large number of dislocation accumulations, which can contribute to the formation of the low angles boundaries [40]. As is well known, dislocation movement in the crystal is normally arrested by various obstacles (e.g. solid solution atom, forest dislocation, grain boundaries, etc.) during

the tensile deformation process, however the mobile dislocation can slip through the obstacles due to the thermal activation and the applied stress. In the present work, the slip system of the crystal in the FV566 steel was activated under the high temperature conditions, thereby a part of the crystal sliding was relative to the other part, which finally lead to plastic deformation.

Additionally, the grain reference orientation deviation (GROD) parameter was introduced to compare the local crystal deformation in two separate zones of the fractured specimens. It is proven to be linearly related to the nominal plastic strain under both tension and creep condition [41]. The higher value of GROD extracted from the necked zone implies that the plastic deformation in the necked area is larger than that in the uniform zone away from the fracture area, which is consistent with the aforementioned DIC measurement results. As is observed in Fig. 6 and Fig. 7, significant strain concentration was observed around the necked area due to the geometry singularity of the tested specimens. The strain concentrations in the necked area result in the deformation heterogeneity and microstructural rearrangements of the FV566 specimen at high temperature tensile conditions.

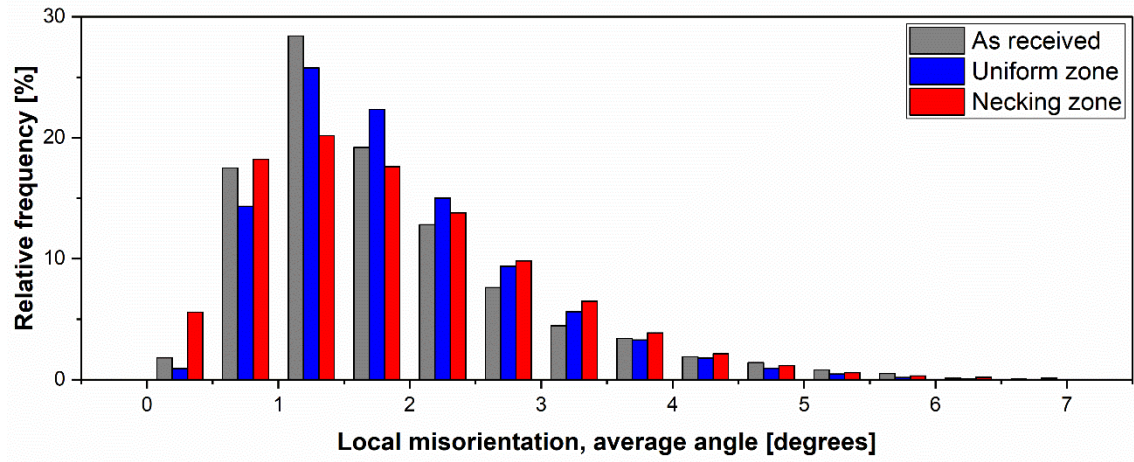
Fig. 11. The distributions of the misorientation angles across the lath and sub-block boundaries for the as-received material and uniform/necked zones of fractured sample.

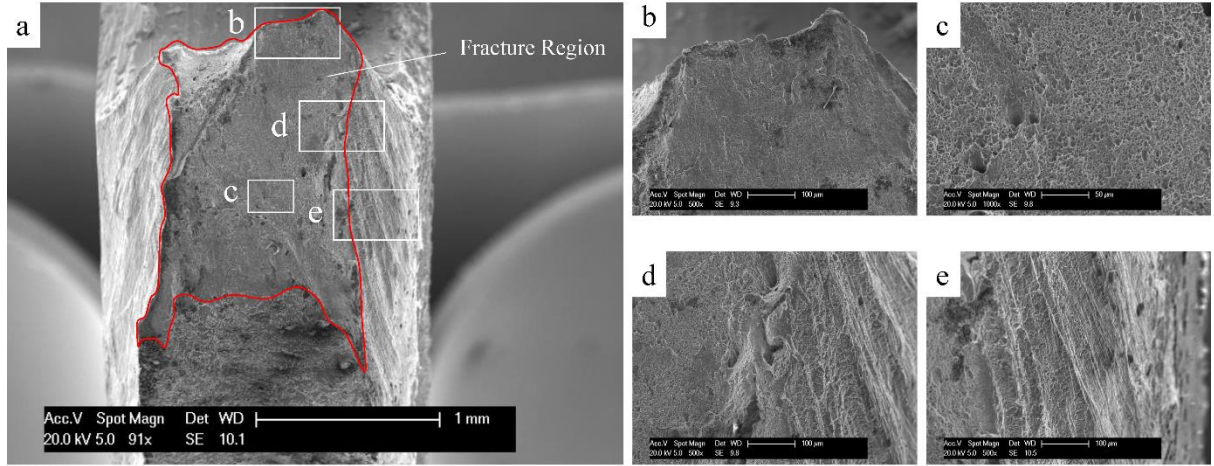
Fig. 12. Scanning electron micrographs of fractured specimens tested at 500 °C showing (a) the overall fracture morphology and (b-e) zoomed details of the local fracture features.

In Fig. 12a and Fig. 13a, a visible necked area as well as a rough surface can be observed on SEM fractography images of both fractured samples subjected to 500°C and 600°C test temperatures, highlighting a large amount of plastic deformation. Zoomed details of other subset areas (namely b, c, d and e in Fig. 12a and Fig.13a) are exhibited in order to deeply investigate the fracture characteristics. A typical dimpled zone and some equiaxed shear dimples surrounded by a shear lip show the typical ductile fracture behavior of the fractured samples at high temperature conditions. The rough surface caused by the large amount of plastic slip during tensile deformation is observable on the plastic deformation path and the micrographs near the shear lip of the sample are also illustrated. Different from the fracture surface of the sample tested at 500 °C, 600 °C tested sample involves a more distinct necking lip on the fracture surface as shown in Fig .13a. Highly correlated to the displacement of ~ 4.2 mm and ~ 5.4 mm for both 500 °C and 600 °C, respectively, see Fig. 4, this fractography observation proves, from micro scale aspect, that the ductile behavior is more pronounced for the specimen tested at higher temperature.

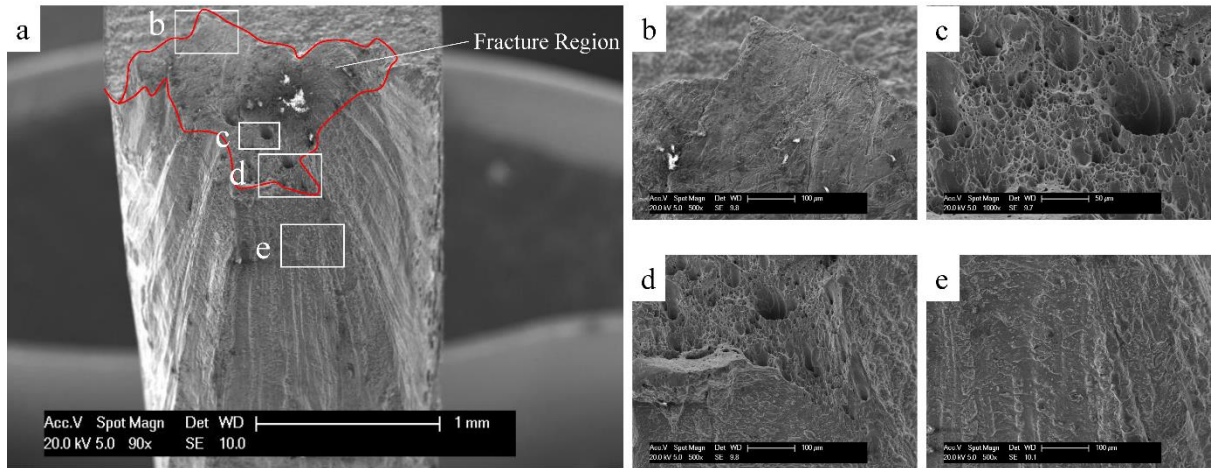
Fig. 13. Scanning electron micrographs of fractured specimens tested at 600 °C showing (a) the overall fracture morphology and (b-e) zoomed details of the local fracture features.

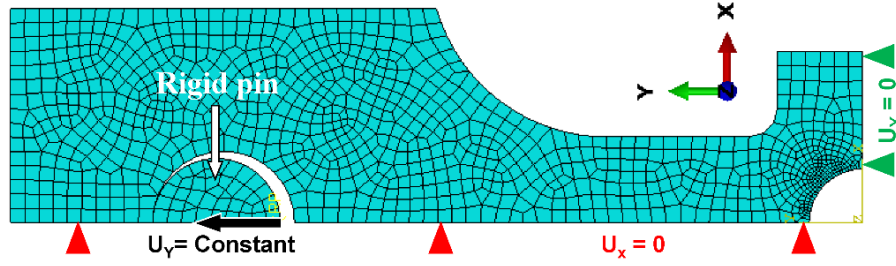
Fig. 14. FE model showing the mesh properties and boundary conditions ($U_y = 1.8\text{mm}$ for the 500°C test and $U_y = 2\text{mm}$ for the 600°C test) used for comparison with the experimental DIC results. Two symmetry conditions were considered with a sample quarter body modelled.

A quarter of the specimen was considered for the FE analyses as indicated in Fig. 14. The loading pins were modelled by a rigid body while a friction free contact was considered between the pins and the specimen holes. The contact between the pin and the specimen was assumed as standard surface to surface interaction where the outer surface of pin was the master surface and the inner surface of the specimen hole was the slave one. A constant displacement loading was applied in the Y-direction at the pin reference point in order to simulate a similar experimental protocol, for which the magnitude was set at 1.8 mm and 2 mm for both the 500 °C and 600 °C test temperatures, respectively. The 3D FE model mesh consisted of 4979 C3D8R elements with 8-noded linear brick, reduced integration, and hourglass controlled.

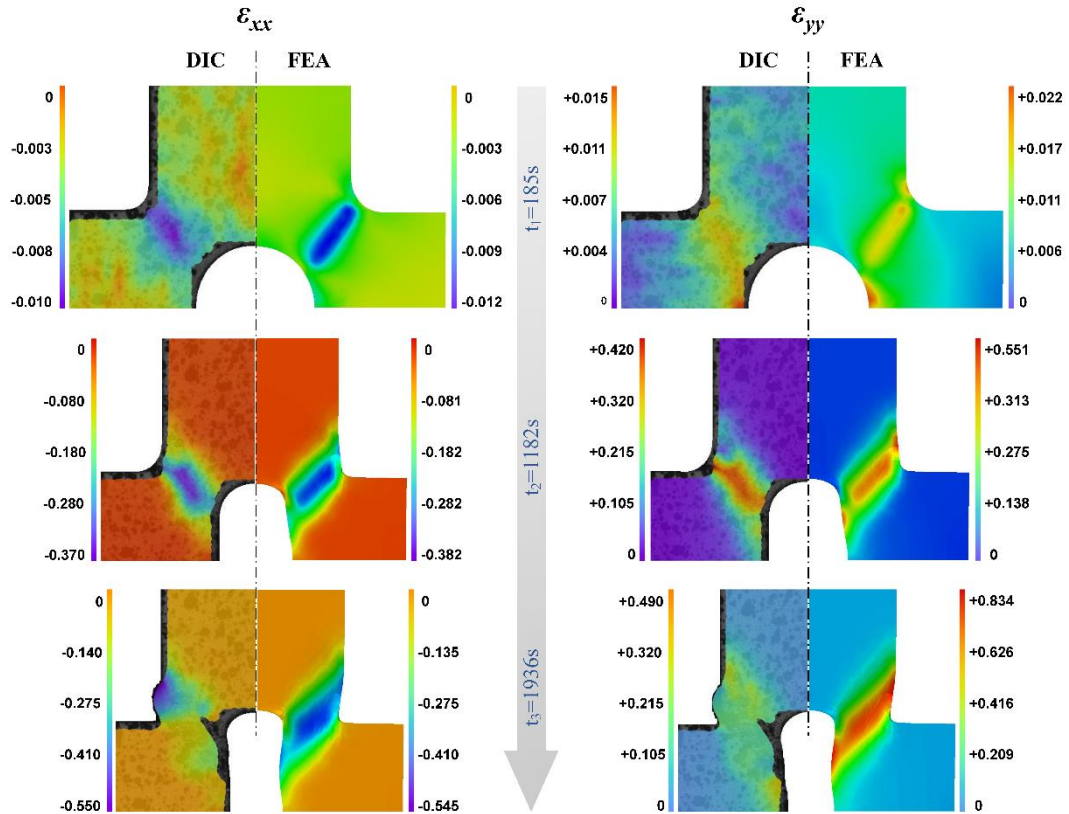
Fig. 15. Comparison of the DIC (left) and numerical (right) strain contours at 500°C test temperature.

Transverse and longitudinal strain patterns of the ROI obtained by DIC measurement and FE analysis are presented and compared in Fig. 15 and Fig. 16. For both 500°C and 600°C investigated temperatures, the spatial-temporal strain distributions and magnitudes were found to be in good agreement, revealing that DIC data trends were consistent with the FE simulation results. The strain localization zones for both experimental and FE data were almost identical even on an atypical strain concentrations area. However, an important difference in the strain magnitude was reported for the longitudinal strain component at the last stages of the loading. This difference may be attributed to the error accumulation of the loading rig, inaccuracy of the DIC measurements, inhomogeneous character of the investigated specimens and/or limitations of current FE model. Fig. 17 shows a comparison of the longitudinal strain plots for both DIC and FE analysis on positions extracted from the same line as introduced in Fig. 5b. The FE simulation results show strain magnitudes that were mostly higher than those of the DIC measurements especially for the high strain locations. Although the magnitude differences are not ignorable, it can be inferred that this methodology provides a good quantitative validation of the DIC measurements at high temperature conditions.

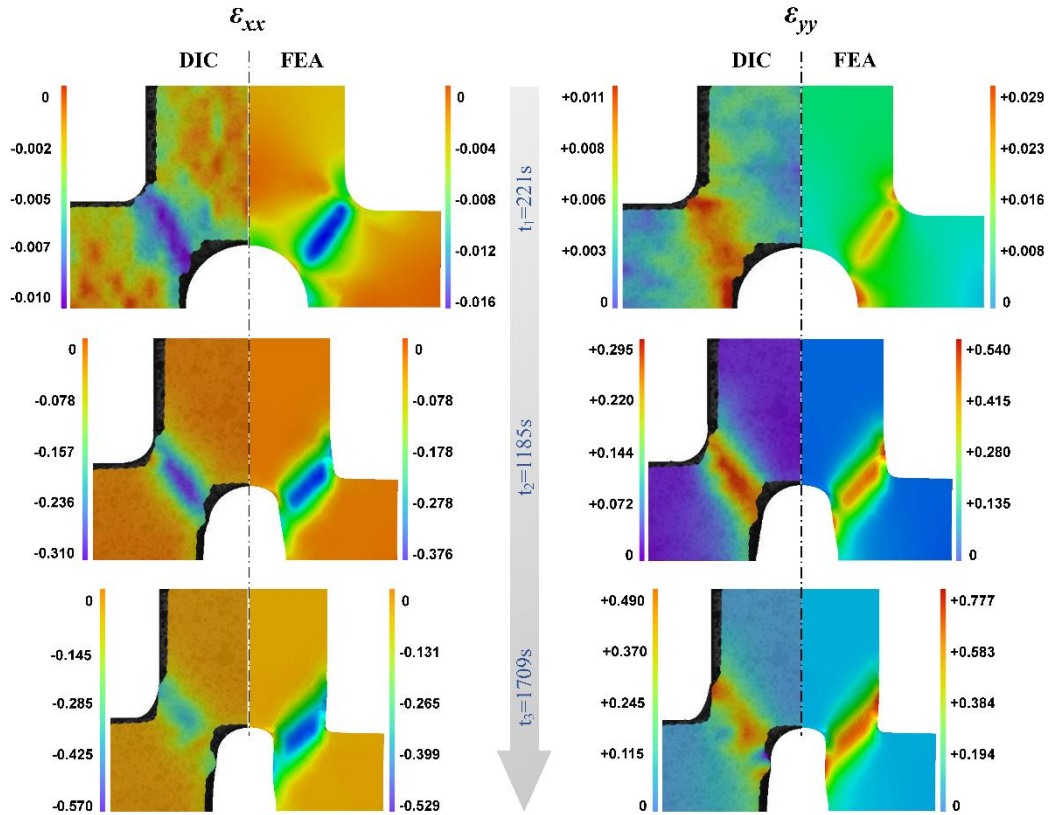
Fig. 16. Comparison of the DIC (left) and numerical (right) strain contours at 600°C test temperature.

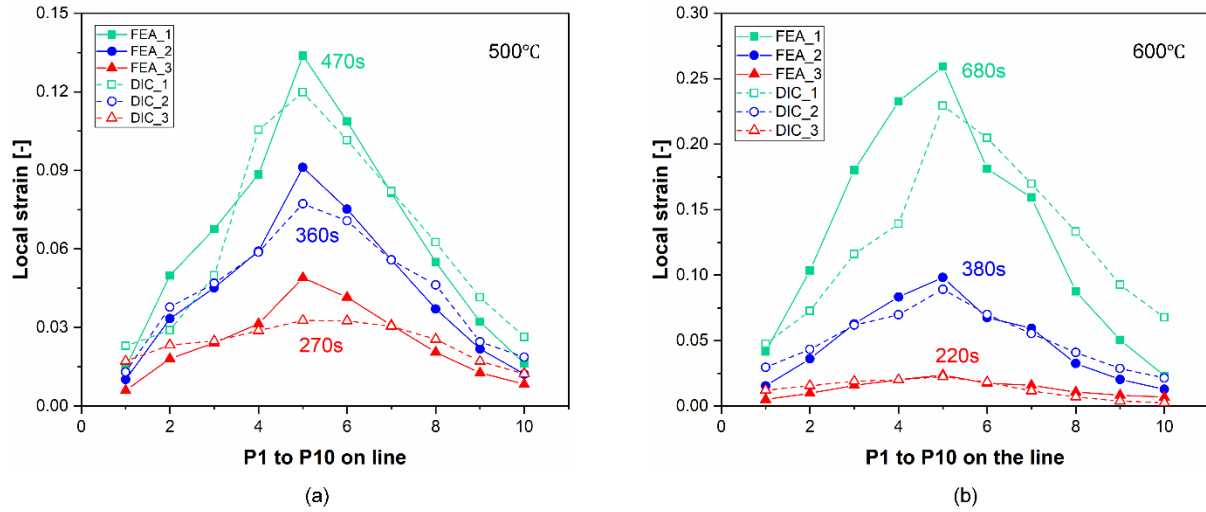
Fig. 17. DIC and FEA longitudinal strain profiles on positions extracted from the same line P1 to P10 (see Fig. 5b).
