Jinyang XU, Chao LI, Ming CHEN, Fei REN, Mohamed EL MANSORI - An investigation of drilling high-strength CFRP composites using specialized drills - International Journal of Advanced Manufacturing Technology - Vol. 103, n°9-12, p.3425-3442 - 2019

An investigation of drilling high-strength CFRP composites using specialized drills

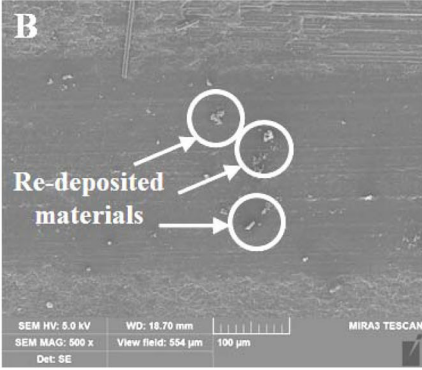
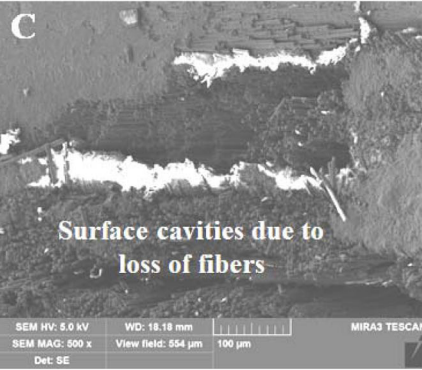
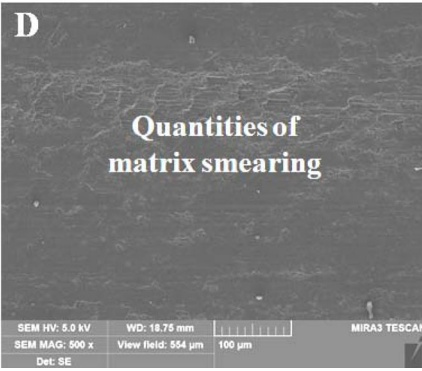
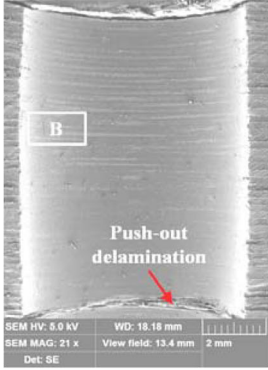
Fig. 7 SEM morphologies of the CFRP holes produced by the brad spur drill under different spindle speeds

drill bits under different cutting conditions. In general, the brad spur drill produces the smoothest hole surfaces with fewest defects compared with the twist drill and dagger drill under all the examined cutting conditions. The damage modes residing within the cut surfaces for the brad spur drill are featured by quantities of matrix smearing and re-deposited materials. Additionally, interlaminar delamination characterized by the debonding failure among adjacent plies of carbon fibers occurs almost at the hole exit side as shown in Fig. 7 due to the action of the feed force which pushes away the laminae directly under the drill tip being exceeding the critical thrust force. Increasing the spindle speed or decreasing the feed rate tends to exacerbate the extents of melted matrix smearing, which is possible due to the increased friction at the tool-work interface or the elevated tool-work interaction time resulting in the higher interface temperatures. The poor thermal conductivity of the carbon/epoxy composite was also a contributory factor in relation to the resin melt. The re-deposited materials onto the cut composite surfaces are mostly the debris of fiber dust or the residual resin formed due to the high pressures/temperatures at the tool-work interface. For all the drilling parameters investigated, the middle part of the cut hole surfaces for the brad spur drill basically remains intact without visible cavities or cracking even under the unfavorable fiber cutting angle of -45° as shown in Figs. 7 and 8.
