Chams Eddine RAMOUL, BELIARDOUH NASSER EDDINE, Raid BAH, Abdelghani DJAHOUDI, Michael J. WALOCK, Corinne NOUVEAU - Surface performances of PVD ZrN coatings in biological environments - Tribology - Materials, Surfaces & Interfaces - Vol. 13, n°1, p.12-19 - 2018

Surface performances of PVD ZrN coatings in biological environments

Zirconium nitride (ZrN) thin films were deposited by reactive RF magnetron sputtering on Ti-6Al-4V and Si (100) substrates for potential use in biomedical applications. The tribological behaviour was evaluated against bovine bone in dry condition using a pin-on-disc apparatus. Abrasion is the primary wear mechanism observed in ZrN/bone contact. The corrosion properties were determined through two electrochemical techniques: potentiodynamic polarization and electrochemical impedance spectroscopy. The coatings with reduced oxygen content provided: (i) good resistance against corrosion when exposed to physiological solution and (ii) better anti-bioadhesion against *Staphylococcus aureus* bacteria.

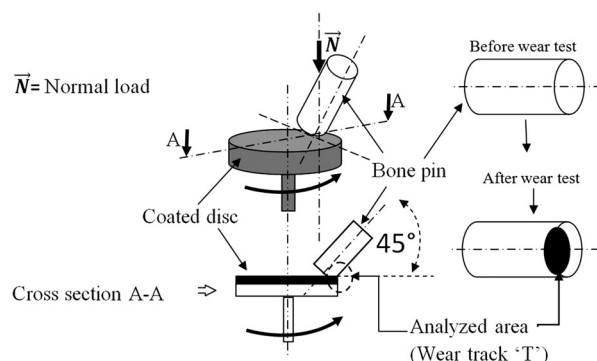
When it is impossible to make a ball geometry, e.g. from organic matter of animal origin (bone, cartilage, etc.), the pin-on-disk configuration provided by [®]CSM Instrument tribometer is perfectly adapted for this case (Figure 1). The pin holder is positioned at 45° ; this allows to make several tests with one pin. The tribological test parameters are listed in Table 2.

Figure 1. Schematic of the pin-on-disc tests.

Figure 6 (a–d) shows micrographs of the bone pin wear scars. It appears that the edges of the bone pin (see Figure 1; analyzed area (Wear track ‘T’)) become larger after acting as counterparts against ZrN-coated discs. Wear scars also reveal deformation of the Haversian system, lacunae (crevasses indicated by white narrows), isolated wear particles (black narrows) and entrapped particles (ellipse). EDS analyses, carried out at different locations (isolated as well as entrapped

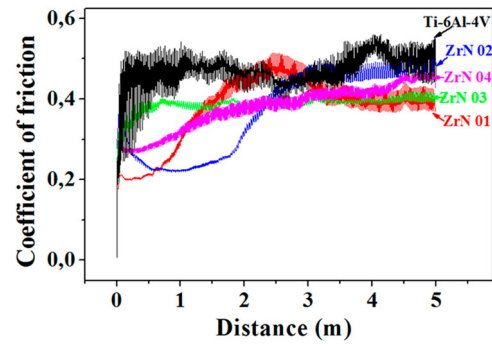
Figure 3 shows the friction coefficient curves of the ZrN films sliding against bovine bone in dry conditions. It shows that the friction coefficients of the four coatings possess similar features, i.e. the friction curves of ZrN films are characterized by two different stages. The first stage represents run-in and ends with a rapid increase of the COF; the second stage was the steady state wear regime.

During dry sliding tests, the following scenario most probably occurs; at the beginning of the wear test, there is a severe material transfer between the coating and the pins, which leads to an increase of the COF. When the steady state is reached, the material transfer is slowly reduced and stabilized after a large percentage of the wear track area is covered with the transferred material. At the steady state, the highest COF value (~ 0.58) was observed for the ZrN-02 coating surface, whereas lower COF values (~ 0.38) were obtained for the other three ZrN coatings (Figure 3). Thus, the COF is fairly high. That is the disadvantage of hard ceramic coatings (ZrN), e.g. their brittleness and relatively high COF. The COF of the uncoated substrate at the

**Figure 3.** COF of the ZrN coatings sliding against bone counterparts.

steady state was ~ 0.58 . From Figure 3, there is clear evidence that, after 3 m of sliding distance the coatings are destroyed.

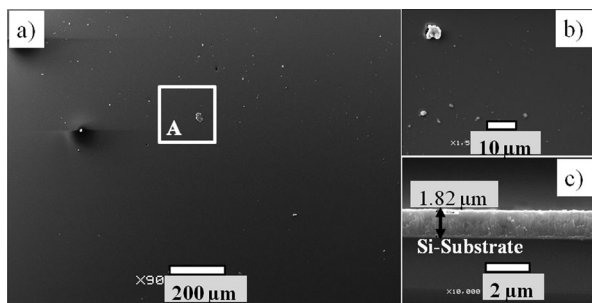
Figure 2 shows SEM images of an as-deposited ZrN coating on a Si substrate. There are some sputtering defects, e.g. pits and droplets, as shown in Figure 2

(a–b). All films have an overall thickness of ~ 1.6 to $1.9 \mu\text{m}$ and exhibit a columnar structure, as shown in Figure 2(c). The surface roughness of the samples is shown in Table 2. No remarkable differences in roughness parameters (R_a , R_q) are observed. The ZrN-01 and ZrN-02 samples have a relatively low oxygen content in comparison to ZrN-03 and ZrN-04.

**Figure 2.** SEM images of the as-deposited ZrN-01 coating on Si substrate: (a) global view of the surface, (b) magnified image of the region enclosed by the white square (area A) and (c) cross-section image of the same sample.

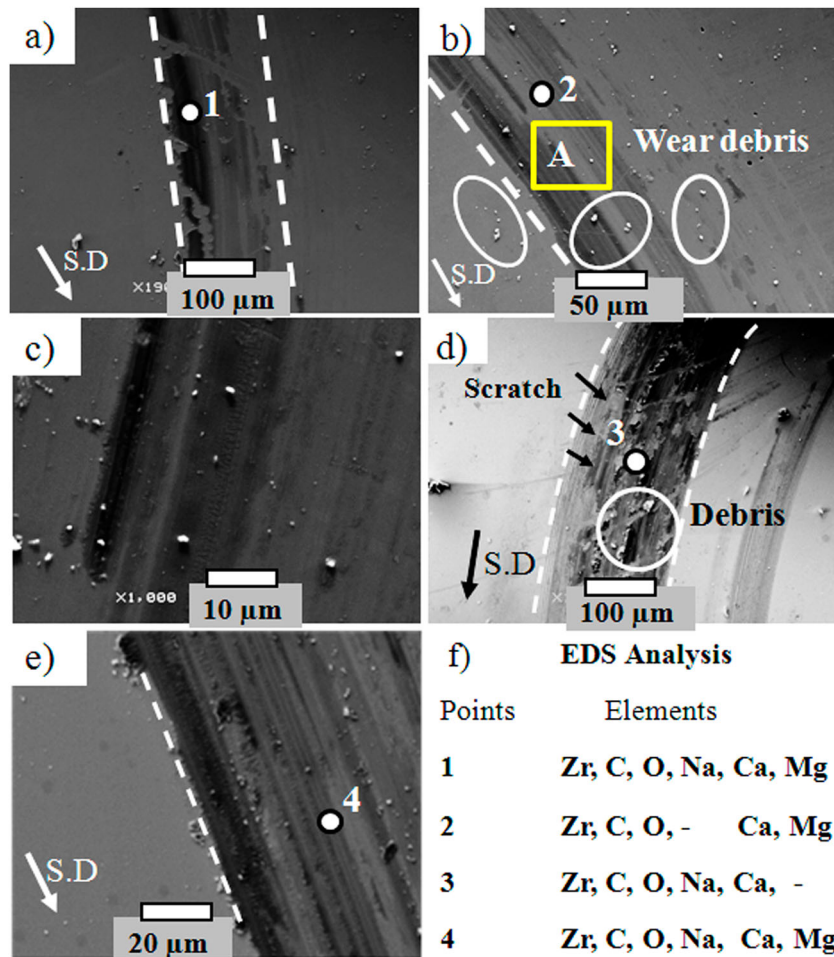
Figure 4 shows the wear tracks of ZrN coatings on Ti-6Al-4V substrates tested against bone pins as counterparts in dry conditions. The primary wear mechanism appears to be abrasion, as shown in Figure 4(a–d). In addition to grooves and scratches parallel to sliding direction, wear debris accumulated in the wear tracks are also observed as deep furrows from trapped particles (Figure 4(c)). The elemental composition of some isolated particles, analysed by EDS, indicates the presence of both bone elements (Na, Mg, Ca, K, etc.) and coating elements (Zr and oxygen) in the adhered film (points 1, 2, 3, 4 in Figure 4(a–e)). So, the wear debris is a mixture of the antagonist pair components. From this, one can conclude that bone adhesion to the disc is the second wear mechanism observed in the ZrN/bone contact pair. SEM analysis also revealed some areas within the wear track where the coating did not appear to be damaged after the wear tests. No plastic deformation was detected in the wear tracks on any of the coatings.

Figure 4. Wear mechanism of ZrN coatings: abrasion (scratches-grooves) and bone adhesion wear; (a) wear track of ZrN-01, (b) wear track of ZrN-02, (c) zoom of the square A, (d) wear track of ZrN-03, (e) wear track of ZrN-04 and (f) EDS analysis results at points 1, 2, 3, 4; (S.D – sliding direction).

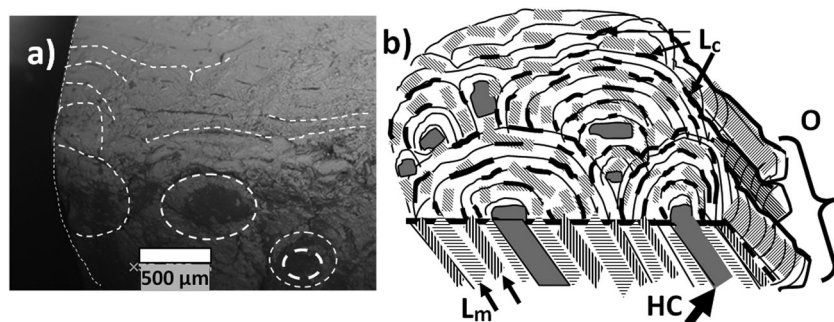
systems or osteons. [6]. The macrostructure of the bone pin specimen (cortical bone) is shown in Figure 5.

Figure 5. (a) SEM micrograph of a bone pin specimen. (b) A schematic diagram illustrating the macrostructure of cortical bone; O – Osteons (Haversian systems), L_m – concentric lamellae, HC – Haversian canal and L_c – lacunae.

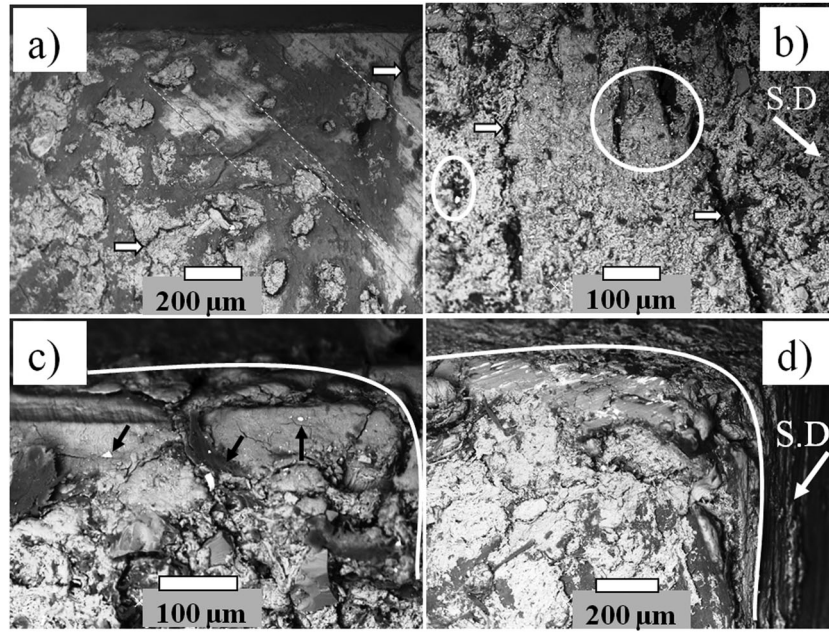
particles) within the wear scars, indicate that a mixture of both the antagonist elements in contact was found. Abrasive wear is the only wear mechanism observed on the bone pins.

Figure 6. SEM images of wear scars of bone pins after pin-on-disc tests for: (a) ZrN-01, (b) ZrN-02, (c) ZrN-03 and (d) ZrN-04 (dash lines indicate scratch marks, SD – sliding direction).

When sliding against ZrN-coated discs, segments of the bone pins were initially scraped off by surface asperities along the wear track. This is due to the large difference in mechanical properties between the antagonists in contact. A literature study reveals the average hardness (H) and elastic modulus (E) of cortical bovine bone obtained from nanoindentation in

transversal direction between 0.647 and 0.892 GPa and 19.8 ± 1.6 GPa, respectively [7]. ZrN coatings hardness and modulus values range from 15 to 34 GPa and 240 to 320 GPa, respectively [8]. As the number of sliding cycles increases, the transferred layer onto ZrN surface becomes brittle and is destroyed through fatigue; the resulting wear debris acts as a third body.

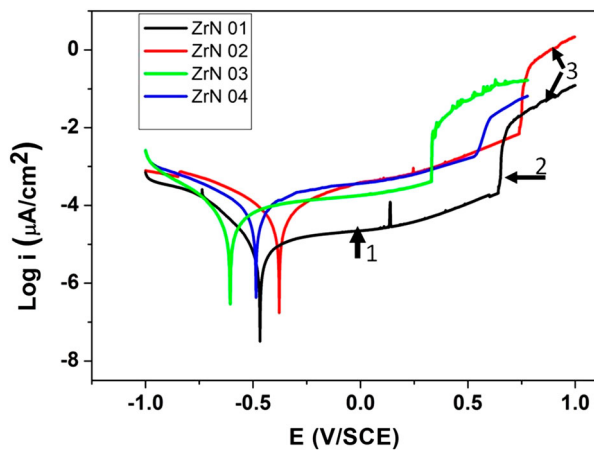
Figure 7(a) shows the potentiodynamic polarization curves (plots of potential vs. log current density) of the ZrN coatings exposed to the PS for 2 h. All specimens form an anodic domain (labelled '1'), which corresponds to the formation of a self-passivating (Zr, N,

Figure 7. Potentiodynamic polarization curves of ZrN coatings in physiological liquid solution.

O) film after being soaked for a period of time. The size of this domain is indicative of the durability of the self-passivating film and the corrosion resistance of each coating. For example, the anodic plateau remained flat from -0.4 up to $+0.65$ V in the case of ZrN-01. The rupture of the passive film occurs in the trans-passivation domain (labelled '2'). In this domain, the current density abruptly increases as the materials start to corrode (labelled '3'). The polarization resistance (R_p) of Tafel curves, which takes into consideration both the corrosion current density and the slopes of polarization curves, can provide a quantitative ranking of coatings resistance to corrosion and can be estimated using the well-known Stern–Geary equation.

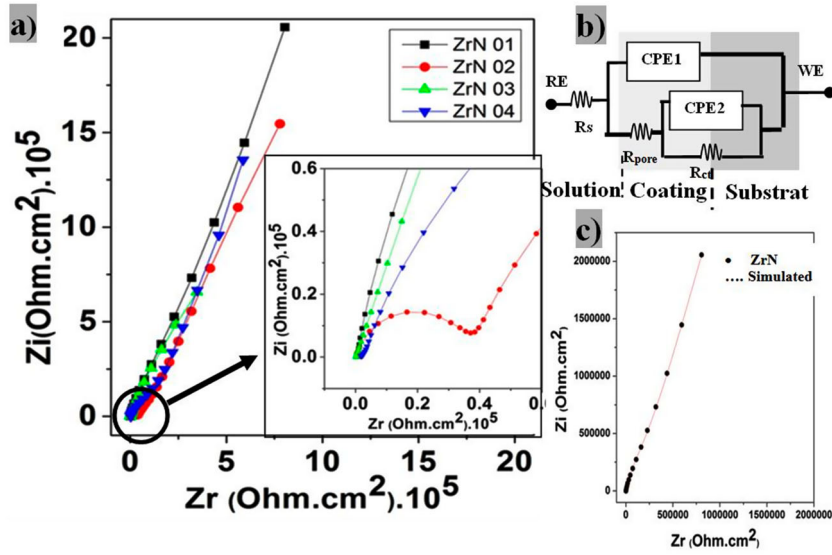
Each sample's impedance was measured after 1 h of immersion in the PS. Nyquist plots of the real and imaginary parts of the impedance are shown in Figure 8(a). The plots show that all tested samples are characterized by two capacitive loops in the high and medium

Figure 8. Electrochemical test results (EIS): (a) Nyquist plots of tested specimen in physiological liquid solution, (b) equivalent circuit model and (c) example of fitting curve (WE = working electrode and RE = reference electrode).

frequency range. By comparing the diameters of the loops in the Nyquist plot, the sample's corrosion properties can be easily evaluated. Larger diameter loops equate to higher corrosion resistance. This analysis supports the previous conclusion: ZrN-01 has the best corrosion resistance of the four tested samples. An equivalent circuit (EC) model, which is shown in Figure 8(b), was selected for quantitative studies. This EC is extensively used in similar situations [9]. Figure 8(c) shows good agreement between the experimental and modelled values. The fitted line was plotted as a dashed line. The fitting errors for each configuration in this study were less than 9%.

In the selected equivalent circuit, R_s represents the electrolyte resistance. The Constant Phase Elements, CPE1 and CPE2, are the double layer capacitance and the coating capacitance respectively. R_{ct} is the charge transfer resistance and R_{pore} represents the pore resistance (and other fails of coating).

The overall corrosion resistance of the coating can be estimated by the sum of all resistances of the circuit model in accordance with the method described by Subramanian et al. [9]. Therefore, using the quantitative data given in Table 4, the ZrN-01 coating presents the highest resistance against corrosion in a physiological liquid solution of the four tested samples, as expected.

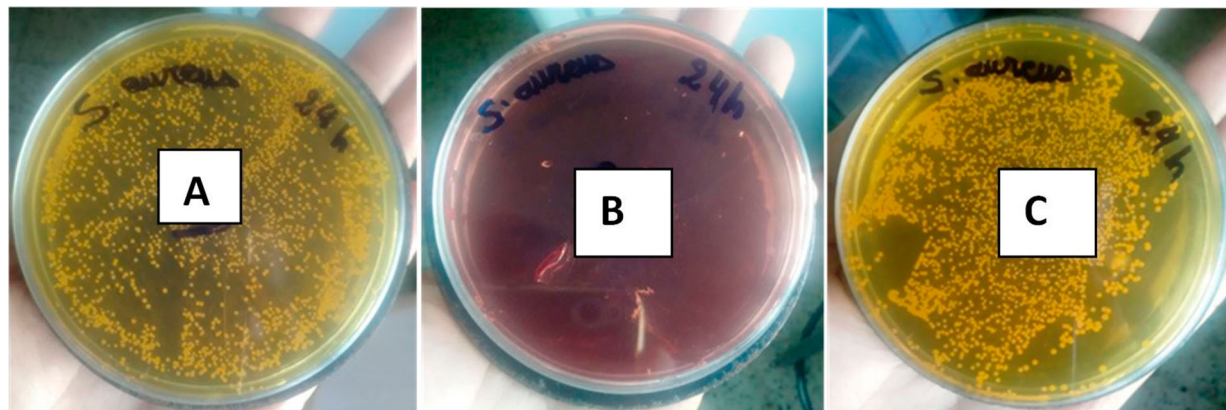
After incubation, the *S. aureus* colonies are clearly visible (Figure 9) and were easily counted. The results indicate that *S. aureus* bacteria were completely killed in specimen B, while the surviving bacterial colonies are 3.2×10^5 (CFU/ml) for specimen A and 5.2×10^5 (CFU/ml) for specimen C. Specimen B and Specimen C have approximately similar surface parameters (i.e. roughness, morphology, etc.) but there is a noticeable difference in the oxygen content of the samples. So, surface morphology effects cannot explain the difference in the biocidal effect of these two specimens (B and C). In addition, it has been reported that a surface roughness $<0.2 \mu\text{m}$ may not affect bacterial adhesion because most bacteria are $>0.2 \mu\text{m}$ [12].

**Figure 9.** *Staphylococcus aureus* colonies grown in sterilized Petri dishes of: (a) specimen A, (b) specimen B and (c) specimen C.
