Chams Eddine RAMOUL, BELIARDOUH NASSER EDDINE, Raid BAH, Abdelghani DJAHOUDI, Michael J. WALOCK, Corinne NOUVEAU - Surface performances of PVD ZrN coatings in biological environments - Tribology - Materials, Surfaces & Interfaces - Vol. 13, n°1, p.12-19 - 2018

Surface performances of PVD ZrN coatings in biological environments

Zirconium nitride (ZrN) thin films were deposited by reactive RF magnetron sputtering on Ti-6Al-4V and Si (100) substrates for potential use in biomedical applications. The tribological behaviour was evaluated against bovine bone in dry condition using a pin-on-disc apparatus. Abrasion is the primary wear mechanism observed in ZrN/bone contact. The corrosion properties were determined through two electrochemical techniques: potentiodynamic polarization and electrochemical impedance spectroscopy. The coatings with reduced oxygen content provided: (i) good resistance against corrosion when exposed to physiological solution and (ii) better anti-bioadhesion against *Staphylococcus aureus* bacteria.

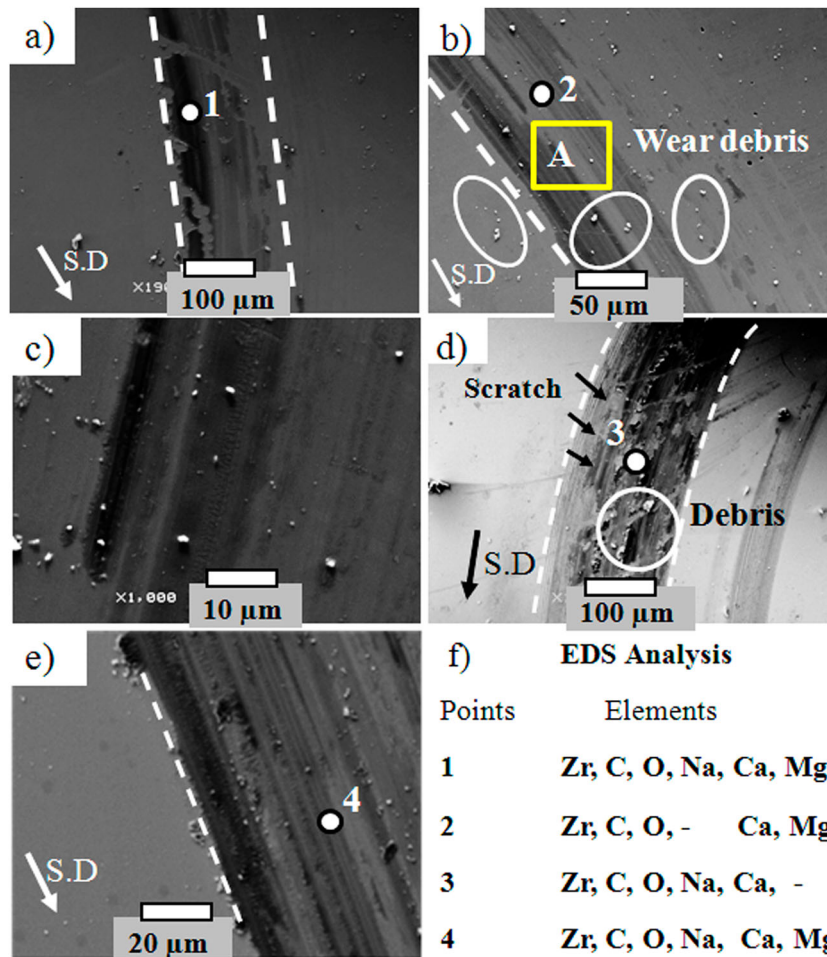
Figure 4. Wear mechanism of ZrN coatings: abrasion (scratches-grooves) and bone adhesion wear; (a) wear track of ZrN-01, (b) wear track of ZrN-02, (c) zoom of the square A, (d) wear track of ZrN-03, (e) wear track of ZrN-04 and (f) EDS analysis results at points 1, 2, 3, 4; (S.D – sliding direction).

Figure 4 shows the wear tracks of ZrN coatings on Ti-6Al-4V substrates tested against bone pins as counterparts in dry conditions. The primary wear mechanism appears to be abrasion, as shown in Figure 4(a–d). In addition to grooves and scratches parallel to sliding direction, wear debris accumulated in the wear tracks are also observed as deep furrows from trapped particles (Figure 4(c)). The elemental composition of some isolated particles, analysed by EDS, indicates the presence of both bone elements (Na, Mg, Ca, K, etc.) and coating elements (Zr and oxygen) in the adhered film (points 1, 2, 3, 4 in Figure 4(a–e)). So, the wear debris is a mixture of the antagonist pair components. From this, one can conclude that bone adhesion to the disc is the second wear mechanism observed in the ZrN/bone contact pair. SEM analysis also revealed some areas within the wear track where the coating did not appear to be damaged after the wear tests. No plastic deformation was detected in the wear tracks on any of the coatings.

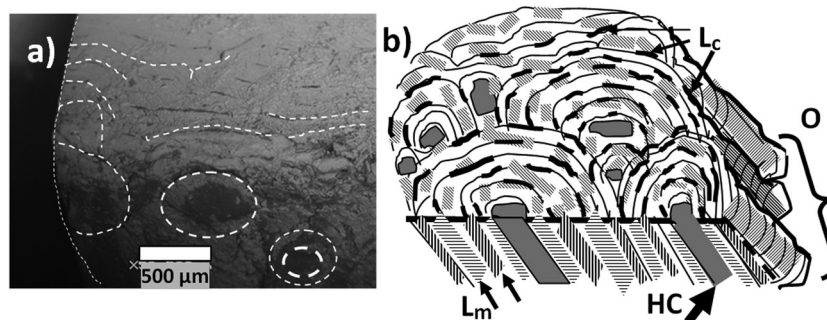
Figure 5. (a) SEM micrograph of a bone pin specimen. (b) A schematic diagram illustrating the macrostructure of cortical bone; O – Osteons (Haversian systems), L_m – concentric lamellae, HC – Haversian canal and L_c – lacunae.

systems or osteons. [6]. The macrostructure of the bone pin specimen (cortical bone) is shown in Figure 5.

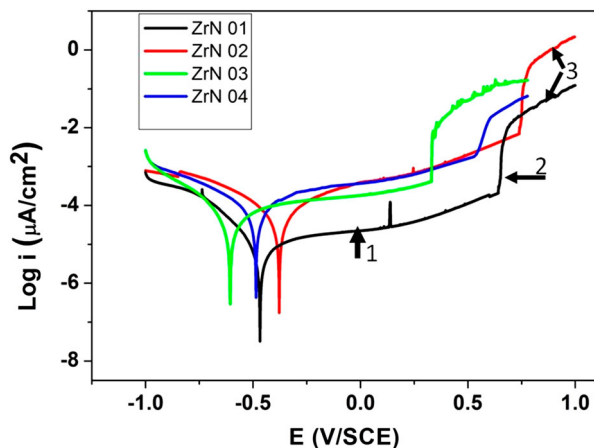
Figure 7. Potentiodynamic polarization curves of ZrN coatings in physiological liquid solution.

Figure 7(a) shows the potentiodynamic polarization curves (plots of potential vs. log current density) of the ZrN coatings exposed to the PS for 2 h. All specimens form an anodic domain (labelled '1'), which corresponds to the formation of a self-passivating (Zr, N,

O) film after being soaked for a period of time. The size of this domain is indicative of the durability of the self-passivating film and the corrosion resistance of each coating. For example, the anodic plateau remained flat from -0.4 up to $+0.65$ V in the case of ZrN-01. The rupture of the passive film occurs in the trans-passivation domain (labelled '2'). In this domain, the current density abruptly increases as the materials start to corrode (labelled '3'). The polarization resistance (R_p) of Tafel curves, which takes into consideration both the corrosion current density and the slopes of polarization curves, can provide a quantitative ranking of coatings resistance to corrosion and can be estimated using the well-known Stern–Geary equation.

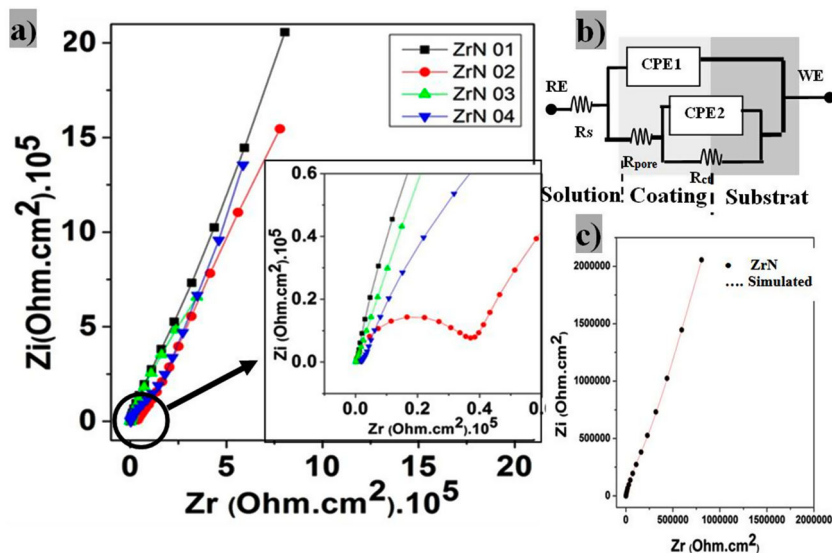
Figure 8. Electrochemical test results (EIS): (a) Nyquist plots of tested specimen in physiological liquid solution, (b) equivalent circuit model and (c) example of fitting curve (WE = working electrode and RE = reference electrode).

Each sample's impedance was measured after 1 h of immersion in the PS. Nyquist plots of the real and imaginary parts of the impedance are shown in Figure 8(a). The plots show that all tested samples are characterized by two capacitive loops in the high and medium

frequency range. By comparing the diameters of the loops in the Nyquist plot, the sample's corrosion properties can be easily evaluated. Larger diameter loops equate to higher corrosion resistance. This analysis supports the previous conclusion: ZrN-01 has the best corrosion resistance of the four tested samples. An equivalent circuit (EC) model, which is shown in Figure 8(b), was selected for quantitative studies. This EC is extensively used in similar situations [9]. Figure 8(c) shows good agreement between the experimental and modelled values. The fitted line was plotted as a dashed line. The fitting errors for each configuration in this study were less than 9%.

In the selected equivalent circuit, R_s represents the electrolyte resistance. The Constant Phase Elements, CPE1 and CPE2, are the double layer capacitance and the coating capacitance respectively. R_{ct} is the charge transfer resistance and R_{pore} represents the pore resistance (and other fails of coating).

The overall corrosion resistance of the coating can be estimated by the sum of all resistances of the circuit model in accordance with the method described by Subramanian et al. [9]. Therefore, using the quantitative data given in Table 4, the ZrN-01 coating presents the highest resistance against corrosion in a physiological liquid solution of the four tested samples, as expected.
