Mohamed ACHOURI, Guénaél GERMAIN, Philippe DAL SANTO, Serge BOUDE, Jean-Lou LEBRUN, Delphine SAIDANE - Development of a microscopic damage model for low stress triaxiality - Key Engineering Materials - Vol. 473, p.460-467 - 2011

# Development of a microscopic damage model for low stress triaxiality

**Keywords:** HSLA steels, ductile damage, shear, micrographic analysis, in-situ tests, numerical simulation

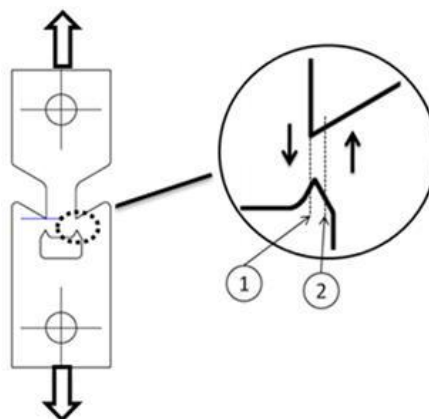
**Specimen tested.** Various forms of shear specimens are tested by the finite element simulation to validate the best geometry, especially to obtain a low triaxiality in shear loading. The form used is described in Figure 1. The specimens was cut by wire Electrical Discharge Machining EDM in the transverse direction of sheet which thickness is 1.5 mm. Polishing was applied to the specimens to obtain a clean surface to observe clearly the evolution of the microstructure. The specimen was mounted and fixed to the micro-test module and installed in the SEM room.

Figure 1: Form of the in-situ shear specimen

**Evolution of cavities.** The sequence of pictures in figure 5 shows the evolution of three inclusions at different loading levels, located at two different locations as noted in figure 1. Inclusions located on line 1 (Fig. 5-a-b) are the most solicited in shear stress because the location is more dense than those found on line 2 (Fig. 5-c). In an unloaded state (0%), inclusions are integral in matrix. However, the difference in stiffness in level matrix / inclusion interfaces gives a local stress concentration. The application of shear mechanical stress, then a strain, generates a decohesion of the inclusions from one side then the other side from a certain load (Fig. 5-a at 88% of breaking load), or fragmentation of the inclusion without decohesion for that which is located at the location 2. Some inclusions on the line the most solicited (place 1) may have two mechanisms together, decohesion and fragmentation as shown in Figure 5-b. The void created between the matrix and inclusions, or between two parts of the broken inclusion, forms a cavity. The mechanism of micro-cavities birth is the nucleation stage or germination which is the origin of ductile fracture. However it is observed that germination can also be done by damage to the matrix in the immediate vicinity of an inclusion (Fig. 7-a at 88%) due to the concentration of shear stresses in bands. The void generated during the germination stage, grow in a state of shear stress. This growth is driven by plastic flow resulting in a hardening of the matrix around the cavities. This flow is not uniform and depends largely on the stress state and shape of the cavity, which is different to that observed in tension and tends to grow in both directions of loading in shear forming corners angular two sides. Deformed cavity also undergoes a rotation depending on loading levels. When the remaining ligament between two cavities is sufficiently small, direct interaction between the two cavities is essential and cannot be neglected. The plastic flow in the ligament causes the fracture by plastic shear (instability). The achievement stage of coalescence of the cavities is assumed to define the initiation of a macroscopic crack. The macroscopic crack propagation is then a succession of stages of coalescence occurring in the structure until the complete fracture.

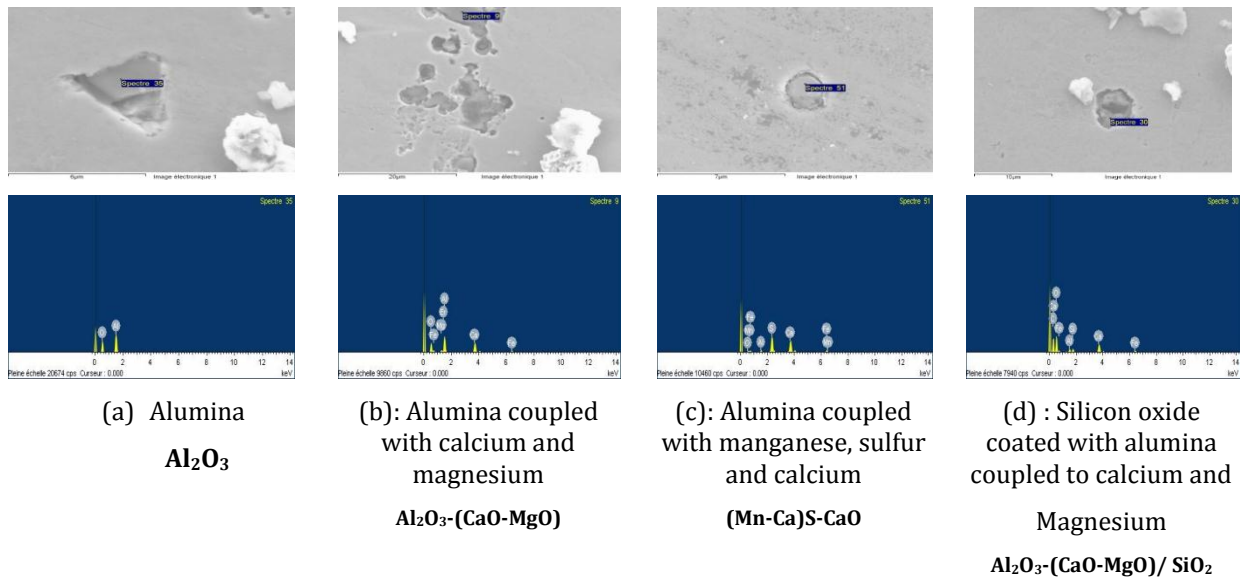
**Identification of inclusions kinds found in material.** The density of inclusions and precipitates created during the development phase of the material will influence the behavior of the sheet during forming. Inclusions located at points of grain or in the matrix are generally harder and more fragile than the latter. In the initial structure, the inclusions are mainly globular type especially in the heart of the sheet. Inclusions present the principal motor of damage. EDS analysis allow to identify the elements present in inclusions encountered, which are essentially of alumina ( $\text{Al}_2\text{O}_3$ ) with their size varied between 1 and 10 microns. Figure 2 illustrates the different types of inclusions identified in the material.

Figure 2: Different types of inclusions found in the material

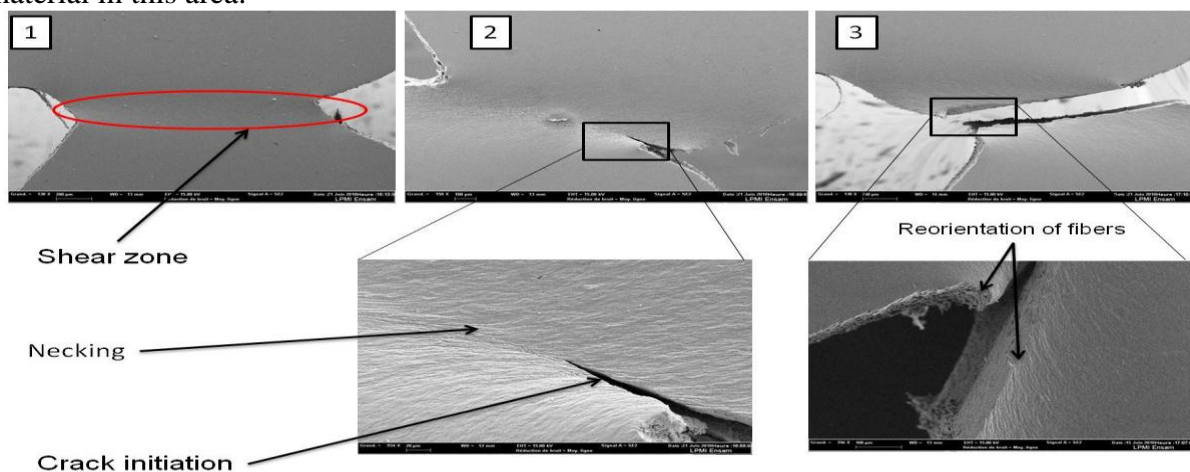
**Evolution of the microstructure.** The damage mechanisms of material are generally attributed to the effect of initiation and growth of micro-defects, which are usually reflected by the degradation of macroscopic properties. Microcracks and microcavities are two common micro-defects in the material. Nucleation, coalescence and propagation of micro defects are the primary mechanism of material damage. The pictures in Figure 3 show the creation of a shear band and it's evolution until failure of the specimen. The shear stresses are localized along a zone which is observed on a reduction in thickness which ends with the initiation of cracks at the edge and then a complete break. An expansion on the edge shows a reorientation in fibers, creating a burr caused by tearing of the material in this area.

Figure 3: Evolution of shear zone until failure.

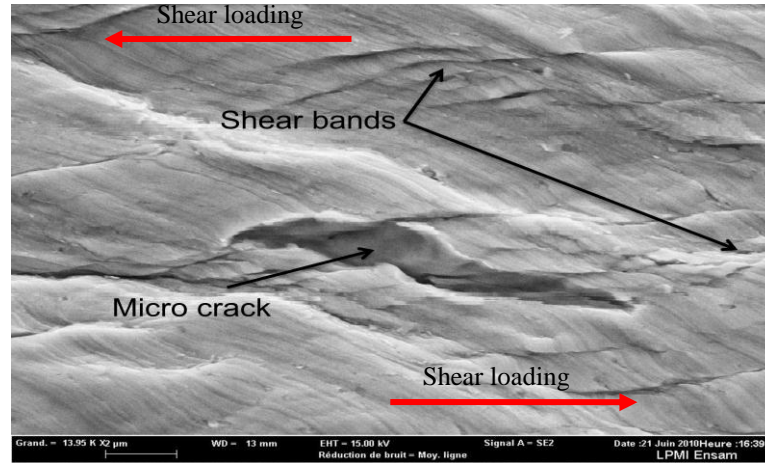
Figure 4 illustrates the evolution of damage in the material matrix. In effect, we observe the creation of shear bands under the effect of stresses localization in the area followed by the creation of microcracks resulting from slip bands. These are elongated and propagated in the directions of shear loading.

Figure 4: The damage evolution in matrix

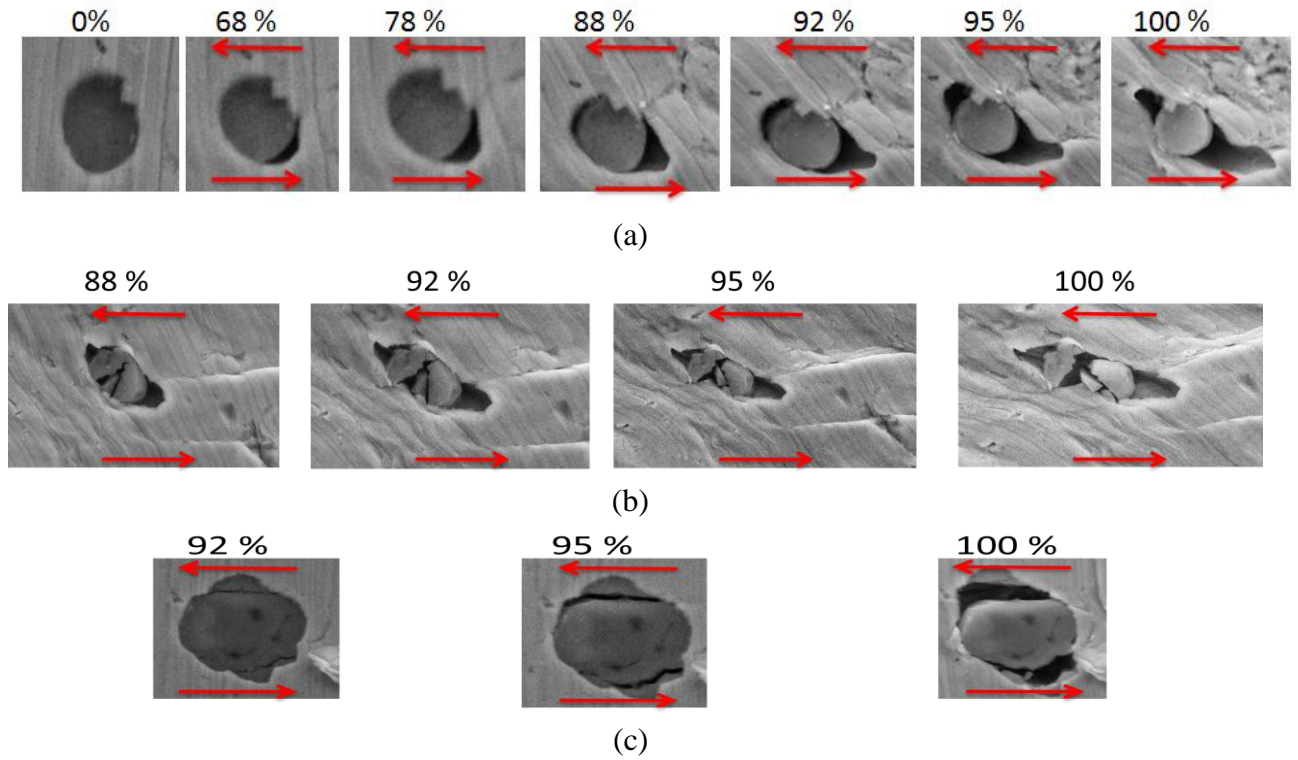
Figure 5: Evolution of germination and growth mechanisms: (a) germination by decohesion of inclusion, (b) germination by decohesion and fragmentation of inclusion, (c) germination by fragmentation of inclusion

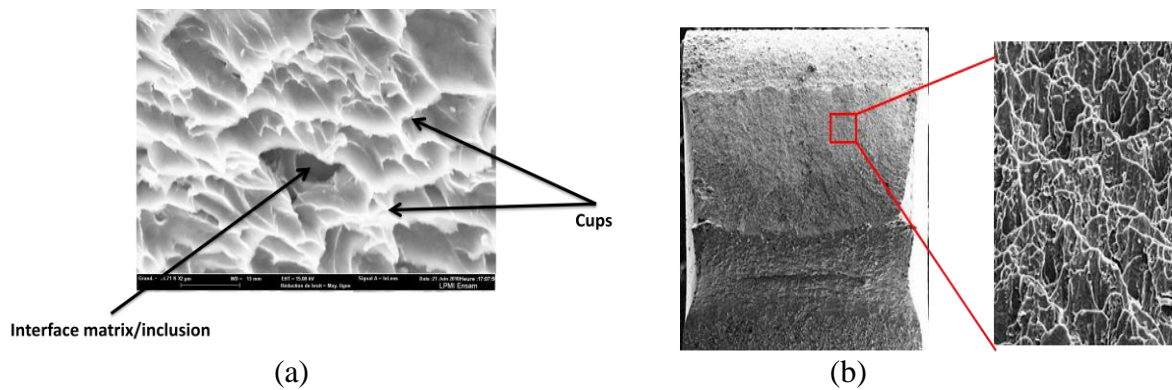
**Fracture surface.** Examination of fracture surfaces with sufficient magnification (Figure 6-a) shows the strong presence of cups within which are located inclusions, which confirms the ductile damage case. The elongation of voids on the surface shear is shown in Figure 6-b.

Figure 6: Fracture surface: (a) ductile damage, (b) elongation of voids on the fracture section

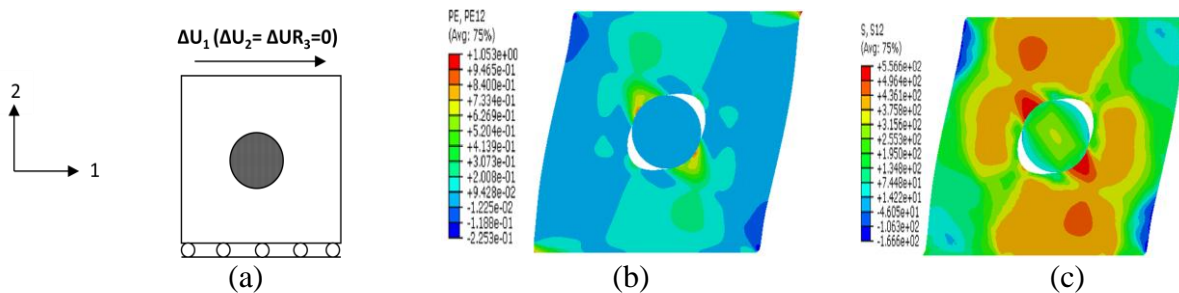
**2D analysis of inclusion-matrix decohesion.** A cellular model introduced by Figure 7 has been studied to determine the behavior of matrix-inclusion decohesion by conducting a finite element analyses of a cell square formed a matrix containing an inclusion of radius 1.9 microns. The cell is subject to a condition imposed macroscopic stress shear. The matrix material used in the finite element analysis has properties elastic, which are identical to properties steel, a Young's modulus  $E = 210$  GPa and a Poisson's ratio  $\nu = 0.3$ . However, properties of the material are those of S500MC steel. Hence, assuming isotropy with respect to plastic yielding a model of the matrix material, chosen in this study, obeys a power-law hardening, for which the plastic portion of the true stress–plastic strain curve is fitted to the following function:

$$\sigma = 563 + 584\varepsilon_p^{0.5} \quad (1)$$

Parameters of this law have been identified by the inverse method using experimental data from a uniaxial tensile test.

The material used is the inclusion of elastic properties, which are identical to the properties of alumina  $Al_2O_3$ , including a Young's modulus  $E = 390$  GPa and a Poisson's ratio  $\nu = 0.3$ .

Figure 7: The 2D plane strain unit cell after inclusion-matrix decohesion: (a) assumed type of boundary conditions, (b) shear strain contour, (c) shear stress contour.

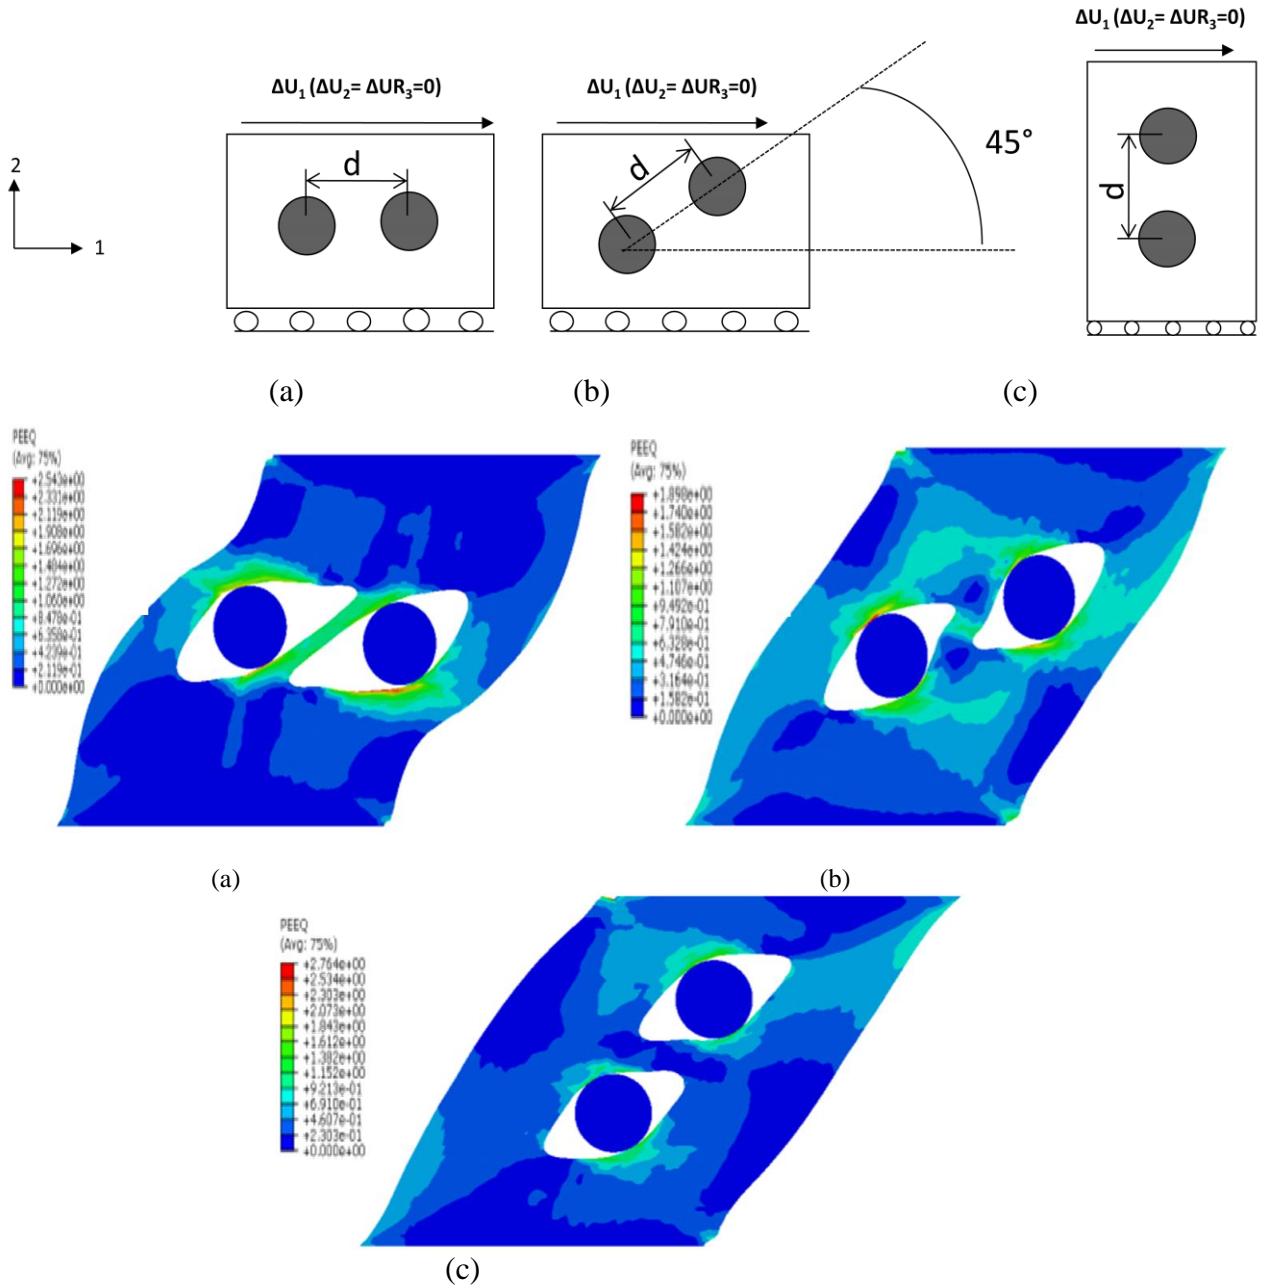
**Growth and interaction between cavities.** To construct a more realistic model of the possible interactions between particles during shear and orientation effect of ligament with the loading direction, a 2D plane strain analysis of a random particle cluster is undertaken. The particle radii are 1.9 microns. The alloy matrix is again modeled using a power-law hardening data used in previous section. Approximately 100 elements were used along the periphery of each particle to avoid mesh distortion effects at large deformations. The goal is to predict the behavior of equivalent strain in the ligament and around cavities in each case as shown in Figure 8, using the same mechanical properties in the previous section. Indeed, the strain field is higher with the angle between ligament and direction shear loading. Each cavity is elongated at  $45^\circ$  in the shear plan. In Figure 8-b, the top of a cavity is aligned with the bottom other and tend to join.

Figure 8: Numerical simulation of interaction between cavities: (a) inclusions parallel to the loading direction, (b) inclusions at  $45^\circ$  to the loading direction, (c) inclusions perpendicular to the loading direction. The distance  $d$  is constant in three configurations.

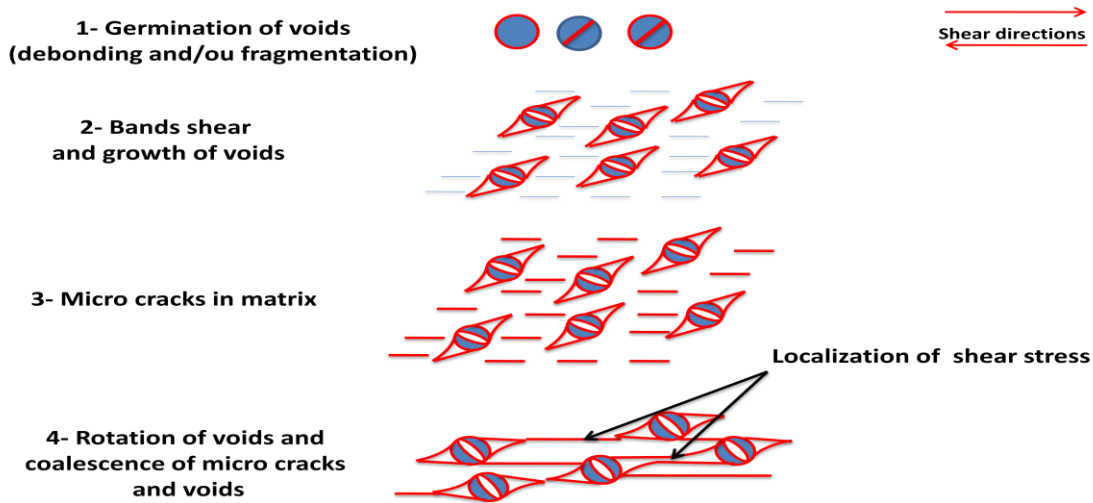
At the end we can conclude the full damage process evolution under shear loading (Fig. 9). This study is useful in the context of development, in progress, a micromechanical damage model adjusted with low triaxiality loading.

Figure 9: Schematic of the damage process observed in shear
