# Excimer laser treatment of ZE41 magnesium alloy for corrosion resistance and microhardness improvement

## ABSTRACT

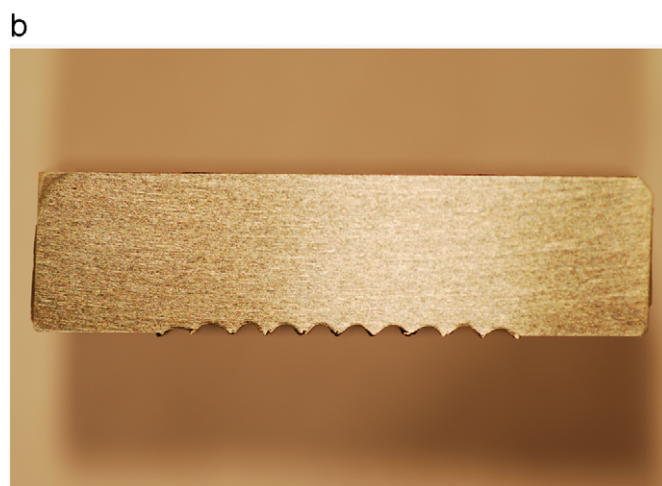
**Fig. 4.** Morphology of the irradiated surface.

After the laser surface melting treatment, the ZE41 displayed a complex rippled surface morphology. Fig. 4 shows a wavy morphology: a succession of hollows and hills can be seen on the irradiated surface of the ZE41 specimen. Each hollow corresponds to a laser beam track. Such morphology is due to several causes. The first one is loss of material by evaporation caused by the high power density ( $160 \text{ MW cm}^{-2}$ ) of the laser beam. This power density is not homogenous within the laser spot; it reaches the maximum at the centre of the beam and decreases whenever we approach the beam border. Therefore evaporation is emphasized at the centre and a hollow is created. In addition, the high power density brought by the laser pulse creates a temperature gradient around the irradiated zone. This temperature gradient induces a gradient of surface-shear stress, which increases with the distance from the irradiated surface. Consequently, the molten material is pushed away from the irradiation centre towards the beam periphery where the surface-shear stress is the highest. During laser surface melting treatment, we noticed a creation of plasma on the magnesium alloy surface. The plasma vapours' pressure drives shock waves and compresses the molten material beneath the incident laser beam, enhancing formation of the wavy topography. The irradiated surface is dark and covered with a white powder which can be wiped off. This white powder comes from ionized gas and metal from the plasma which reacts together and form solid products deposited on the magnesium surface as an extremely thin film. The dark thin layer on the irradiated surface is formed by the oxidation of the very hot laser-melted surface.

As noted in Section 3.1, the laser-melted zone displays a rippled surface morphology with several asperities, especially in laser track borders (Figs. 4 and 5). These asperities can give rise to crevice corrosion [14]. Examining the sample after 24 h of immersion in a 0.5 M NaCl solution, we find that this surface was uniformly corroded. We cannot determine whether crevice corrosion took place or not. In addition, the salt-spray test shows that, after 131 h of exposure, the laser-treated surface is intact, and devoid of any sign of crevice corrosion. Knowing that the later type of corrosion needs an incubation time, after which the corrosion process begins to develop rapidly, this incubation time may be longer than 131 h. Therefore we cannot detect it during the tests performed.
