Experimental study of the brittle–ductile transition in hot cutting of SG iron specimens

Laurence Fouilland ^{a,*}, Mohamed El Mansori ^{a,b}

The present paper investigates the brittle-ductile transition (BDT) of the primary shear zone during cutting of spheroidal graphite (SG) iron in the austenitization temperature range (around 1000 °C). The experimental tests were performed using a cutting test bench in the cutting speed range of 0.8 to 1.6m.s⁻¹. The cut surfaces were studied using optical microscopy and Scanning Electron Microscope (SEM) analysis techniques. The obtained results revealed either consequent deep fractured regions governed by a brittle-cracking regime (BCR) or a crack-free cut surface governed by a ductile-shear regime (DSR) with large plastic deformations.

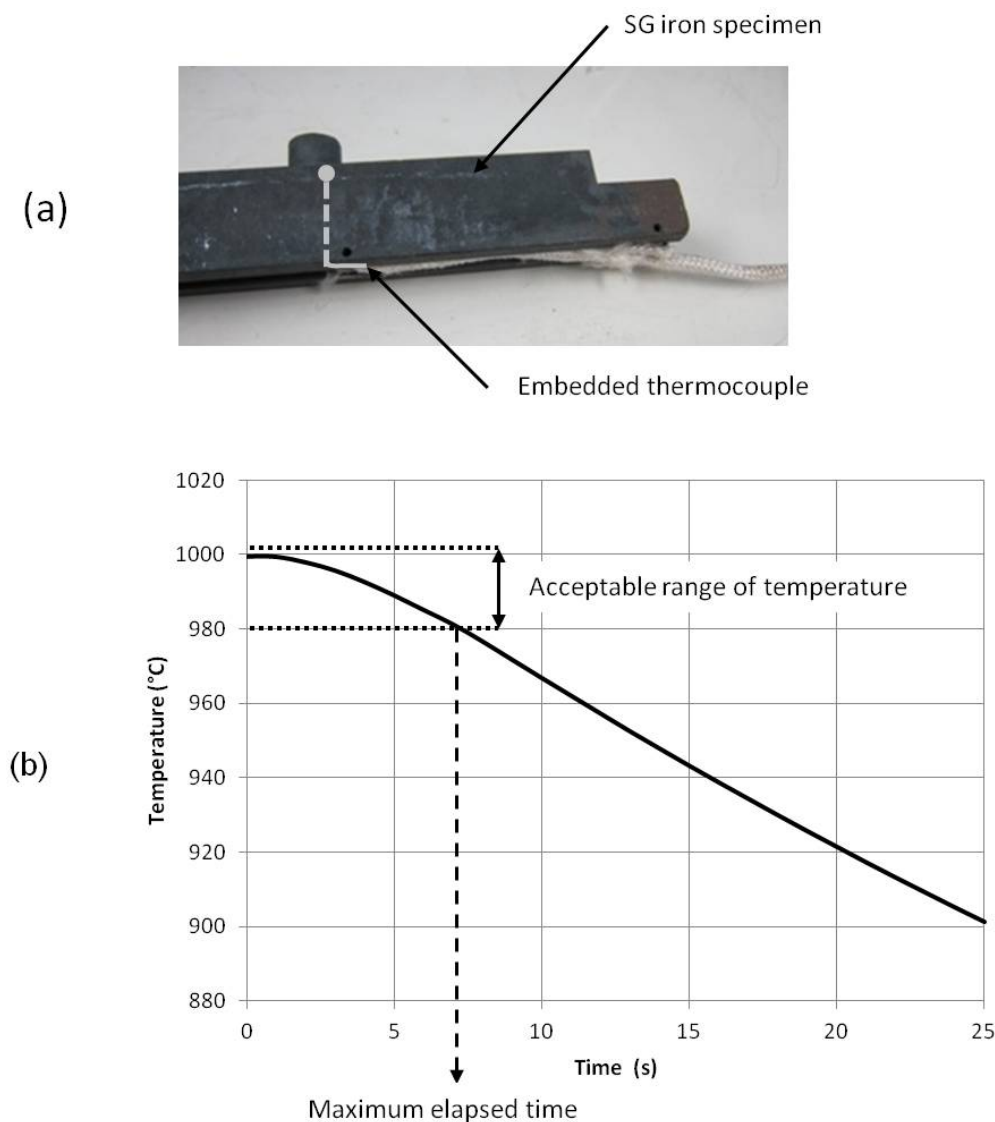
Figure 3. (a) Temperature measurement obtained thanks to an embedded thermocouple; (b) Temperature variation in a heated specimen during cooling into the clamping setup.

prevents heat losses. Indeed, the SG iron specimen must stay in the (austenitization temperature range) range of stability of the austenite phase during the cutting operation (i.e. between 980 and 1000°C). To evaluate the “available time” to perform the test with this condition fulfilled, thermocouples embedded in cutting specimens (Figure 3(a)) have been used to measure the loss of temperature between the take-out of specimen from the furnace and the beginning of the cutting test. Figure 3(b) shows the temperature decrease with time. According to this curve (Fig. 3b), the elapsed time must not exceed seven seconds. Consequently, the experimental tests have been systematically performed under the required conditions.

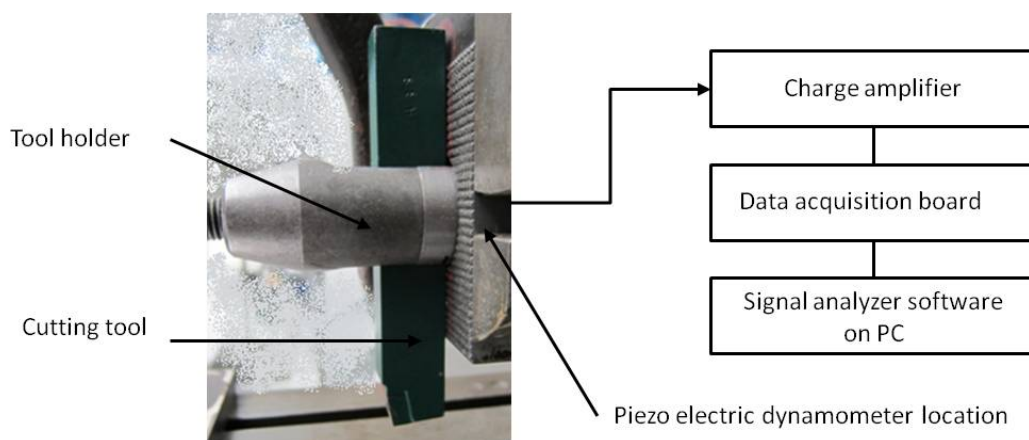
Figure 4. Description of the force sensor setup

The cutting force in the cutting direction has been measured using a KISTLER piezoelectric dynamometer (type 9104A) mounted on the tool holder (Fig. 4). By the piezoelectric technology, when subjected to a cutting load, quartz produces an electrical charge proportional to the load.

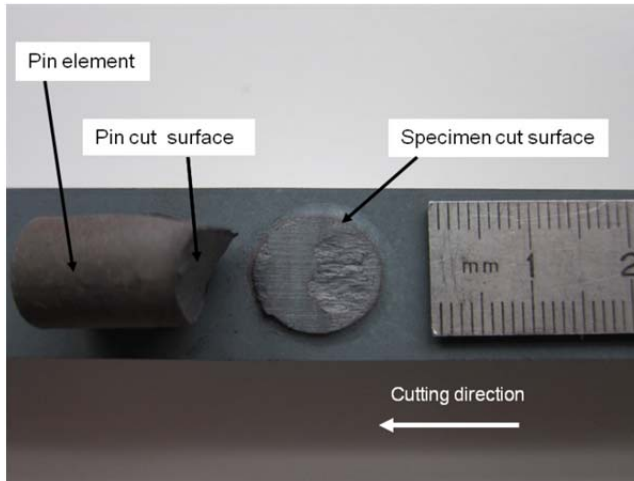
Figure 5. Photograph of the machined specimen showing the cut surface of both the base specimen and the pin element.

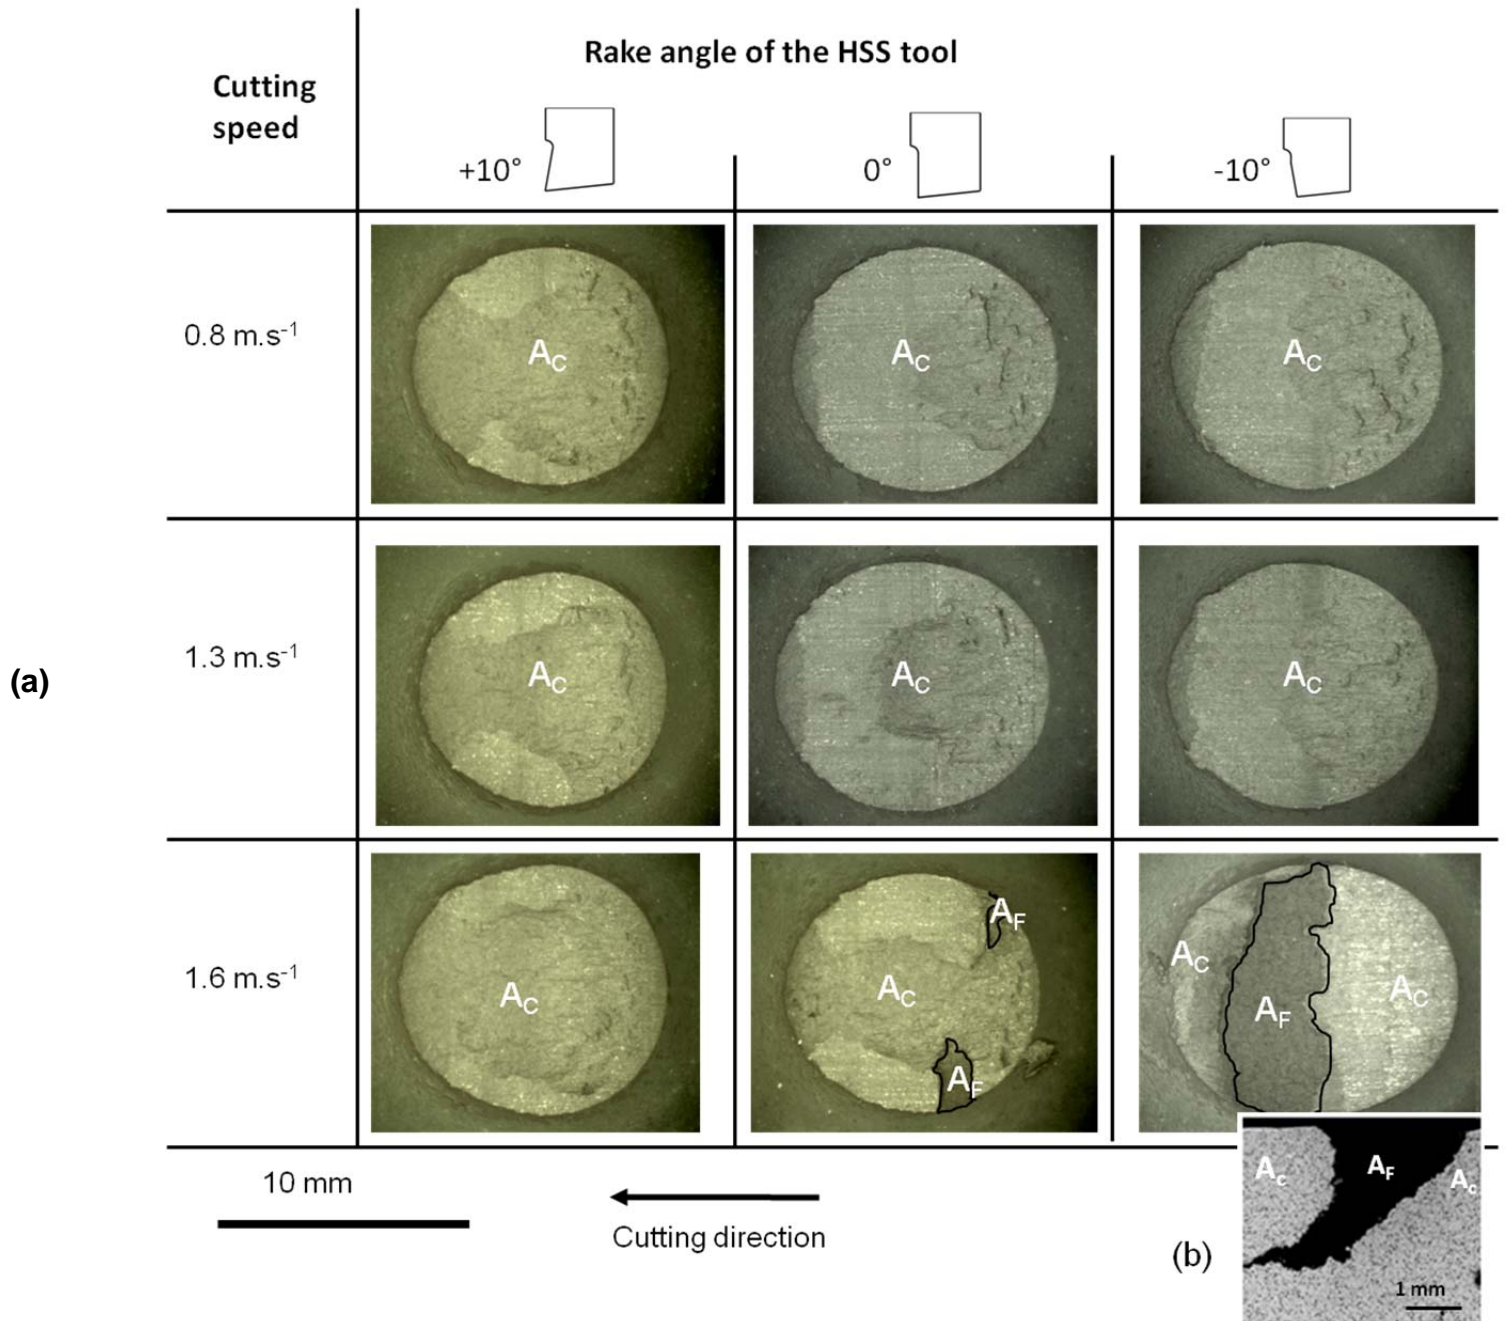
Figure 6. Optical views of specimen cut faces after hot cutting tests versus to the rake angles of the HSS tool and the cutting speeds tested ($h=15\text{mm}$; $\phi=10\text{mm}$). (a) Cut and Fractured areas are respectively named A_C and A_F . (b) Typical cross section view highlighting deep cracking in A_F .

Figure 6(a) shows optical micrographs of the cut surface of the specimen ($h = 15\text{mm}$ and $\phi = 10\text{mm}$) for different cutting conditions. At low cutting speeds ($\leq 1.3\text{m.s}^{-1}$) irrespective of the tool rake angle, pin elements are completely and nearly perfectly cut, showing a whole quasi flat cut area (referred to as A_C). For the highest cutting speed ($=1.6\text{ m.s}^{-1}$) and the rake angles of -10° or 0° (tests respectively named as $1.6\text{ m.s}^{-1}_{-10^\circ}$ and $1.6\text{m.s}^{-1}_{0^\circ}$) the aspect of the cut surface becomes heterogeneous: a fractured area (referred to as A_F) showing deep cracking (typical depth of a few millimeters) highlighted on figure 6(b) appears within the cut area A_C .

Two distinct trends can be identified from the first set of tests:

- The fracture propensity increases with the decrease of the rake angle;
- The fracture propensity increases with the increase of the cutting speed.

Clearly here, cutting parameters, which are the most influencing (in terms of presence and span of the fractured area in the cut surface) are those with a negative rake angle (-10°) associated with the highest cutting speed (1.6 m.s^{-1}). Consequently, all other pin diameters (5 mm, 7.5 mm and 10 mm) and pin heights (5 mm, 10 mm and 15 mm) have been tested under this cutting condition (1.6 m.s^{-1} and -10°) to investigate the influence of dimensional characteristics on the cutting surface morphology.

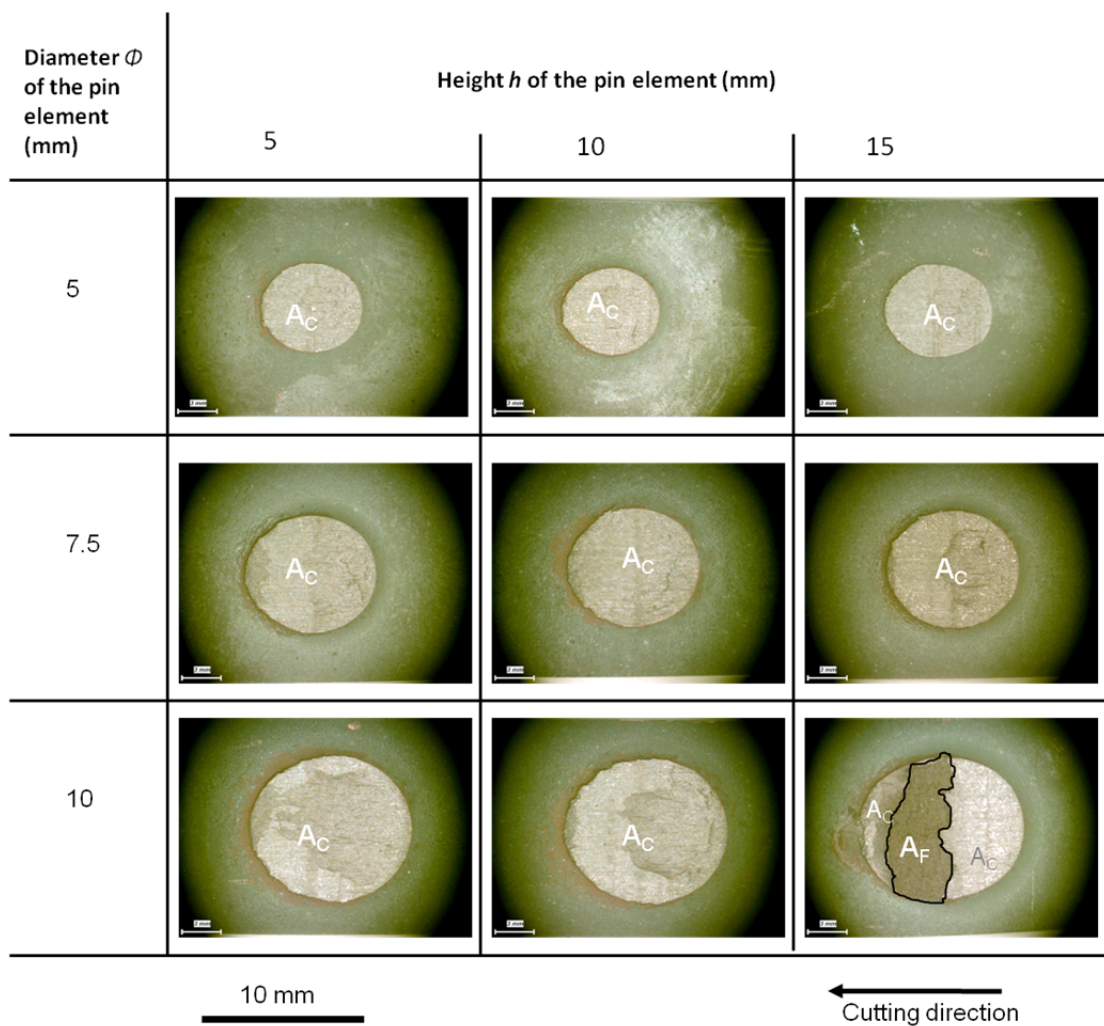
Figure 7. Optical views of specimen cut faces after hot cutting tests (Cutting speed= 1.6 m.s^{-1} ; tool rake angle $= -10^\circ$) versus to the pin heights and diameters tested. Cut and Fractured areas are respectively named A_C and A_F .

Corresponding specimens cut surfaces are shown in figure 7 for different dimensional conditions. The fractured area (A_F) occurs only for the specimen with a pin height of 15mm and a pin diameter of 10mm (as identified above Fig. 6, specimen named $1.6 \text{ m.s}^{-1} - 10^\circ$).

Finally, one can observe that the generation of a damaged cut surface is only activated by the combinations of several penalizing parameters: negative (or null) rake angle of the tool; cutting speed $\geq 1.6\text{m.s}^{-1}$; $\phi \geq 10\text{ mm}$; $h \geq 15\text{ mm}$.

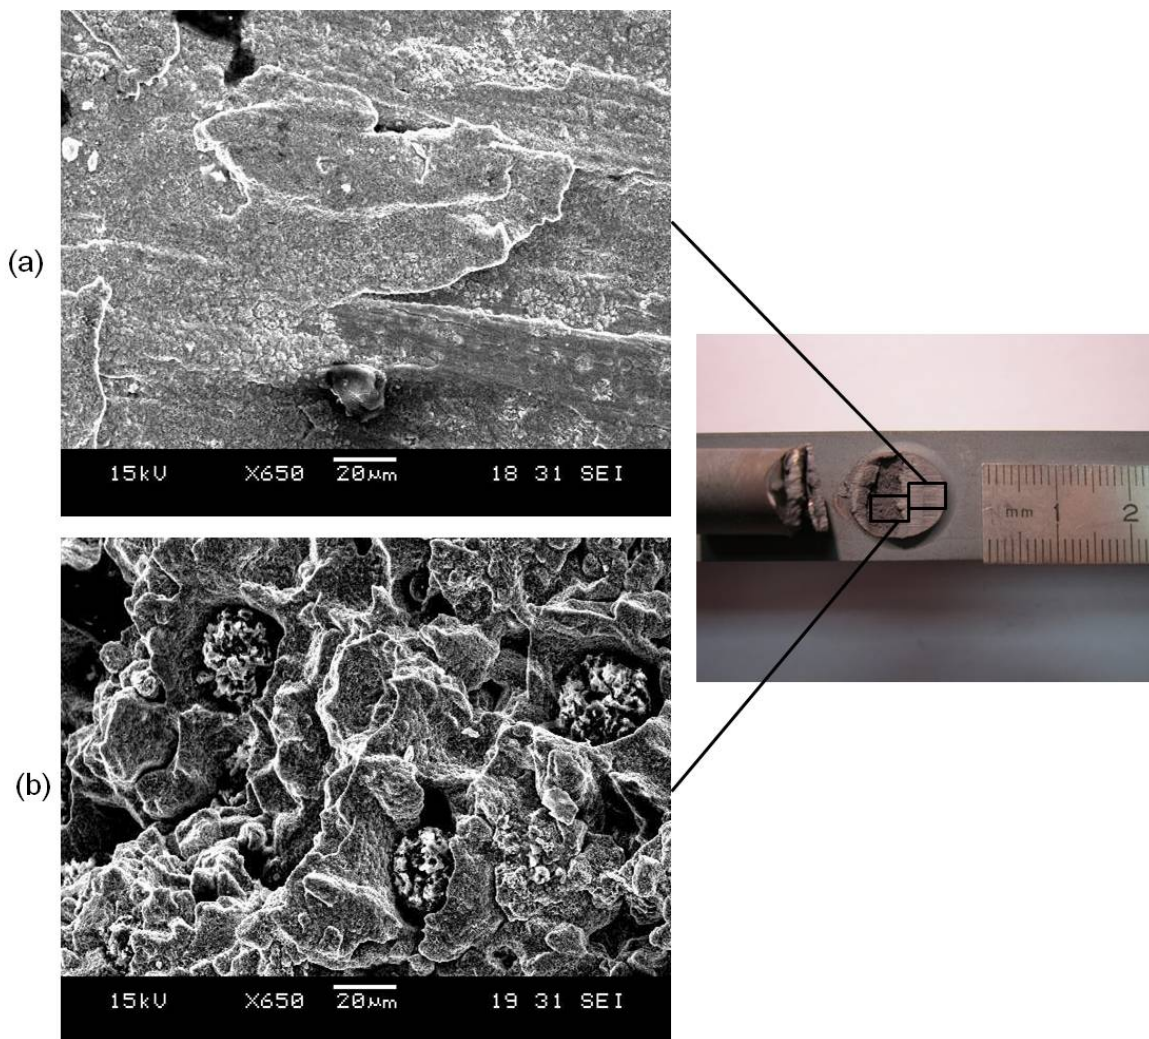
Figure 8. SEM details views of the 1.6 m.s^{-1} -10° specimen cut face in (a) the cut area (A_C) ; (b) the fractured area (A_F).
[Cutting speed = 1.6m.s^{-1} ; rake angle = -10° ; $h=15\text{mm}$ and $\phi=10\text{mm}$].

In order to understand the physical mechanisms involved in the generation of both A_C and A_F regions, SEM observations have been made. They can be seen on figures 8 and 9. The A_C region shows a flat cut surface without any deep damage. On the contrary, the A_F area shows a brittle fracture which results from micro-cracks associated with the graphite-matrix interface that surround the spherical nodules and then propagate to the matrix.

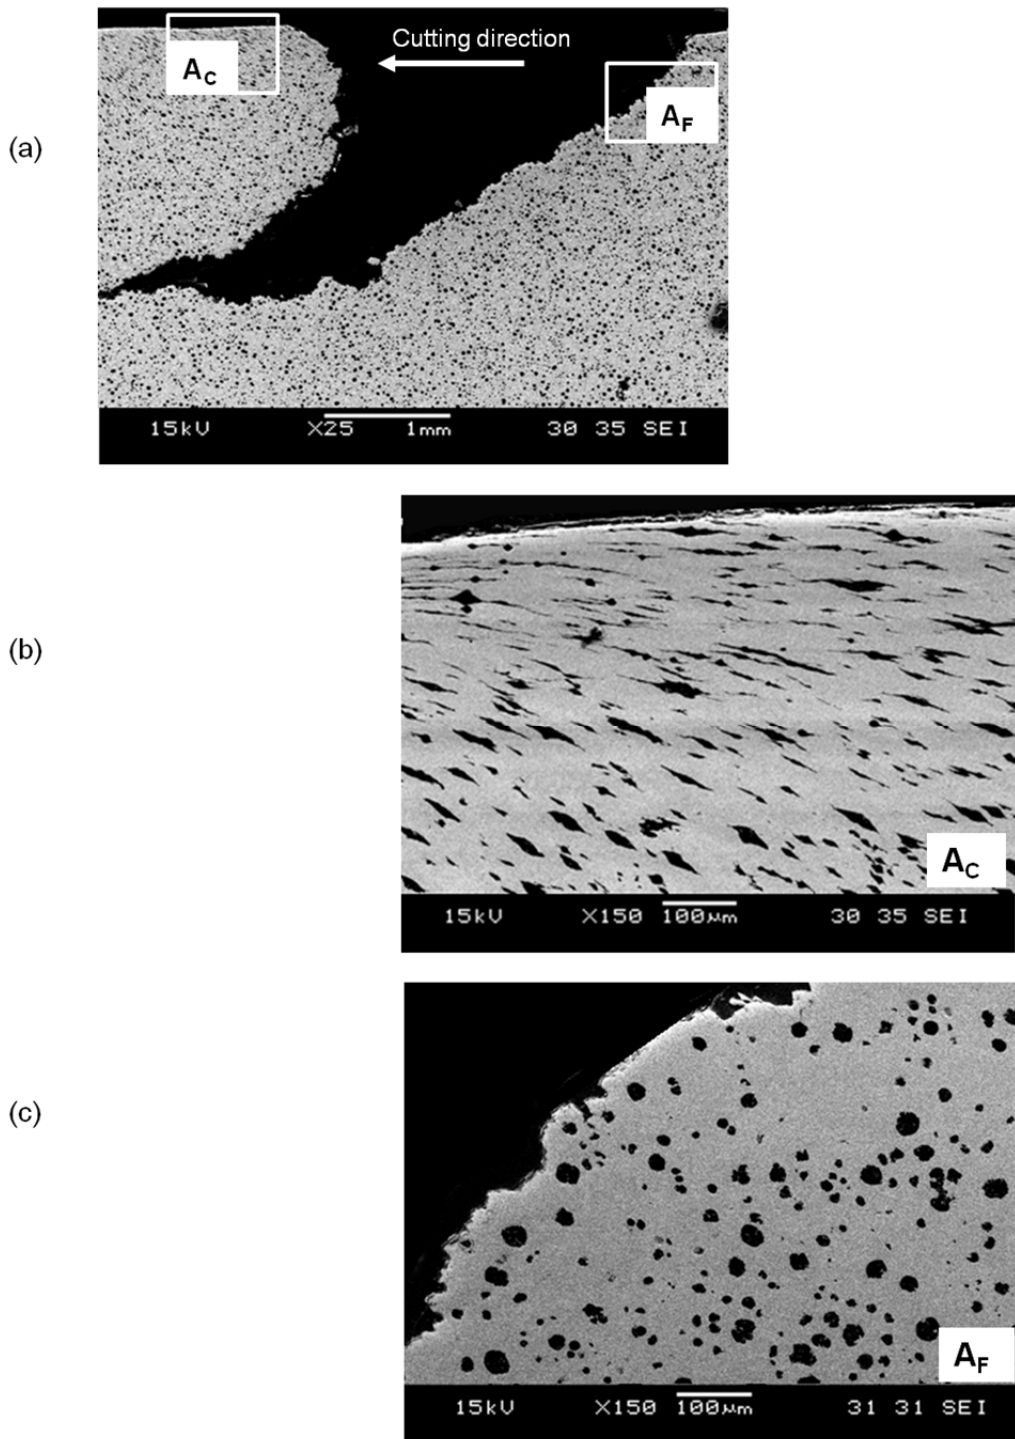
Figure 9. Cross section SEM view of 1.6 m.s^{-1} -10° specimen with deep cracking damage (8(a)). Microstructural details of the A_C area (8(b)) and the A_F area (8(c)). [Cutting speed = 1.6 m.s^{-1} ; rake angle = -10° ; $h=15\text{mm}$ and $\phi=10\text{mm}$].

Cross section micrographic views of the same specimen (1.6 m.s^{-1} -10°) are shown on figure 9 (a) where graphite nodules are highlighted without any chemical etching.

In the A_C zone (figure 9(b)), highly elongated graphite nodules parallel to the cutting direction are observed. On the contrary, in the fractured area A_F , no change can be noticed from the original

nodules shape (figure 9(c)). This suggests a brittle fracture in A_F whereas A_C shows a large plastic deformation of the nodules consistent with a ductile shear mode.

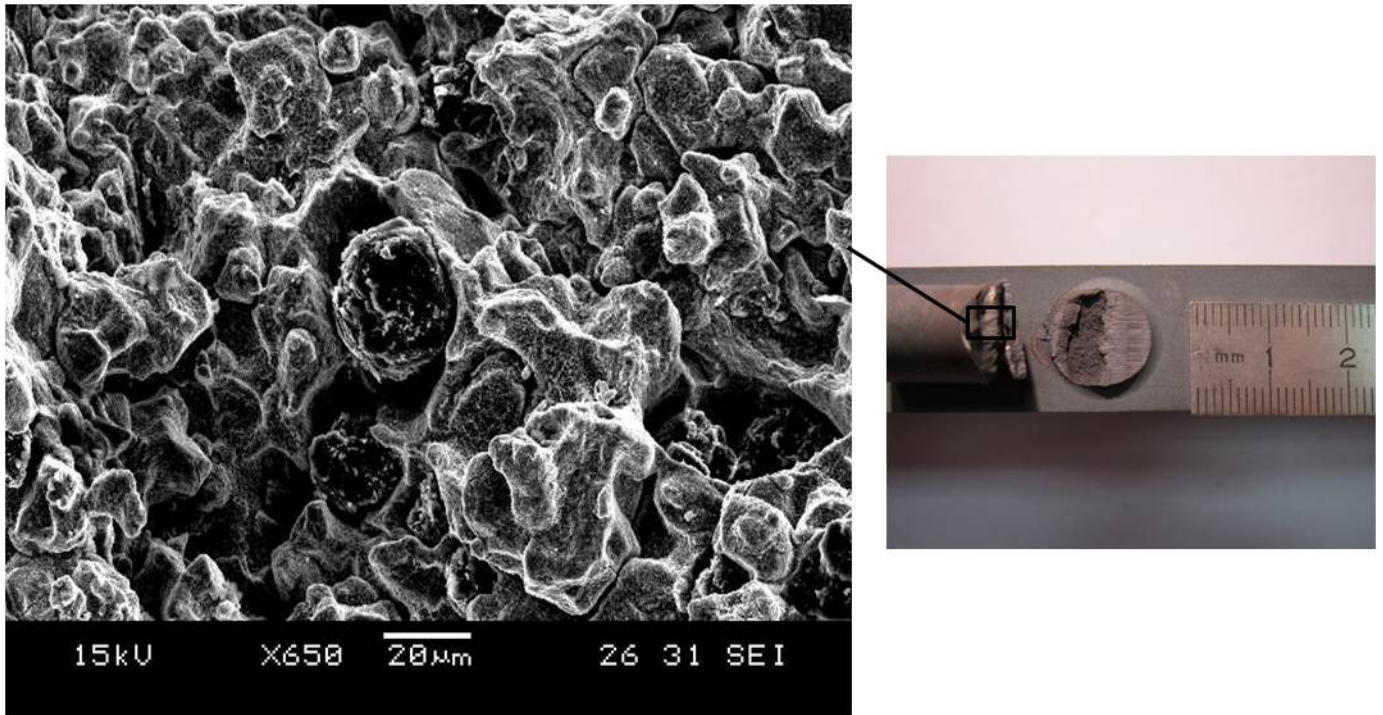
Figure 10. SEM views of $1.6\text{m.s}^{-1}_{-10^\circ}$ specimen “Chip-Pin” cut face. [Cutting speed = 1.6 m.s^{-1} ; rake angle = -10° ; $h=15\text{mm}$ and $\phi=10\text{mm}$].

The analysis of the “Chip-Pin” face corresponding to the A_F cut surface is illustrated in figure 10. A decohesive rupture surface can be observed where the graphite nodules interface acts as crack initiation sites.

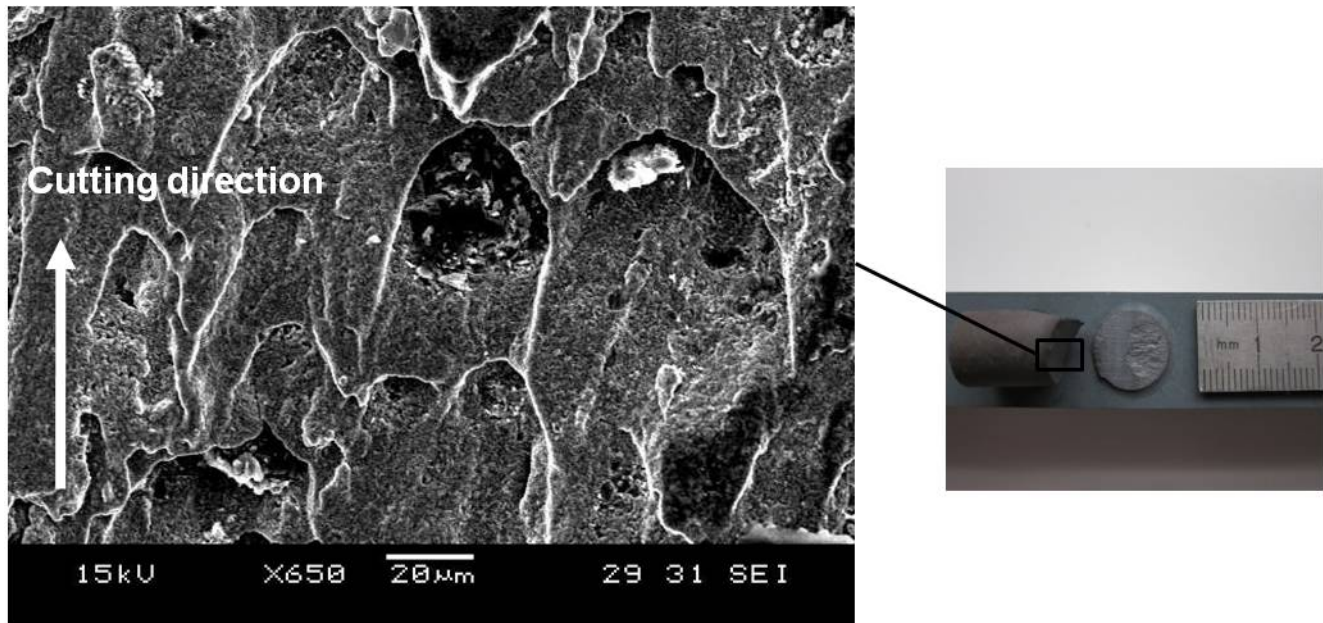
Figure 11. SEM views of 1.3m.s^{-1} -10° specimen "Chip-Pin" cut face. [Cutting speed = 1.3 m.s^{-1} ; rake angle = -10° ; $h = 15\text{mm}$ and $\phi = 10\text{mm}$].

For comparison, a “Chip-Pin” cut without any deep damage ($1.3\text{m.s}^{-1}_{-10^\circ}$ specimen for example) has been observed. It indeed shows a cut surface oriented in the direction of maximum shear stress (cutting direction) with elongated dimples showing cup-cone ductile fracture pattern (figure 11).

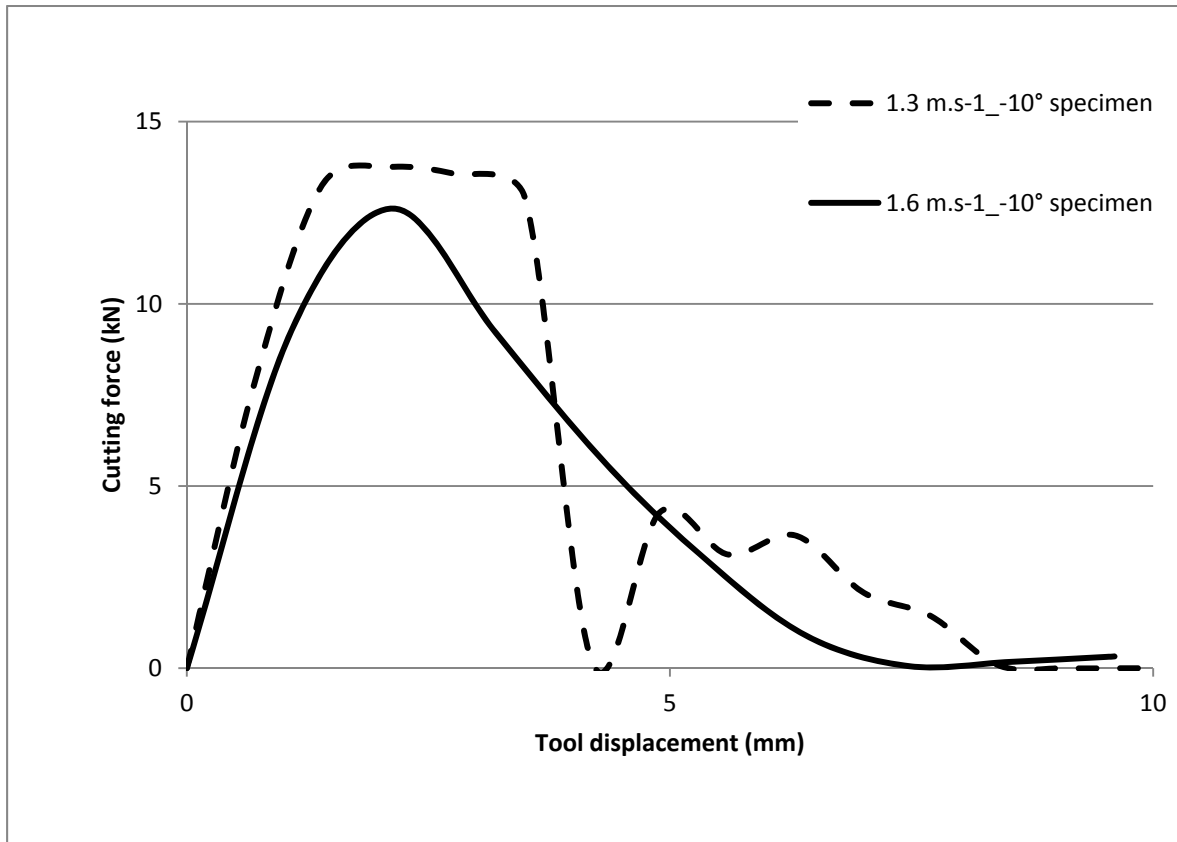
Figure 12. Experimental cutting force-displacement curves for both $1.3\text{ m.s}^{-1}_{-10^\circ}$ and $1.6\text{m.s}^{-1}_{-10^\circ}$ specimens. [$h=15\text{mm}$ and $\phi=10\text{mm}$].

The cutting force curves versus the tool displacement are shown in figure 12 for the tests made on both previous compared specimens ($1.3\text{m.s}^{-1}_{-10^\circ}$ and $1.6\text{m.s}^{-1}_{-10^\circ}$ ones).

The reported results (Fig. 12), representative for a large number of similar tests, state the following specific information:

- The “Chip-pin” element is removed from the specimen after a short tool displacement d ($\leq 0.5\phi$);
- The curve recorded for a specimen presenting a large fractured area ($1.6\text{m.s}^{-1}_{-10^\circ}$ specimen) reaches a peak of a maximum value before coming down smoothly to zero;
- The curve obtained for a specimen without any fractured area ($1.3\text{m.s}^{-1}_{-10^\circ}$ specimen) reaches a plateau for a course of several millimeters ($\approx 0.3\phi$) before falling down quickly to zero. The curve then shows some rebounds.

The dependence between the falling portion of the force-displacement curve and the presence or absence of the fractured area within the specimen cut surface may be explained by the brittle-ductile transition (BDT) taking place within the SG iron specimen at the hot temperatures.

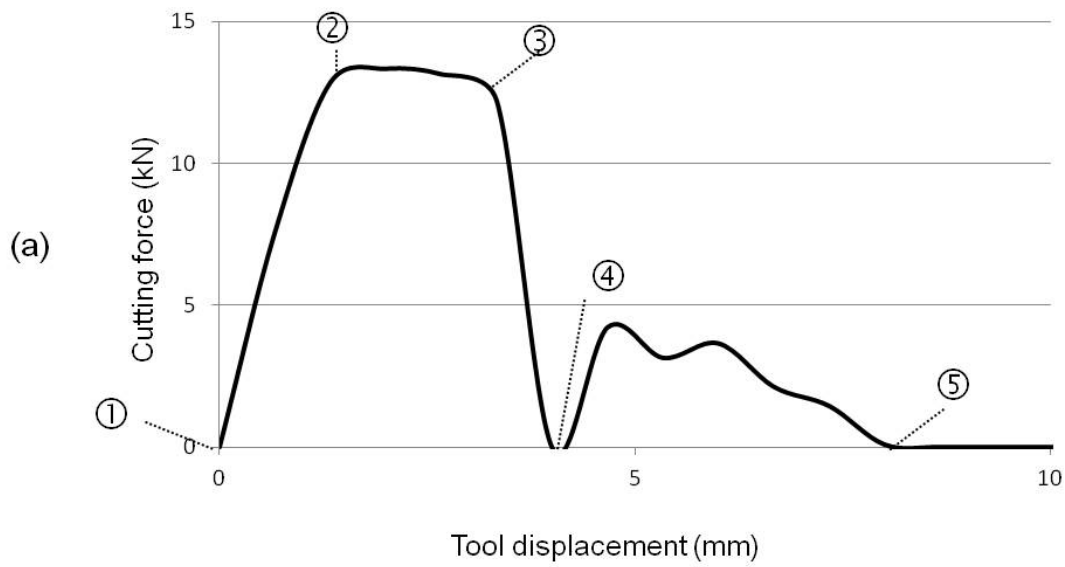
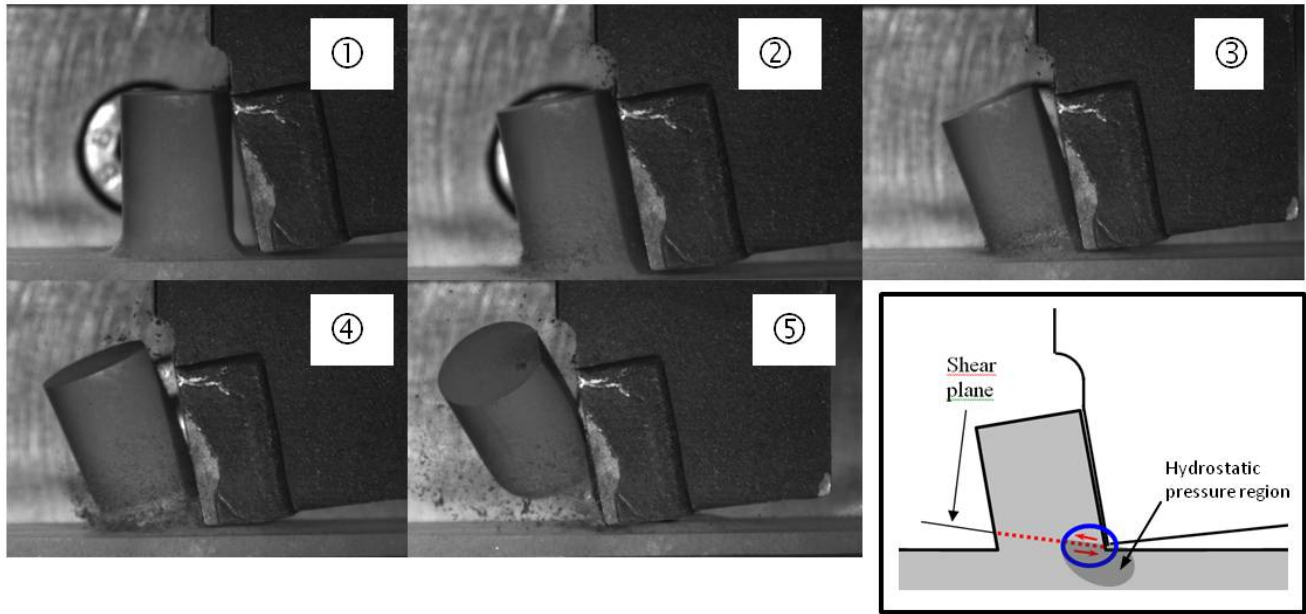
Figure 13. Views of hot cutting action for the $1.3\text{m.s}^{-1}_{-10^\circ}$ specimen (b) with corresponding cutting force data (a).

Schematic view of the ductile-shear regime (DSR) governed by the plastic deformation occurring at the base of the “chip pin” element (c). [Cutting speed = 1.3m.s^{-1} ; rake angle = -10° ; $h=15\text{mm}$ and $\phi=10\text{mm}$].

For the lowest cutting speed ($1.3 \text{ m.s}^{-1}_{-10^{\circ}}$ specimen) a named Ductile-Shear Regime (DSR) governed by plastic deformation seems established: the shear stress on the shear plane increases as the tool is fed, until a sufficient value is reached to suddenly produce the fracture. Between the scenes ③ and ④ of figure 13 (b), the pin element is completely removed and ejected following a flat surface free of cracks. A schematic view of this phenomenon is illustrated on the figure 13 (c).

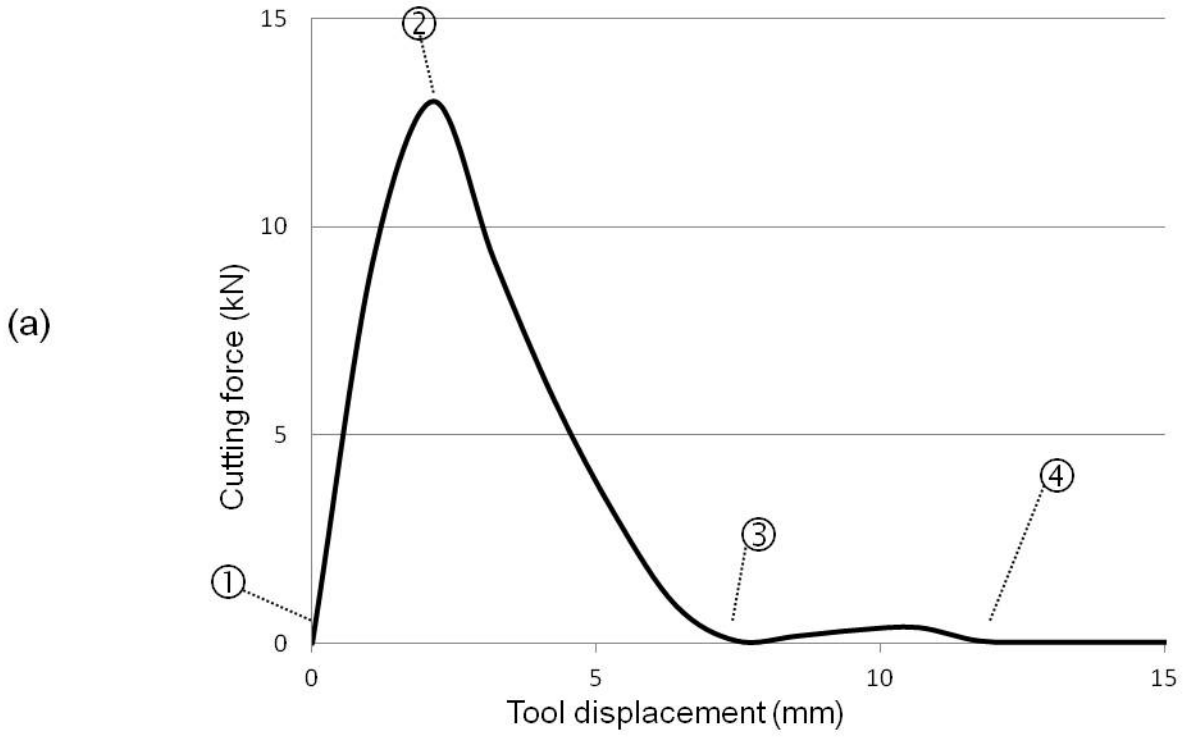
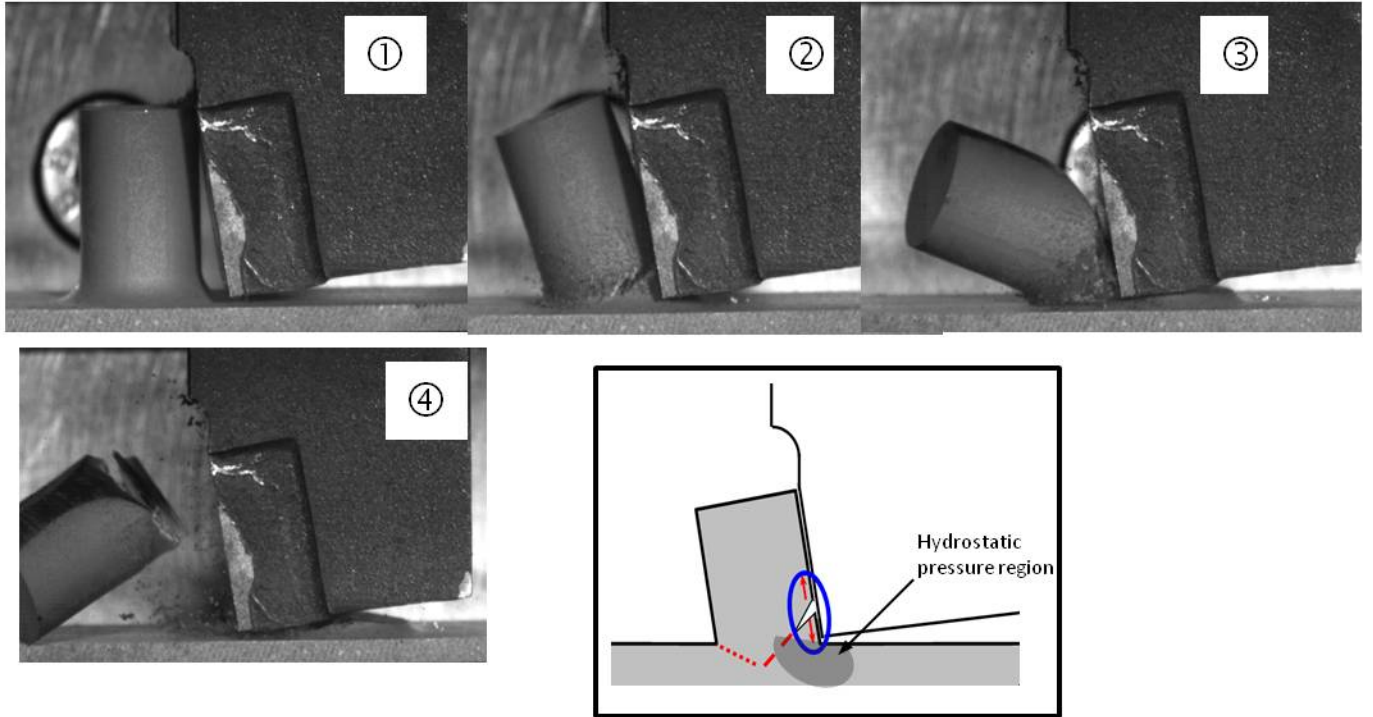
Figure 14. Views of hot cutting action for the $1.6 \text{ m.s}^{-1}_{-10^\circ}$ specimen (b) with corresponding cutting force data (a). Schematic view of the brittle-cracking regime (BCR) governed by the brittle deformation of the “chip pin” element (c). [Cutting speed = 1.6 m.s^{-1} ; rake angle = -10° ; $h = 15 \text{ mm}$ and $\phi = 10 \text{ mm}$].

As the cutting speed increases to 1.6 m/s ($1.6\text{m.s}^{-1}_{-10^\circ}$ specimen), the pin element is rather extruded between the tool and the specimen free surface (figure 14). During this extrusion, the “Chip-pin” element does not slide along the tool face but is rather pushed down. A named Brittle-Cracking

Regime (BCR) governed by the brittle deformation mode is rather established: an initial crack is formed within the pin base in the vicinity of the cutting edge where high tensile normal stresses take place. The fracture occurs with consequent surface and subsurface brittle damages before a short shearing process starts (see schematic view in figure 14(c)). In such a combination of a high cutting speed (a high implied strain rate) and an hydrostatic pressure field caused by negative rake angle, the energy required to propagate cracks is believed to be lower than the energy required for plastic deformation, so that brittle-cracking regime is the predominant mechanism of the material removal.

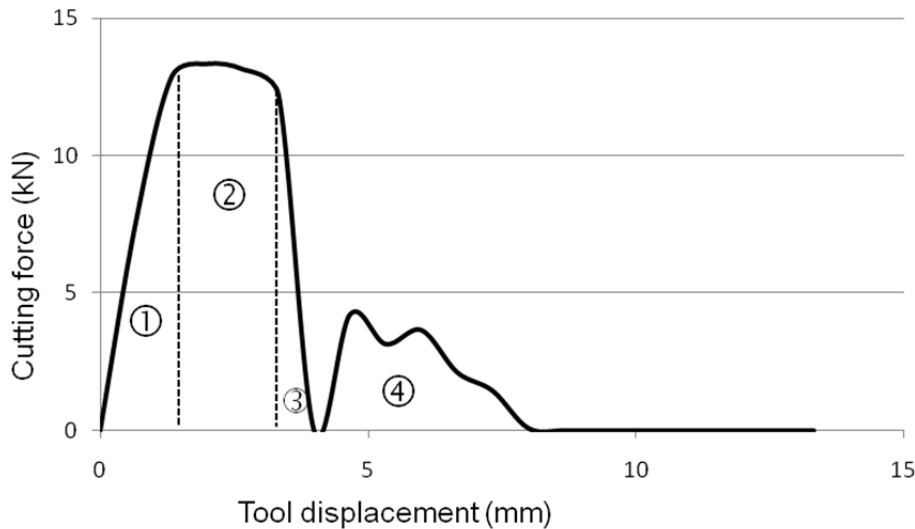
Figure 15. Typical cutting force-displacement curve for ductile-shear regime. [1.3 m.s^{-1} -10° specimen i.e. Cutting speed = 1.3 m.s^{-1} ; rake angle = -10° ; $h = 15\text{mm}$ and $\phi = 10\text{mm}$].

For the ductile-shear regime (DSR) they are brought out in figure 15:

- Stage ① corresponds to an elastic behavior of the material under the tool solicitation;
- Stage ② corresponds to the material plastic deformation by ductile shear. The cutting force rises to a plateau for a more or less short tool displacement according to the cutting speed tested (Fouilland and El Mansori, 2010);
- At the stage ③, the “Chip-pin” is broken free from the specimen along a shear plan. The cutting force falls suddenly to zero;
- Stage ④ reveals the shaping of the remaining excess metal with small thickness.

The existence of a fractured area within the cut surface is now directly related to the brittle behavior (BCR) without any plastic deformation stage identified from the force-displacement curve. On the contrary, a crack-free cut surface is associated to the ductile regime (DSR) with a large ductile deformation stage by shear (stage ② on figure 15).

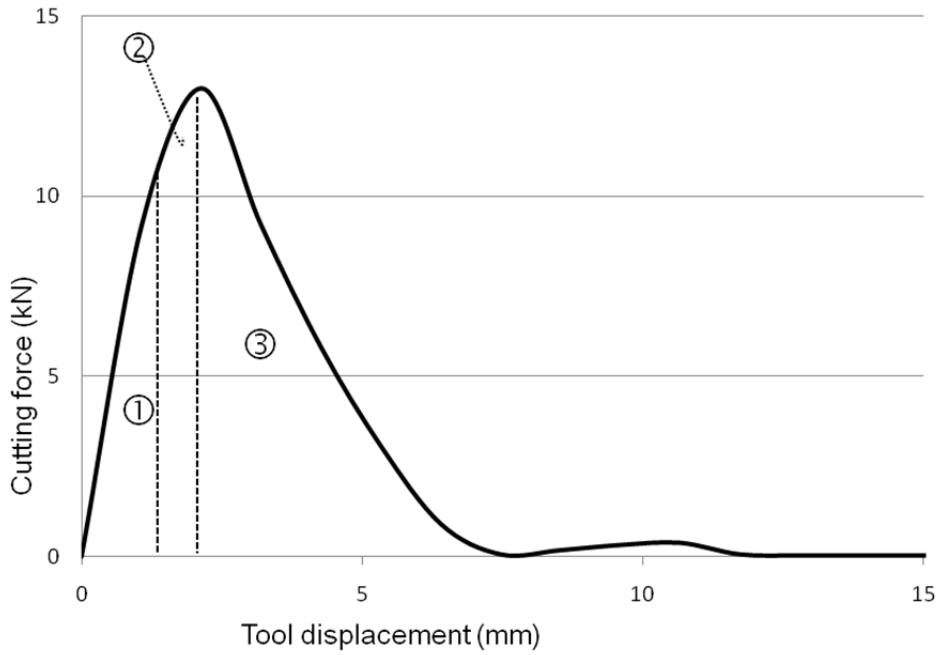
Figure 16. Typical cutting force-displacement curve for brittle-cracking regime. [1.6 m.s^{-1} -10° specimen i.e. Cutting speed = 1.6 m.s^{-1} ; rake angle = -10° ; $h = 15\text{mm}$ and $\phi = 10\text{mm}$].

On the contrary, typical stages of the brittle-cracking regime (BCR) are shown in figure 16. After stage ① (elastic behavior), a short crack stage takes place (stage ②) followed by simultaneous “Chip-pin” ejection and shaping of the remaining excess thickness (Stage ③).

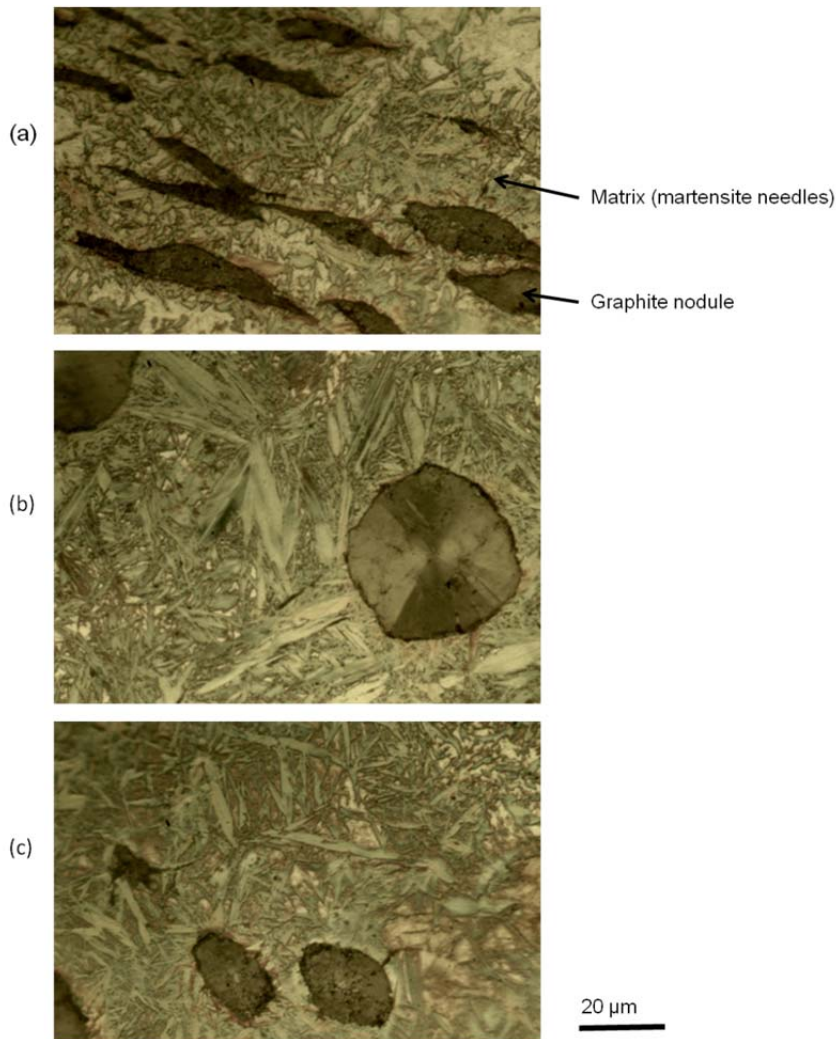
Figure 17. Cross section microstructural details after oil quenching.

(a) sub cut-surface of the $1.3 \text{ m.s}^{-1}_{-10^{\circ}}$ specimen, (b) far away from the cut surface of the $1.3 \text{ m.s}^{-1}_{-10^{\circ}}$ specimen, (c) $1.6 \text{ m.s}^{-1}_{-10^{\circ}}$ specimen just below (A_F) region. [Etched with supersaturated nitric acid].

The observed cross sectional surface of the $1.3 \text{ m.s}^{-1}_{-10^{\circ}}$ specimen shows that martensite needles just below the cut surface are finer (figure 17-a) and shorter than these observed far away from the cut surface (figure 17-b). Concerning the $1.6 \text{ m.s}^{-1}_{-10^{\circ}}$ specimen cut surface (i.e. just below the

fractured region (A_F)), no needles refinement was found (figure 17-c). According to Dragos et al. (1978), and as mentioned above, the fineness of the needles depends on the austenite grains size from which they originate and is thus a valid indicator of the dynamic recrystallization activation. This allows asserting that the dynamic recrystallization phenomenon is activated at the vicinity of the cut surface only for the $1.3 \text{ m.s}^{-1}_{-10^\circ}$ specimen. For the $1.6 \text{ m.s}^{-1}_{-10^\circ}$ specimen the cutting speed seems high enough to prevent this phenomenon. As a consequence, this metallographic study gives confidence in the previous results and indicates that the dynamic recrystallization is the main origin of the BDT in SG hot cutting process.

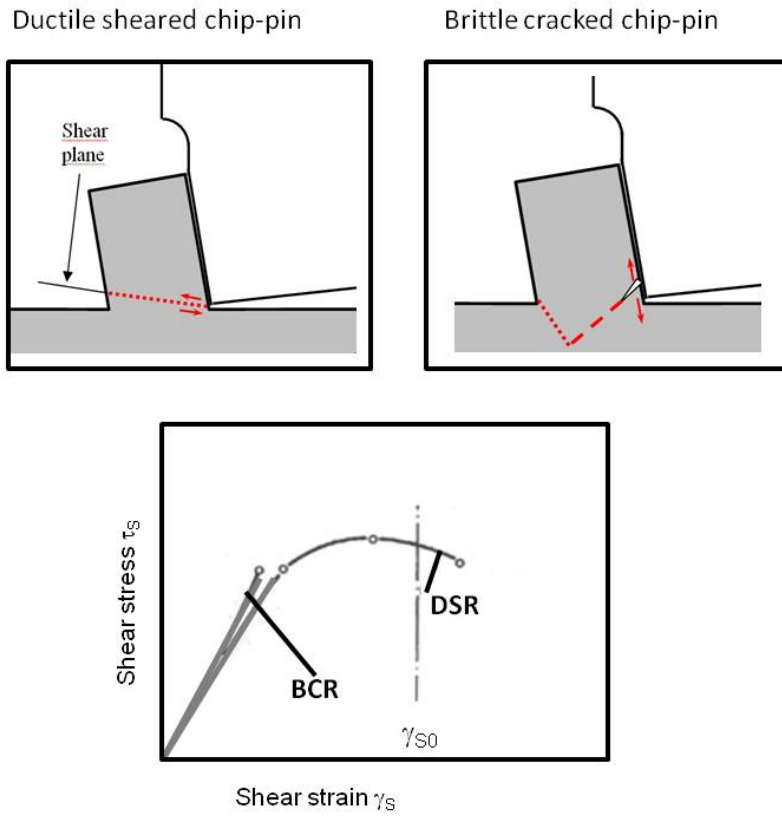
Figure 19. Chip-pin formation mechanisms in terms of stress/strain curves (BCR=Brittle Cracking Regime, DSR=Ductile Shear Regime).

In the present study, when the strain softening resulting from dynamic recrystallization is more pronounced than the associated strain-hardening, a ductile shear regime (DSR) takes place (figure 19 vs curve DSR) and the pin element is completely sheared (ductile sheared chip-pin in figure 19) following a flat shear surface in analogy with the segmented chip formation mechanism. The discontinuous chip formation mechanism described by Grzesik (2008) may also aid the brittle cracked chip-pin mechanism comprehension (figure 19 vs curve BCR) when the pin fracture occurs without any plastic deformation.
