Vanessa RODRIGUEZ, Jacob SUKUMARAN, Yeczain PEREZ DELGADO, Mariana STAIA, Alain IOST, Patrick DE BAETS - Scratch evaluation on a high performance polymer - Mechanical Engineering Letters - Vol. 9, p.76-84 - 2013

# Scratch evaluation on a high performance polymer

## Abstract

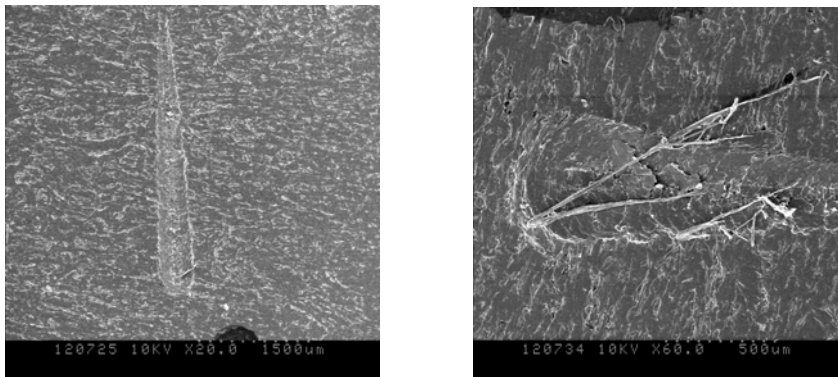
*Figure 4.* The scratch surface damage observed using scanning electron micrographs on PEEK-E02 under the scratching load of 50N and scratching velocity of 10mm/min

Additionally a few analysis of scanning electron microscopy images for the PEEK-E02 polymer figure 4 and figure 7 for PEEK-S01, were performed to understand how material deformation and removal processes take place during scratching. This has indications in the understanding of abrasive wear process for polymers because abrasive wear mechanism takes places by hard asperities or loose debris particles.

In figure 4, the sample of PEEK polymer filled with carbon fibers, graphite fibers and PTFE shows that the surface deforms with the formation of noticeable cracks, microcracks, materials removal and some detached debris particles within the scratch zone for PEEK-E02 material. In some cases depending upon the type of the materials and the severity of the contact, the material deformation can take place around the scratch tip with or without wear debris formation (Rajesh and Bijwe 2005).
