Houda YAHYAOUI, Naoufel BEN MOUSSA, H SIDHOM, N BEN FREDJ, Chedly BRAHAM - Role of machining defects and residual stress on the AISI 304 fatigue crack nucleation - Fatigue and Fracture of Engineering Materials and Structures - Vol. 38, p.420-433 - 2015

Role of machining defects and residual stress on the AISI 304 fatigue crack nucleation

ABSTRACT Machining defects as rebuilt material and dislodgement were often induced by cutting of difficult to machining AISI 304 stainless steel. Their density increases with a decreasing of cutting speed. The effect of these defects on surface topography and residual stress was evaluated by roughness and X-ray diffraction measurements coupled with numerical simulation. The role of the rebuilt material on the distribution of fatigue crack nucleation sites was investigated by scanning electron microscope examination of post fatigue samples loaded at different imposed strain amplitudes. The association of machining defects and fatigue crack nucleation sites was attributed to the contribution of additional tensile residual stresses induced by rebuilt material rather than local stress concentration. Moreover, the fatigue crack coalescence is promoted

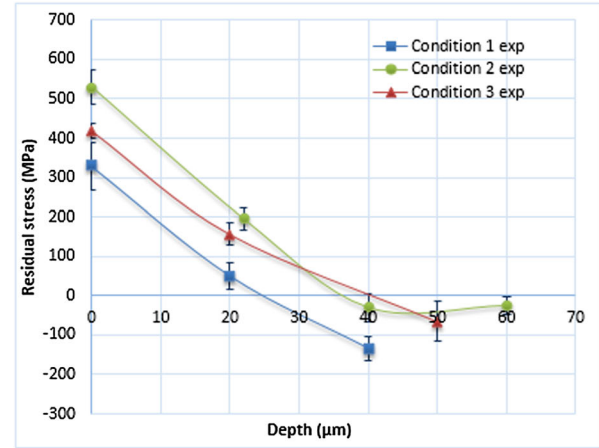
Fig. 6 Effect of cutting conditions on the residual stress: (a) hoop stress and (b) axial stress.

The measured residual stress profiles are in good agreement with the cutting conditions severity (Fig. 6). Indeed, the near surface hoop tensile residual stress levels increase with an increase in the cutting speed (V_c). However, the axial residual stresses are compressive for all cutting conditions.

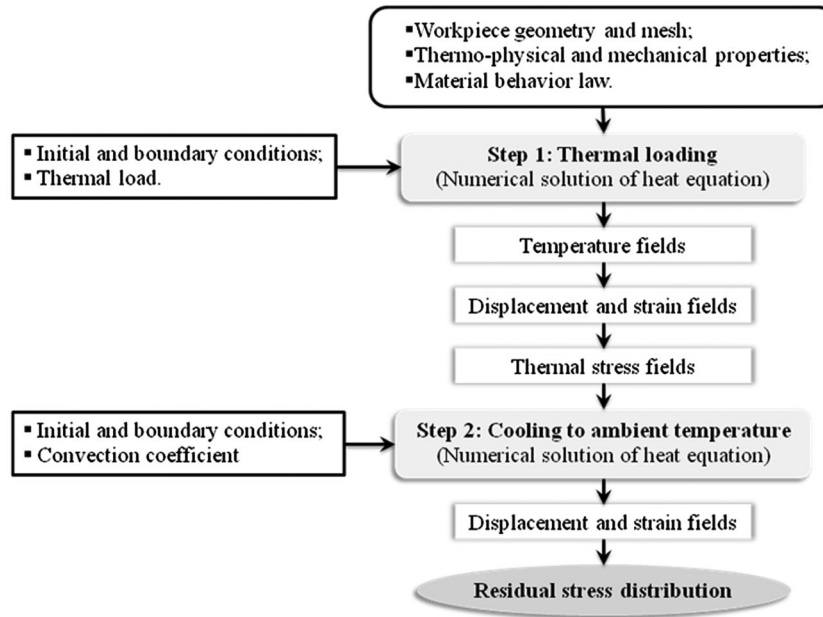
Fig. 7 Residual stress calculation procedure.

modification are considered. The methodology used to predict residual stress is presented in Fig. 7.

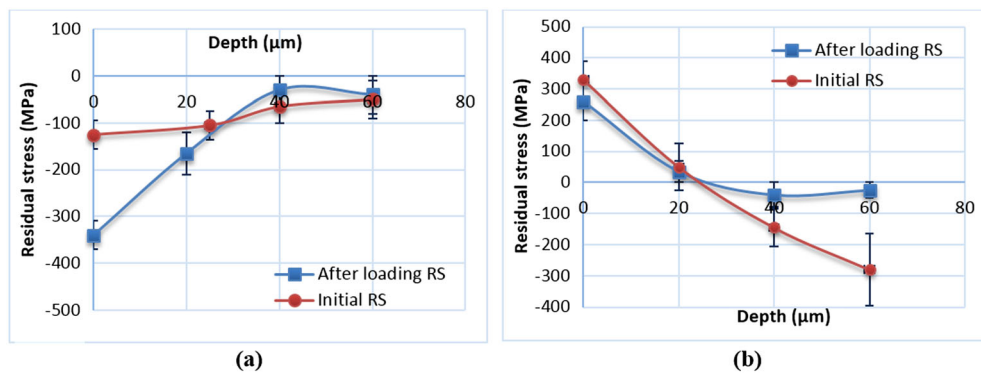
Fig. 13 Stabilized residual stress profiles determined by X-ray diffraction, Condition 1 ($\frac{\Delta\epsilon}{2} = 0.3\%$, $N_R = 26689$), (a) axial stress and (b) hoop stress.

Low-cycle fatigue loading relaxes, partially or totally, the machining residual stress in both directions (Fig. 13). The residual stress relaxation is more
