Shaoxiong LIANG, Papa-Birame GNING, Laurent GUILLAUMAT - Quasi-static behaviour and damage assessment of flax/epoxy composites - Materials and Design - Vol. 67, p.344-353 - 2015

# Quasi-static behaviour and damage assessment of flax/epoxy composites

Experimental investigations were conducted on flax and E-glass fibres reinforced epoxy matrix composites subjected to quasi-static loadings. Flax/epoxy samples having  $[0]_{12}$ ,  $[90]_{12}$ ,  $[0/90]_{3S}$  and  $[\pm 45]_{3S}$  stacking sequences, with a fibre volume fraction of 43% have been tested under tension, compression and in-plane shear loadings. Overall, the compression strength of glass/epoxy was 76% greater than for the flax/epoxy composite. The damage evolution of flax/epoxy of  $[0/90]_{3S}$  and  $[\pm 45]_{3S}$  samples has been evaluated in terms of transverse crack densities with respect to the load increment. The crack density exhibited a classical “S” shaped pattern for  $[0/90]_{3S}$  and linearly for  $[\pm 45]_{3S}$  specimens versus the applied load. The final crack densities were respectively of 32/cm and 25/cm for the  $[0/90]_{3S}$  and  $[\pm 45]_{3S}$  samples.

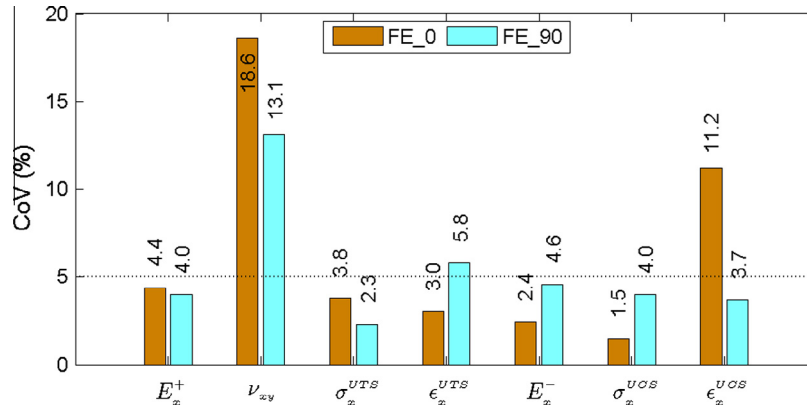
Fig. 6. CoV of mechanical properties of FE\_0 and FE\_90.

the mechanical properties of elementary flax fibres, is between 21% and 57%. In this present study, the measured CoV of the properties of the flax/epoxy UD layers are generally lower than 5%, except for Poisson's ratios ( $\nu_{xy}$ ), ultimate tensile strain ( $\epsilon_x^{UTS}$ ) for FE\_90 and compression strain ( $\epsilon_{11}^{UCS}$ ) for FE\_0, as illustrated in Fig. 6. This remark highlights the fact that the variability level of UD flax composites' properties is largely smaller than that of single fibres. The decrease of scattering from the single fibre scale to the composite specimen scale can be explained by an "averaging" effect due to the very large number of single fibres contained in the composite sample. Indeed, under load, the reaction of fibres having higher mechanical properties compensates that of weaker ones, covering the dispersions of behaviours between them. This results in the decrease of the macroscopic variability at laminate scale.

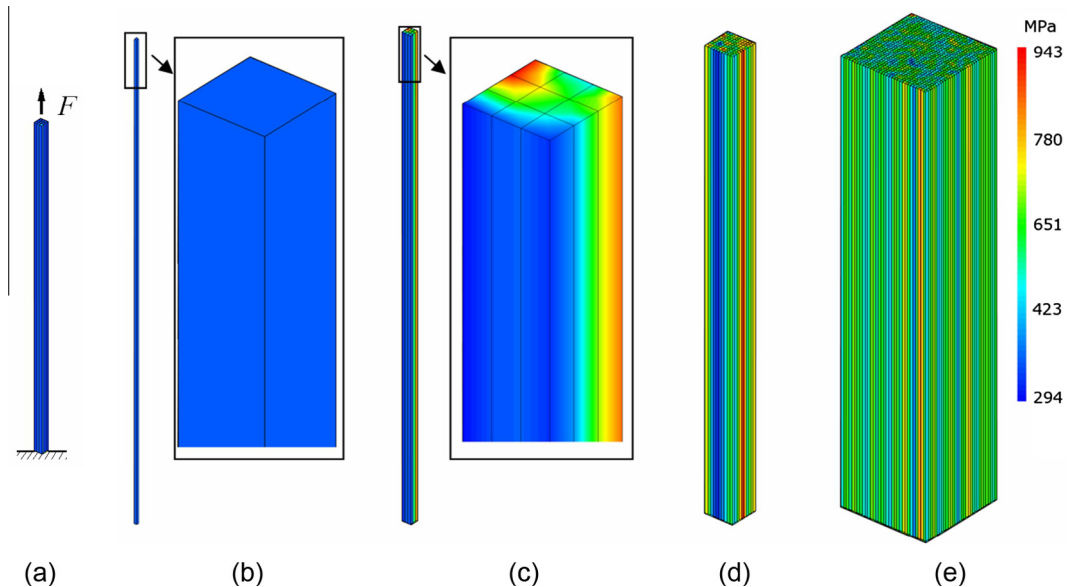
Fig. 7. FEM of fibres' variability: (a) boundary conditions and loading, models of bundles containing: (b) 1 single fibre, (c) 9 fibres, (d) 100 fibres and (e) 1024 fibres.

To illustrate this effect, a Finite Element Model (FEM) of a single fibre and bundles of fibres loaded in tension, was achieved with *Cast3m* code, in order to estimate the variability of the bundle's Young's modulus as a function of the number of considered fibres. The 3D model is constructed by 8 nodes cubic elements. Four models containing  $n_f$  fibres, respectively equal to 1, 9, 100 and 1024 (Fig. 7), were longitudinally loaded with an uniaxial tensile force  $F$  applied on top of the fibres bundles and rigidly fixed at the other extremity (Fig. 7a). The input of longitudinal modulus of each fibre was randomly affected following a normal distribution law with a CoV of 28% taken from Baley's study [4]. The bundle's modulus ( $E$ ) was calculated by Eq. (4), where  $S$  and  $\epsilon$  are respectively the cross-section area and the longitudinal strain of the bundle.

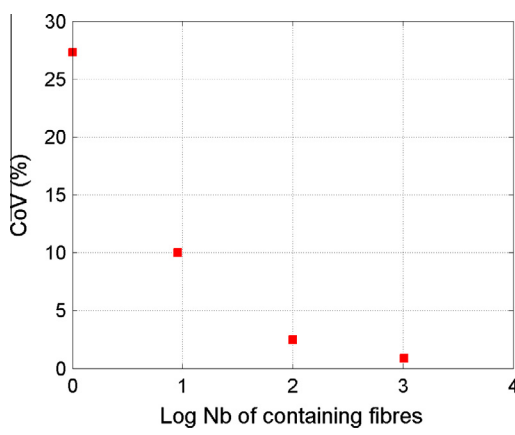
**Fig. 8.** CoV of bundles' modulus as a function of the number of fibres contained in bundles.

The CoV of each bundle was determined after 50 random simulations and plotted in Fig. 8. It appeared clearly that, the scattering decreased very strongly with the number of fibres and was lower than 1% for  $n_f = 1024$ . By extrapolation, it is possible to imagine that the CoV of a full scale specimen that contains a very large number of fibres should be insignificant compared to the variability of a single fibre's properties. However, some following reasons can slow down

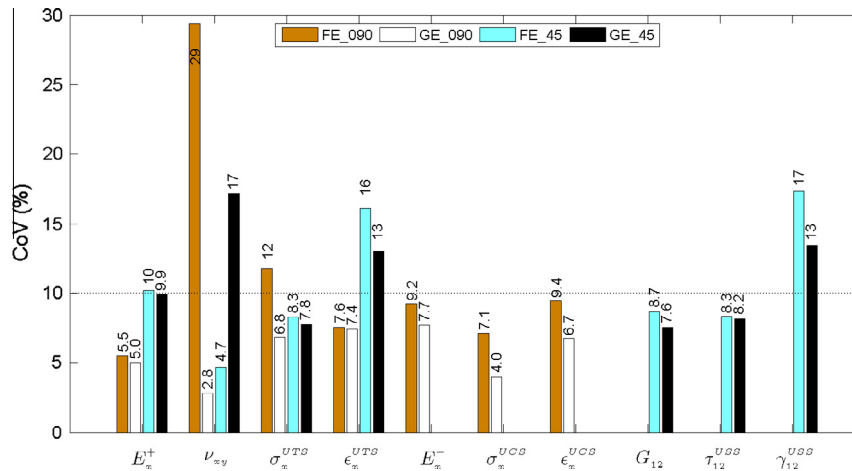
**Fig. 9.** CoV of mechanical properties of FE\_090, GE\_090, FE\_45 and GE\_45.

In the same manner, the measured CoV of the properties of the flax/epoxy UD layers were on general lower than that of flax/epoxy cross-ply laminates (FE\_090 and FE\_45). For the latter the CoV were globally beneath 10%, except for the Poisson's ratio ( $\nu_{xy}$ ) for FE\_090, ultimate tensile strength  $\sigma_x^{UTS}$  for FE\_090, ultimate tensile and shear strain ( $\epsilon_x^{UTS}$  and  $\gamma_{12}^{USS}$ ) for FE\_45, as shown in Fig. 9. The increase of the properties' scattering, from UD to cross-ply laminate, can be explained by the presence of half less fibres loaded, hence less "averaging" effect, and the existence of a second stacking direction that adds the origins of uncertainties. It is remarkable that the variability of flax/epoxy laminates (FE\_090 and FE\_45) was of the same level as that of man-made E-glass/epoxy laminates (GE\_090 and GE\_45) (Fig. 9). As illustrated by the 3D FEM, the scattering of constitutive elementary fibres is covered by the averaging effect in laminate scale. Thus, disregard the important variation in

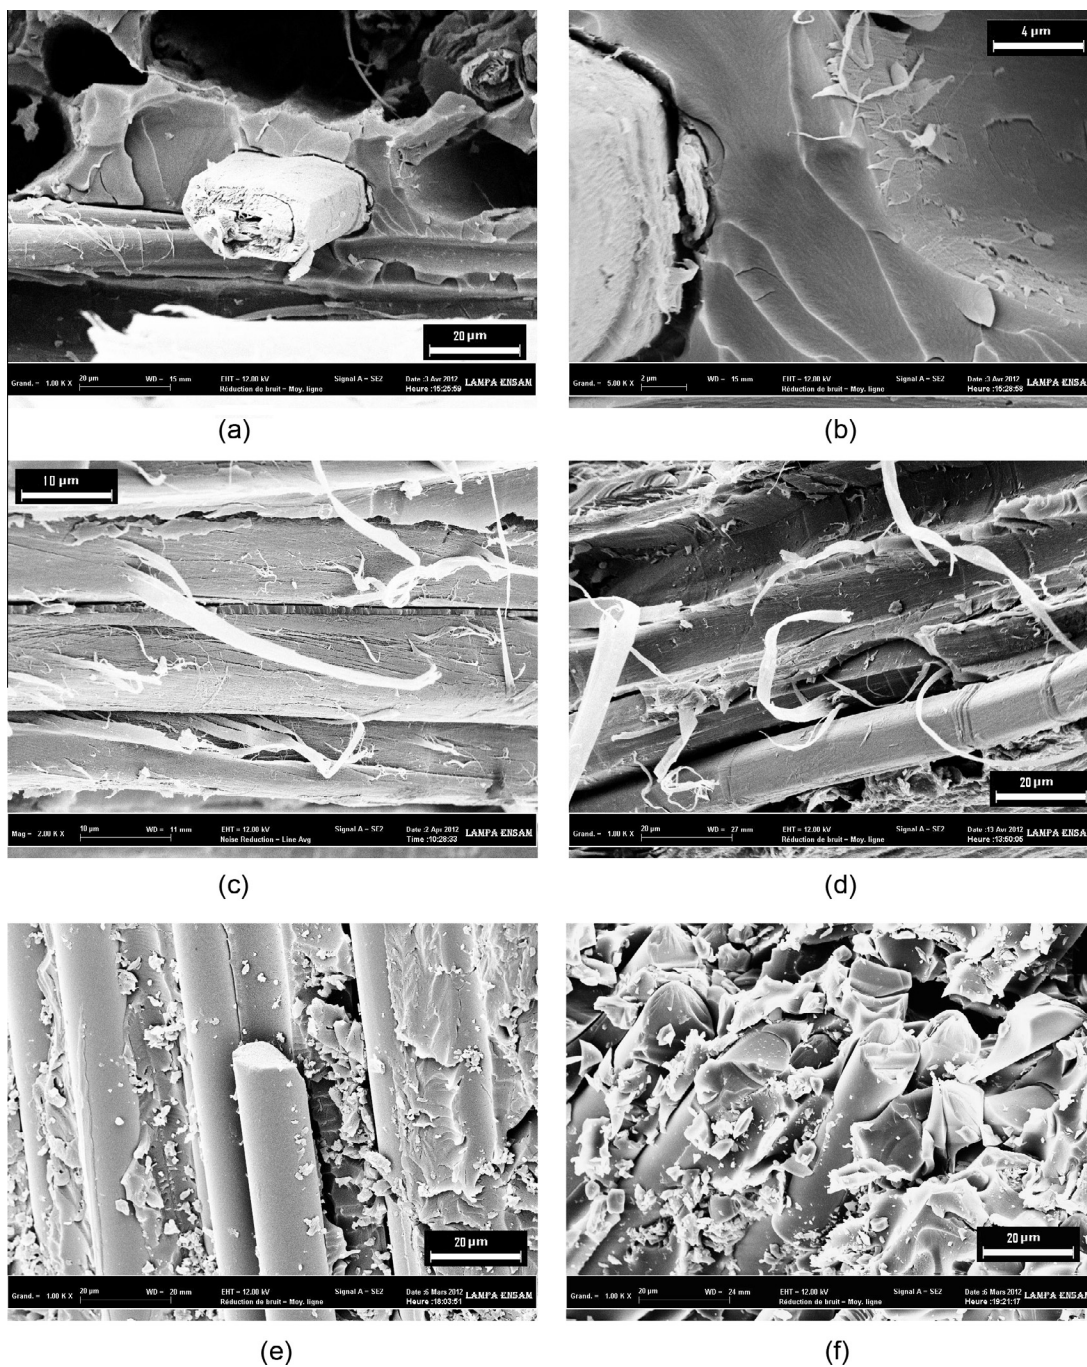
**Fig. 10.** SEM images of the edges of fractured specimens: (a) pulled-out flax fibre and imprints of removed fibres in the 0° layer, (b) detail view of flax fibre/matrix interface and pull-out imprint, (c) view of denuded fibres in fractured 90° oriented layer, (d) denuded flax fibres and removed fibre prints in matrix of 45° oriented layers, (e) matrix residues on the fibre surface of failed glass/epoxy interface of GE\_090 specimen and (f) glass fibres enclosed in epoxy matrix of GE\_45 sample.

Micrographics of fractured edges of tested FE\_090, FE\_45 and GE\_090 specimens in tensile loading until failure are shown in Fig. 10. Single fibres from pull-out and remaining traces of pulled fibres from the matrix were observed in 0° oriented layers of

FE\_090 specimens (Fig. 10a and b). Almost no matrix residue has been found on the surface of the fibres of 0°, 90° (Fig. 10a and c) and 45° (Fig. 10d) oriented layers. This observation is consistent with the poor adhesion between hydrophilic plant fibres and hydrophobic matrix as reported in [26]. By comparison with [0/90]<sub>3S</sub> and [±45]<sub>3S</sub> glass/epoxy specimens, matrix remnants were found attached to the surface of the fibre interface due to a stronger adhesion (Fig. 10e and f).

It can be noticed that, flax fragments were found stuck to the matrix after fibre pull-out (Fig. 10b). Moreover, superficial flax shavings appeared partially separated from the fibres, i.e. not completely torn from the reinforcements (Fig. 10c and d). The presence of flax residues on both matrix and fibre surfaces suggests that the adhesion between the primary and secondary fibre cell walls has comparable toughness to the primary cell wall/epoxy matrix interface. Therefore, fibre cell walls separation can be considered as an additional type of damage mechanism for vegetal fibre reinforced composites. Until now, no data of the primary/secondary cell walls interface resistance is available in literature. Further work is needed to measure this toughness knowing that the main difficulty is that the thickness of the primary cell walls, of approximately 0.2 µm, is very small [27].

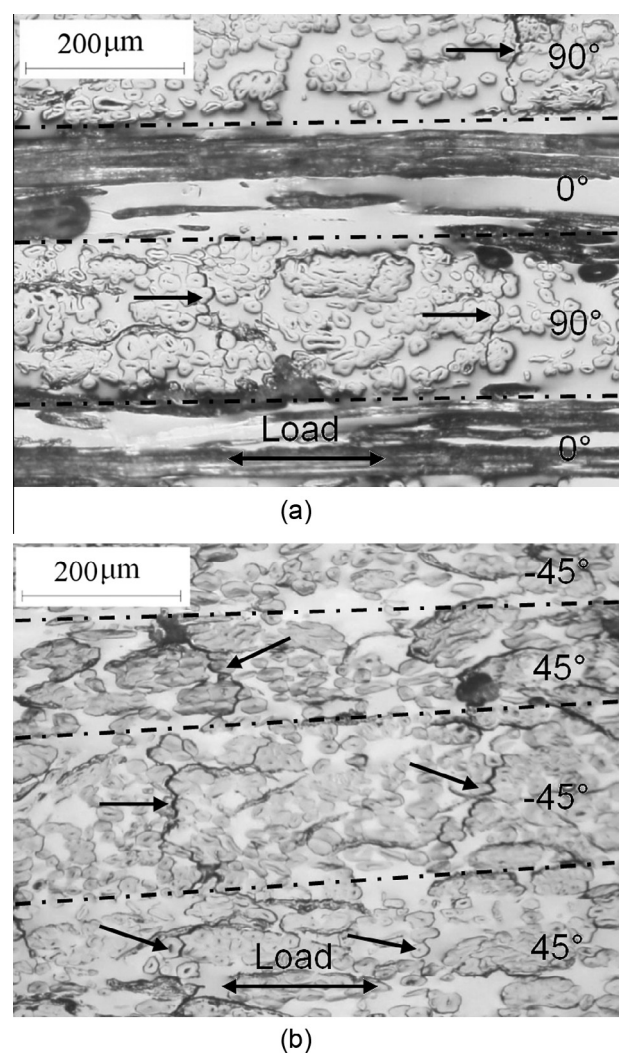
**Fig. 12.** OM images of (a) FE\_090 and (b) FE\_45 specimens tested at 80% UTS. Arrows point to the through-the-thickness cracks. Layers orientation and loading direction are indicated.

Samples tested at different load levels were then cut parallel to the loading direction for damage assessment in terms of crack density development. Fig. 12 shows micrographics of FE\_090 and FE\_45 samples loaded at 80% UTS. Cracks propagated tortuously only in 90° layers for [0/90]<sub>3S</sub> laminates (Fig. 12a) by following the fibre/matrix interface which is the lowest energy path. Similar cracks were observed in all plies of [±45]<sub>3S</sub> tested samples (Fig. 12b).

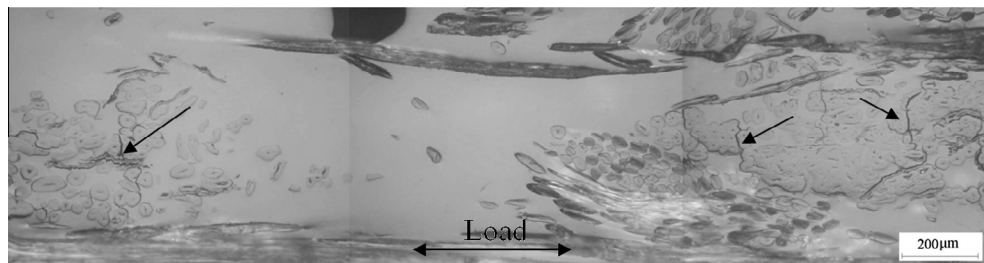
**Fig. 14.** OM images of transverse crack distribution and rich resin zones (monochrome areas) of an FE\_090 specimen loaded up to failure. Arrows point to the cracks.

The number of cracks increased with the load for both FE\_090 and FE\_45 specimens. The crack spacing was not regular, even for higher levels, when saturation was reached. Larger distances corresponded to rich resin zones, e.g. monochrome areas visible along the loading axis of a FE\_090 sample tested until failure in Fig. 14. In fact, the difference between the maximum tensile strain of the pure epoxy resin, in the range of 1.7–4.6% [10] and that of 90° oriented FFRP composites i.e. FE\_90 samples of 0.62%, suggests that the crack creation is probably due to the weakness of the transverse resistance of flax fibres or/and the poor interfacial adhesion properties between flax and matrix. Therefore, few cracks have been observed in resin rich zones. This observation reveals that, the increase of the mechanical properties of FFRP composites is linked to the improvement of the interfacial adhesion.
