BELIARDOUH NASSER EDDINE, Hakan KALELI, Corinne NOUVEAU - Wear performance of duplex treated low alloyed steel against wood (beech) as static partner - Journal of the Balkan Tribological Association - Vol. 20, n°1, p.84-92 - 2014

WEAR PERFORMANCE OF DUPLEX TREATED LOW ALLOYED STEEL AGAINST WOOD (BEECH) AS STATIC PARTNER

ABSTRACT

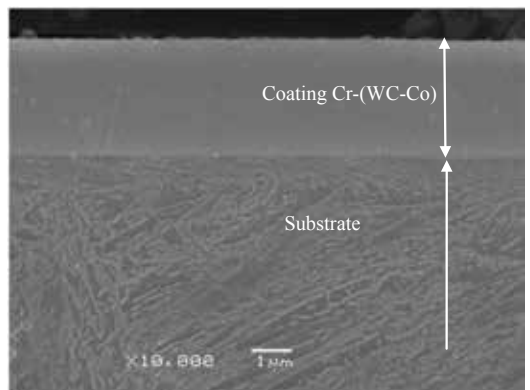
Fig. 1. SEM micrograph: cross-section view of duplex treated samples. The Cr-(WC-Co) layers developed a dense structure

Sample elaboration. The substrate used in this work was a commercial low alloy steel DIN 18CrMo4. Before thermo-chemical treatment, the samples were polished with P800 paper, ultrasonically cleaned, and finally introduced into a vacuum furnace 'BMI Furnace'. The carburising gas was ethylene (C_2H_4) and the temperature was 900°C . The total durations of the boost/diffusion stages were 120 min (carburising C1) and 105 min (carburising C2). After the carburising process, samples are in-situ quenched in a high pressure N_2 environment (500 kPa), subsequently annealed at 200°C for 120 min, and finally cooled in a 100 kPa N_2 atmosphere. The Vickers hardness values of C1-treated surface layer is $H_{v.100} = 768 \pm 5$ and the C2-treated samples yield $H_{v.100} = 654 \pm 5$. Additionally, carbon analysis of the surface layer yields 0.667 wt.% and 0.615 wt.% for C1 and C2 treatments, respectively. Both of treated C1 and C2 samples present the same hardness's value at the core of the substrate ($H_{v.100} \sim 300$) and approximately the same depth of carburised layers (550–600 μm). A standard and typical microstructure was developed after carburising process. At the top layers, the microstructure consists of martensite phase and cementite (Fe_3C) with evidently a few quantities of γ retained austenite. After that, Cr(WC-Co) coatings onto carburised surface samples were elaborated as can be seen in Fig. 1.

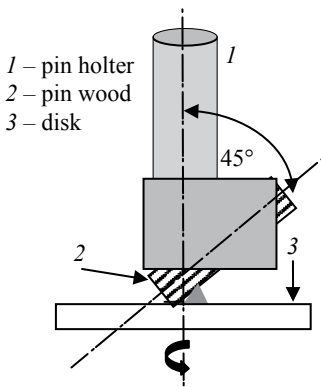
**Fig. 2.** Pin-on-disk tests**Table 2.** Parameters of experimental wear tests

Samples characterisations. Wear properties of the coatings were evaluated under dry sliding condition at room temperature using a pin-on-disk tribometer (CSM HT1000) and Tribbox 4.1.1 software. The two main standards referring to the pin-on-disk tribometer are DIN 50324 and ASTM G 99 – 95a (Ref. 7). The pin-on-disk tests were performed with the test configuration schematically illustrated in Fig. 2. The pin wood with a diameter of 6 mm is positioned at 45° on the holder and loaded against a rotating disc. Only cemented (C1 and C2) and cemented +coated (F101 and F102) samples were studied.

In order to approach real contact conditions, e.g. the wood process as peeling of beech, test parameters were chosen appropriately as listed in Table 2. A particular preparation is needed when tests are conducted with wood counterpart: the pin was cut perpendicular to fibres (length 20 mm; \varnothing of 6 mm) from a specific specimen of beech tree provided by a regional sawmill. It was then polished to remove any chips and immersed into hot water (70–75°C) for 24 h.

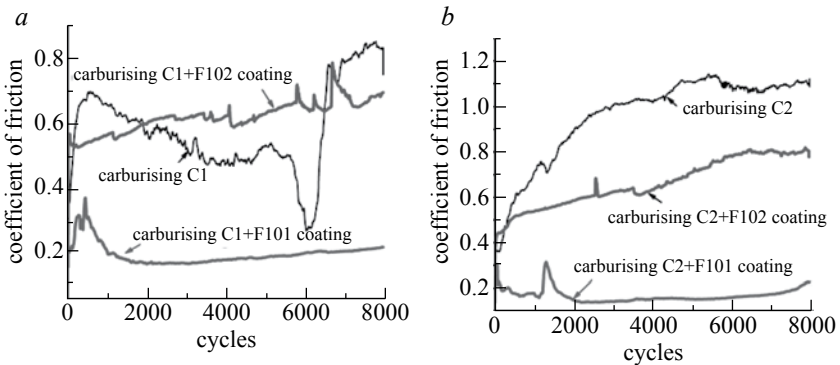
Fig. 3. Friction behaviour of the duplex treated samples ($C_{1,2}+F101$ and $C_{1,2}+F102$) compared with uncoated samples (C1; C2) in interaction with pin wood as counterpart

Coefficient of friction evolution. As can be seen in Fig. 3a, when sliding against the wood pin, the coefficient of friction (COF) of the C1 specimen at the start increases rapidly after that it decreases slightly. Then it reached a maximum value of 0.65 (500 cycles), followed by a sudden decrease to 0.25 (6000 cycles). This phenomenon is also observed when the applied load equals to 1 N. At the end of test, the friction coefficient increases to its maximum value of ~ 0.8 – 0.85 . However, the coefficient of friction of the C2 sample rises slowly and gets stabilised at the end of test about 1–1.2 (Fig. 3b). Both curves show a run-in period followed by a friction coefficient increase. The C1 sample presents a lower COF (0.85) than the C2 sample (1.15) after 8000 cycles of sliding against wood pin.

When duplex treated samples were tested, the coefficient of friction showed a run-in period, and afterwards an increase in slope of curves, as can be seen in Fig. 3. The F102 coating had a high run-in friction and showed a short period of

stabilised COF of around 0.6–0.65 for (C1+F102) and (C2+F102). On the contrary, the F101 coating shows a nearly constant evolution of COF. For both (C1+F101) and (C2+F101) samples, after a run-in period, a value about 0.2 was reached.

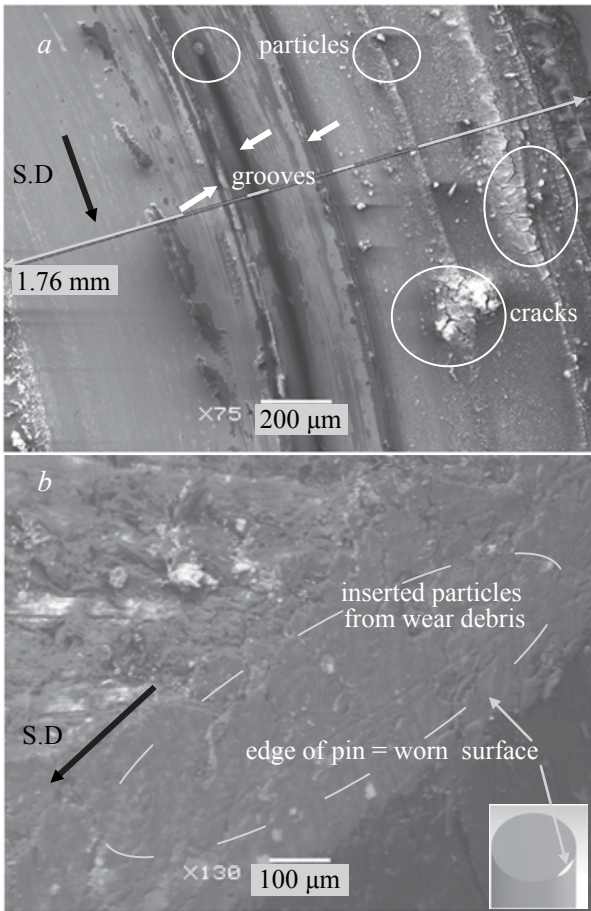
Fig. 4. Example of SEM micrographs of: wear track on disk carburized C1 (a) and the corresponding counterpart worn surface of pin wood after pin-on-disk test (b). The insert image was obtained by CATIAV5 software

Wear analysis. After a tribotest, SEM analysis of the uncoated samples surface revealed a large wear track (1.5–1.8 mm), and substantial amount of wear particles on its edges. These remarks are valuable for all samples treated C1 and C2. An example of wear track of disk seen on C1 samples is shown in Fig. 4a: inside the circular wear track, wear debris were formed. SEM micrographs show also finest and parallel grooves as result of ploughing by oxide particles (third body wear).

Moreover, the wear scar of the counter face, i.e. the edge of the pin wood became smooth as reported in Fig. 4b. Some particles (oxides) are incrustated inside the fiber of wood and a few ‘chips’ are formed at its circumference. Thus initially, at the asperity contact tips, formation of oxides film and, after reaching a critical thickness, breaking of this oxide film (cracks in Fig. 4a) occur as debris formation. Consequently the first step of wear mechanism for the cemented samples sliding against a wood pin is an oxidative wear and the second step is a mild abrasive wear mechanism.

Quantitative analysis. From the wear track profile obtained by 3D profilometry, the volume loss and wear rate of disc were calculated, for all the samples. The wear scar of the counterpart (pin wood), is an ellipse. Then major and minor semi-axes were measured by profilometry and to calculate the volume loss CATIAV5 software was used (see the inserted image in Fig. 4b). The results are presented in Fig. 7.

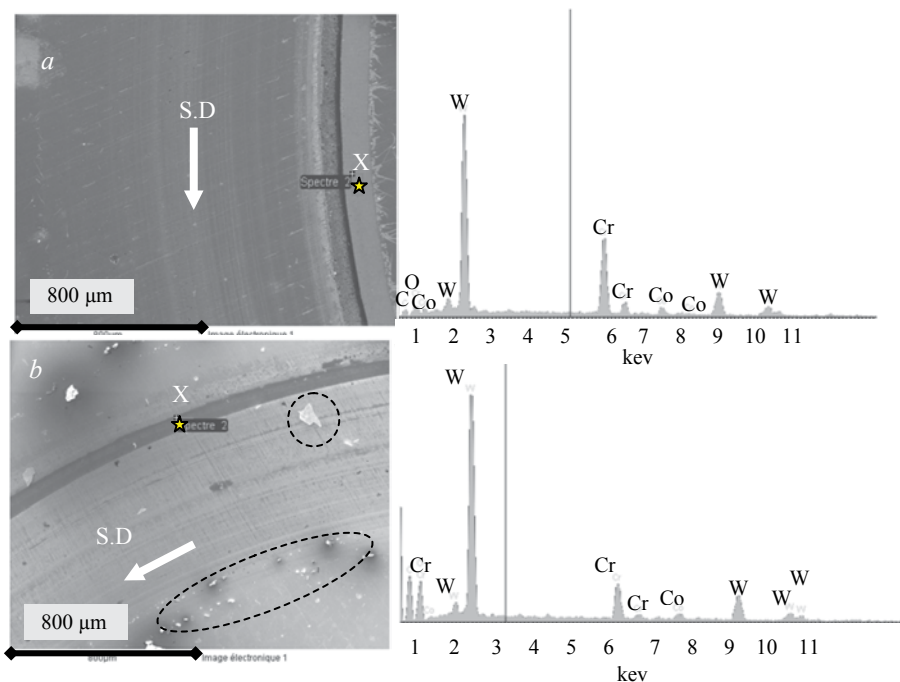
Fig. 5. Duplex treated samples: example of SEM micrographs of wear tracks and corresponding EDS spectra at point 'x': C1+F101 (a) and C1+F102 (b)

All of the duplex treated samples sliding against pin wood showed the largest wear scar but not very deep (Fig. 5a,b). The coatings are then efficient and well protected by the cemented steel. Few of particles inside circular wear track were observed for both coatings F101 and F102 (Fig. 5b). Based on SEM micrographs, no difference was evident between F101 and F102 coating wear tracks was shown and can explain the coefficient of friction evolution in Fig. 3. EDS analysis of the

worn surface and the debris inside wear scar (Fig 5 *a,b*) reveals only the presence of elements of coating (Cr, W, Co): no iron (Fe) signal or oxygen (O) were found, consequently the wear track is free of oxides. In comparison to the carburised samples and according to the above mentioned results, it can be concluded that the wear mechanism undergone by discs was only a slight abrasion wear.

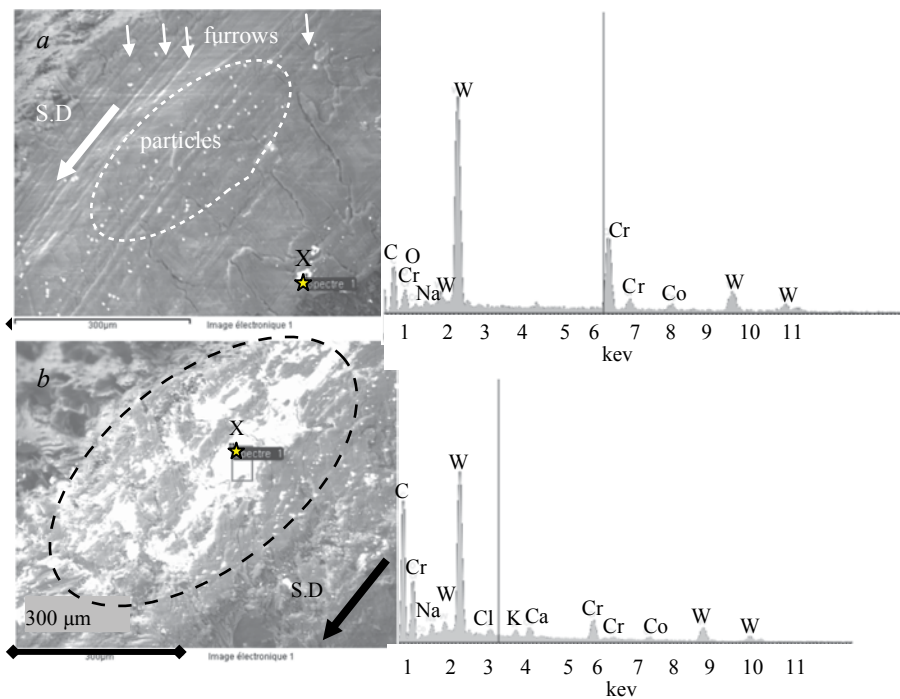
Fig. 6. Example of SEM micrographs of worn surfaces of wood pins against C1+F101 (a) and against (C1+F102) (b). EDS analysis spectra carried out the particles indicate by X

Figure 6 shows the wear scar on wood pin after 200 m sliding distance against duplex treated samples. Considerable difference exists between surface morphology of pin edge after sliding against F101 (Fig. 6a) and F102 (Fig. 6b) coatings. The wear scar of the pin in the case of the F101 coating shows few quantities of particles, dispersed on a smooth wood surface. These particles contain metallic and organic elements of wood as revealed by EDS analysis spectra. Again, no iron peak (Fe) or oxygen (O) were detected; that proves that coating is not entirely destroyed yet. Therefore, the detachment of the coating was presented in the form of wear debris. Some scratches (furrows) parallel to sliding direction are also present and are caused by particles (no oxides) between the contact surfaces. The small amount and size of the observed particles are not sufficient to cause an abrasive wear mechanism. Besides, the COF evolution curve of the F101 coating (Fig. 3), regardless the substrate, indicated that was a mild wear compared to the

F102 one. As a consequence, no evidence of abrasive wear was found. We suppose that movement of particles during sliding can be due to rotation or rolling as reported in literature⁸⁻¹⁰. The coatings are worn gradually, slowly and with continuous wear with micro-chipping of small coating fragments in connection to surface defects. The SEM micrographs of the pin worn surface sliding against F102 is shown in Fig. 6b. This part of the wear scar shows a significant amount of adhered counter material which indicates a stronger adhesion between contact surfaces. This is in agreement with the corresponding friction curve in Fig. 4, which shows significantly higher and more fluctuating values as compared with the friction curve displayed by F101 coating. The wear mechanism in this case is adhesive.

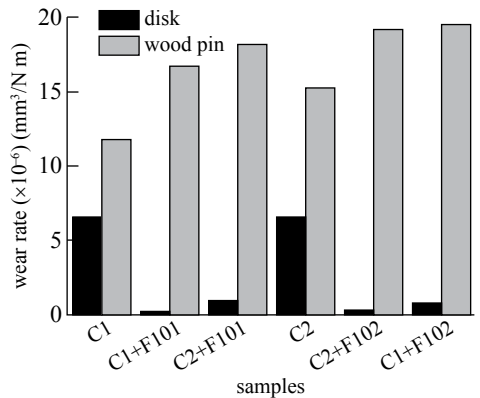
Fig. 7. Estimated wear rates of the tribological couple wood pin/disc

The highest wear rate was obtained for wood pin and the lowest for the duplex treated samples. An intermediate wear rate is observed for the cemented samples. This is probably due to the softer hardness of the wood pin in comparison to the cemented and duplex treated steel samples. Besides, the cemented samples showed a similar wear rate value as the duplex C1/F101 and C2/F101 or C1/F102 and C2/F102 treated samples. Nevertheless, the duplex treated samples (wear rates K of about 1 to $2 \times 10^{-6} \text{ mm}^3/\text{N m}$) were much more wear resistant than the only cemented ones (wear rates K of about $7 \times 10^{-6} \text{ mm}^3/\text{N m}$).

It can also be seen that the F101 coating has a lower wear rate than the F102 one probably due to its low COF (0.2). This confirms SEM analysis and the COF evolution curves.
