Nano- and micro-scale morphological defects in oxidized a-SiC:H thin films

Keywords amorphous SiC films, oxidation, morphological defects

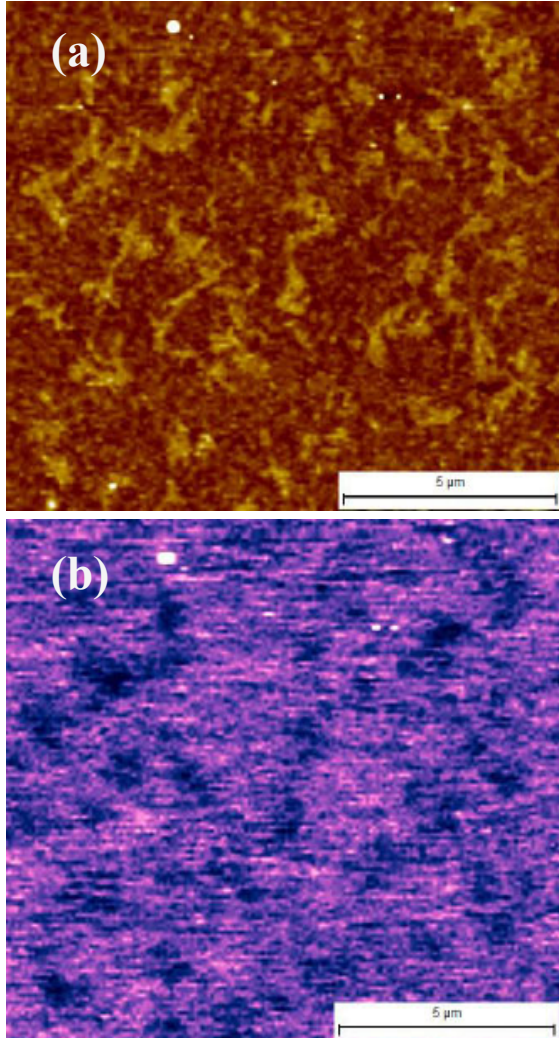
Figure 2 (a) AFM topology (contrast of height in range of 10 nm) and (b) KPFM map (contrast of surface potential in range of 30 mV) of the surface of low density a-SiC:H films after oxidation at 550 °C.

3.1 Nano-scale defects Atomic force microscopy measurements show that surface of as-deposited films is smooth and uniform. But after oxidation of the low density sample (the sample deposited at lowest discharge power, see spectrum 1 in Fig. 1) at 550 °C we observe formation of island-like inhomogeneities (Fig. 2(a)). Such morphological defects were not observed after oxidation at 650 °C. IR spectra of these samples (not presented here) do not differ significantly. The size of island-like morphological

defects ranges from several hundred nm to several μm , and islet defects protrude above the surface of the main body of the films by about 10 nm.

Kelvin probe force measurements exhibit that the surface potential of the defects is significantly lower than that of the surrounding matrix (Fig. 2(b) indicating that electrical properties of the material is also inhomogeneous..

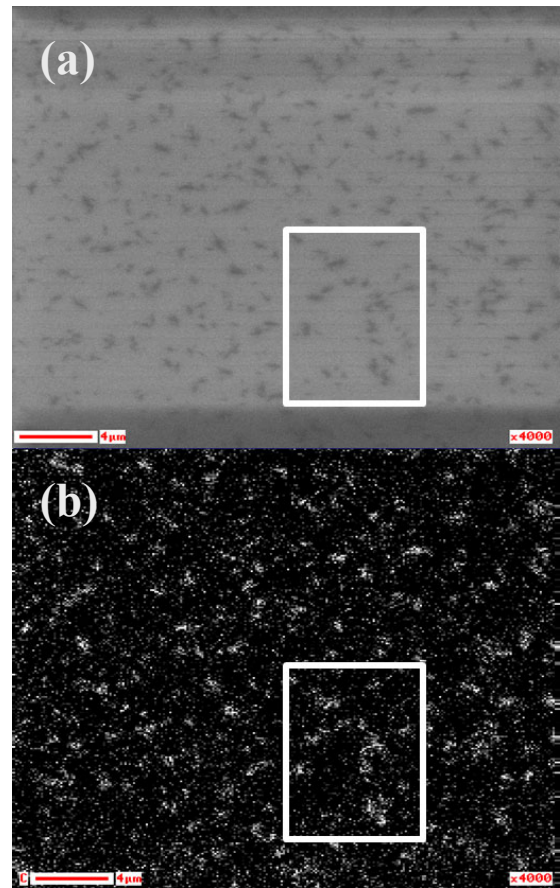
Figure 3 SEM (regime of secondary electron detection) image (a) and carbon distribution map generated by Auger-electron scanning probe (b) of the low density sample after oxidation at 550 °C. Contrast of carbon distribution map corresponds to the range from background signal of the C(KVV) line (black) to maximum of the amplitude of C(KVV) line (white).

Figure 3 shows the SEM image generated by secondary electrons of the surface of the sample after annealing in oxygen at 550 °C (Fig. 3(a)) and the corresponding distribution of carbon on the surface of the

sample (Fig. 3(b)). It is seen that carbon distribution replicates the morphological map, thus indicating that the island-like defects are enriched by carbon in comparison with the surrounding surface. Local nano-probe measurements show that the flat surface contains much more oxygen than island-like defects. Thus island-like defects can be attributed to non-oxidized regions.
