Kheireddine BOUZID, BELIARDOUH NASSER EDDINE, Corinne NOUVEAU - Wear and Corrosion Resistance of CrN-based Coatings Deposited by R.F Magnetron Sputtering - Tribology in Industry - Vol. 37, n°1, p.60-65 - 2015

Wear and Corrosion Resistance of CrN-based Coatings Deposited by R.F Magnetron Sputtering

A comparative study was conducted to evaluate the performances against wear and corrosion of CrN, CrMoN, CrZrN, CrVN single layer thin films. The latest are synthesized onto steel substrates (DIN 90CrMoV8), using R.F reactive magnetron co-sputtering. The experimental work was achieved using ball-on-disc configuration in dry conditions against WC balls. The main conclusions are: (i) electrochemical tests in 0.3 wt.% NaCl solution indicated that CrZrN are improved anticorrosion performance when compared to CrN, while CrMoN demonstrated a poor corrosion resistance;(ii) the CrN coating presents the better tribological properties when compared to the ternary nitride coatings.

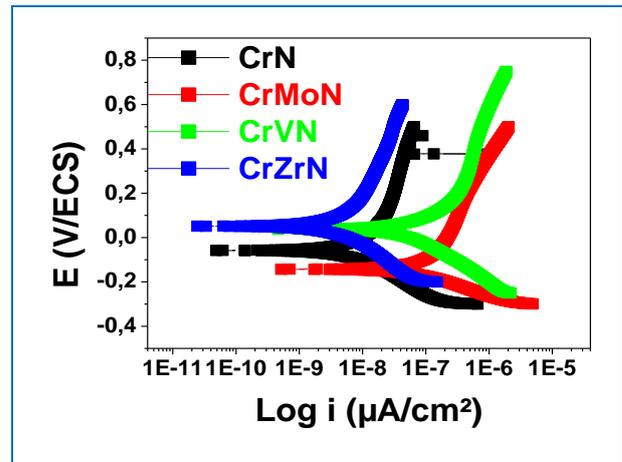
The Tafel polarization curves, shown in Fig. 1 allow finding the values of anodic and cathodic

Fig. 1. Potentiodynamic polarization curves of different samples tested.

These curves indicate that the best behavior related to the corrosion rate should be presented by the CrZrN samples because they present the lowest values of corrosion current densities (I_{corr}) as mentioned in Table 2.

The decrease in I_{corr} of films is a great evidence of the improvement in the corrosion resistance.

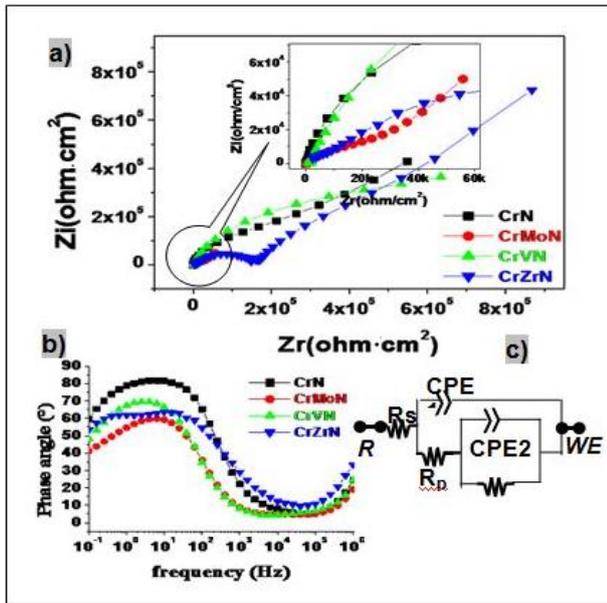
In order to investigate the corrosion performance of PVD hard coating, it was well-known that EIS has found its efficacy [6]. The different shapes of the curves in Nyquist diagrams are obtained as shown in Figure 2(a). The CrZrN coating presents the best corrosion resistance followed by the (CrVN). The CrMoN presents the lowest corrosion resistance. This result confirms the data obtained by potentiodynamic tests (Table 2). In addition, all of the Nyquist plots show two time constants, with a capacitive loop of smaller diameter followed by another capacitive loop of larger diameter. Bode plots of the phase angle as a function of the frequency shown in Fig. 2(b), confirm that the Nyquist's data.

Fig. 2 AC impedance measurements of the coated samples (a) Nyquist impedance diagrams (insert image shows the Nyquist plots at high frequencies), (b) Bode plots and (c) the equivalent circuit model.

From the above mentioned result, it is confirmed that there are effectively two time constants in the experimental frequency bandwidth. Consequently the EIS data indicates the existence of two different interfacial reactions which can be related to the coating/solution interface and substrate/solution interface respectively.

The equivalent circuit (Fig. 2 (c)) consists of the following elements: R_s corresponds to the solution resistance of the electrolyte test between the working electrode (WE), and reference electrode (RE). CPE1 and R_{po} elements are used in parallel to replace the coating dielectrics properties. CPE2 and R_{ct} in parallel are adapted to describe charge transfer at the coating/substrate interface. Results of fitting values obtained by equivalent circuit simulation of different coating configurations indicate that the CrZrN coating has lower CPE1 value and higher charge transfer resistance. On the other hand, the total polarization resistance

The R_p of CrZrN was around 48.10^3 K Ω thus multiplying by factor 04 (four) the R_p value of CrN ($12,15.10^3$ K Ω) indicating their high corrosion resistance. The R_p values for CrVN and CrMoN are 3.10^3 K Ω and $48,23$ K Ω , respectively. These results showed a good agreement with the Tafel potentiodynamic polarization measurements.

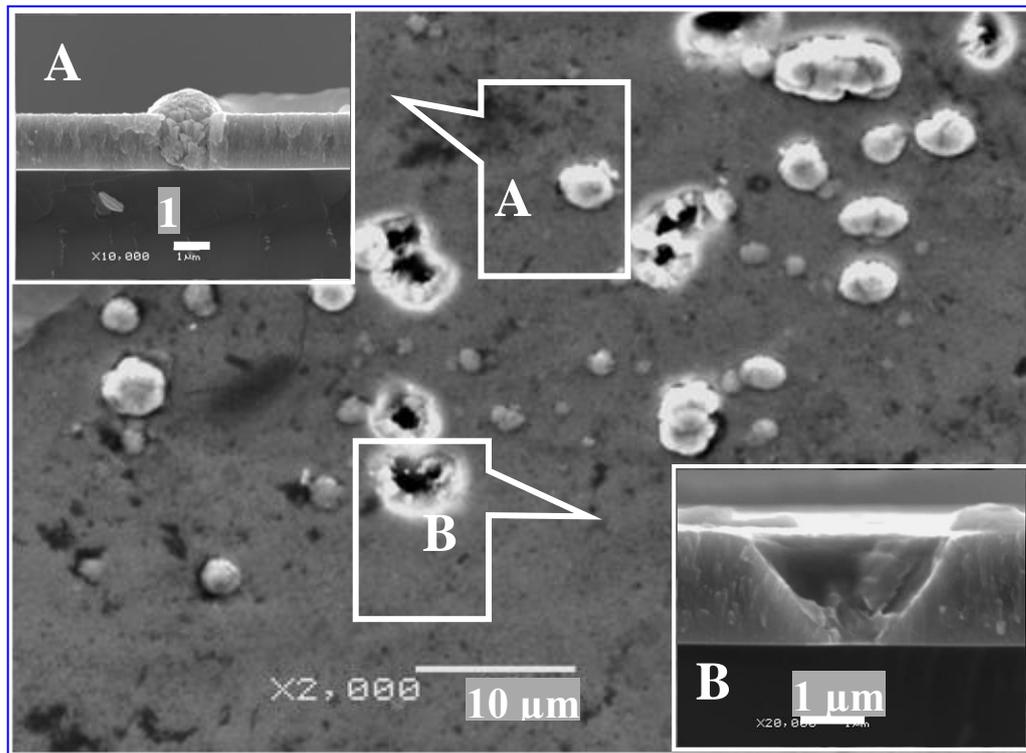
Figure 3 presents an example of the surface morphology of the CrZrN coating after 24 h of immersion and potentiodynamic test measurements in a 0,3 wt. % NaCl solution. SEM images can prove that selective corrosion occurs at growth defect sites. According to Lewis et al [10], a droplet is compositionally metal rich and nitrogen deficient; this defect is anodic with respect to both surrounding coating. It is obvious from Fig. 3, that the corrosive attack occurs with the ejection of droplets (insert image A in Fig. 3) from the coatings which creates a crater (insert image B) at its surface, resulting in direct contact with the substrate.

Fig. 3. SEM micrographs of CrZrN surface. Corrosion damage after potentiodynamic polarisation test; Insert images: cross section view (A) showing droplet and crater in (B).

When compared to similar CrN based coatings, as reported in other works [7-9], our study indicates that all of coatings present better behavior against aggressive chloride ions (Cl⁻). It can be concluded that the different electrochemical behavior may be associated with their different surface defect densities. Our results confirm the remarkable resistance against corrosion in NaCl solution, of CrZrN obtained by Zhang *et al.* [11]. The authors conclude that the additions of Zr into CrN coatings improved their chemical inertness and the corrosion mechanism was due to the slight pitting corrossions, which were mainly localized in the growth defects.

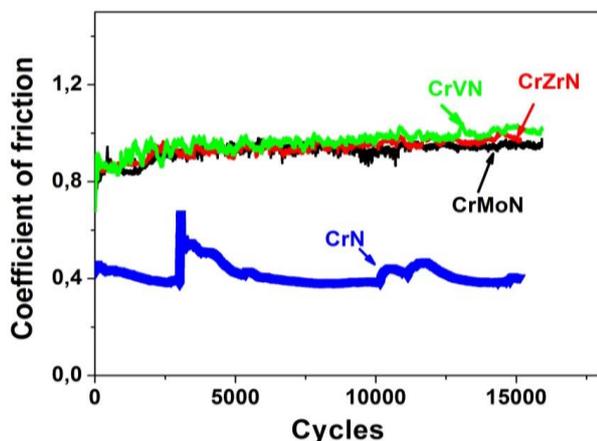
The objective of the second part of this work was to analyze the surface states of the coated samples in terms of the friction coefficient (μ) evolution during dry sliding against WC balls. Fig. 4 shows the variation in the friction coefficient as a function of the number of sliding cycles. It can be seen, at the start of test, the CrN curve shows a running-in period, characterized by an initial transient state followed by a sudden friction coefficient increase and a final gradual-steady state about 0,4.

Fig. 4. Coefficient Of Friction evolution vs cycles of coated samples.

The friction behavior of CrN against WC balls was in agreement with results obtained by other researchers [12-13] although the experimental conditions are not exactly the same.

However, the friction coefficients behavior for ternary CrN-based coatings (CrZrN, CrMoN, and CrVN) in combination with WC balls present similar features: in both cases, the friction coefficient increased rapidly at the start of the test to a maximum value of about 0,85-0,9. Thus, the wear of ternary CrN based coatings was visibly higher than the wear of CrN.

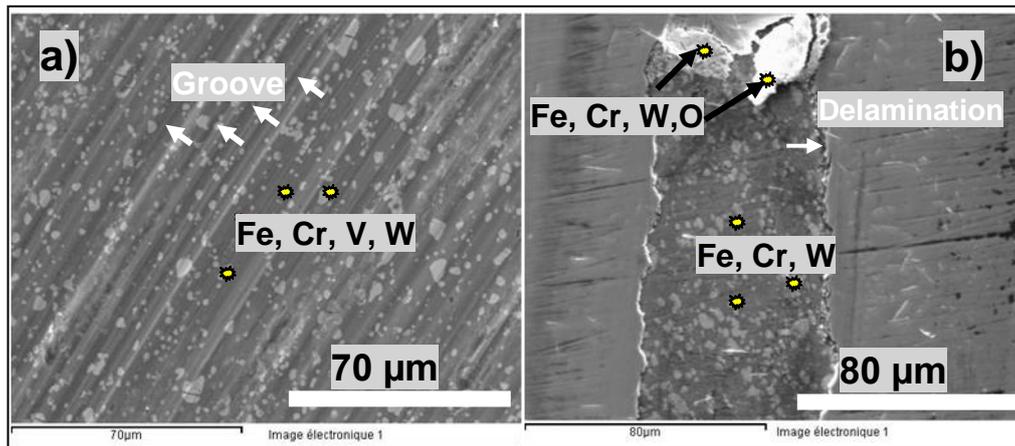
Figure 5 shows the wear scar of CrN and CrVN coatings as an example of SEM observations. The main difference is the fact that plowed grooves along the sliding direction are found on the wear tracks of CrVN, as well as CrMoN and CrZrN as presented in Fig. 5(a).

The wear scar of the tested ternary coatings shows abrasive marks, pits and excess wear debris. Consequently, the three-body abrasive wear was the dominant wear mechanism as reported by M.S. Priyan *et al.* [14].

Fig. 5. SEM micrographs of wear track observed on (a) CrVN and (b) CrN when sliding against WC balls.

No grooves and no scratches are shown inside the CrN wear scar. EDX analysis of wear tracks of ternary nitride coatings reveals the presence of coating's elements (Cr, V, Mo, Zr, N), elements of substrate (Fe) and elements of the counterpart (W). The presence of tungsten is a sign of an adhesive wear. On another hand, absence of oxygen (O) indicates that the wear track is free of oxide. Consequently, the wear mechanism of the ternary coatings seems to be a combination of abrasive and adhesive wear.

In the contrary, SEM investigations of the worn surface of CrN, Figure 5(b), reveal the presence of oxygen (O), in the middle of the wear scar. Consequently the CrN coating suffers a combination of adhesive and delamination wear. It can be noticed that the presence of debris (wear product) inside de wear track can act as a solid lubricant by rolling, and thus reducing the friction. We consider that is the reason why CrN presents lower COF evolution than other ones.
