Kheireddine BOUZID, Nasser Eddine BELIARDOUH, Corinne NOUVEAU - Wear and Corrosion Resistance of CrN-based Coatings Deposited by R.F Magnetron Sputtering - Tribology in Industry - Vol. 37, n°1, p.60-65 - 2015

Wear and Corrosion Resistance of CrN-based Coatings Deposited by R.F Magnetron Sputtering

A comparative study was conducted to evaluate the performances against wear and corrosion of CrN, CrMoN, CrZrN, CrVN single layer thin films. The latest are synthesized onto steel substrates (DIN 90CrMoV8), using R.F reactive magnetron co-sputtering. The experimental work was achieved using ball-on-disc configuration in dry conditions against WC balls. The main conclusions are: (i) electrochemical tests in 0.3 wt.% NaCl solution indicated that CrZrN are improved anticorrosion performance when compared to CrN, while CrMoN demonstrated a poor corrosion resistance;(ii) the CrN coating presents the better tribological properties when compared to the ternary nitride coatings.

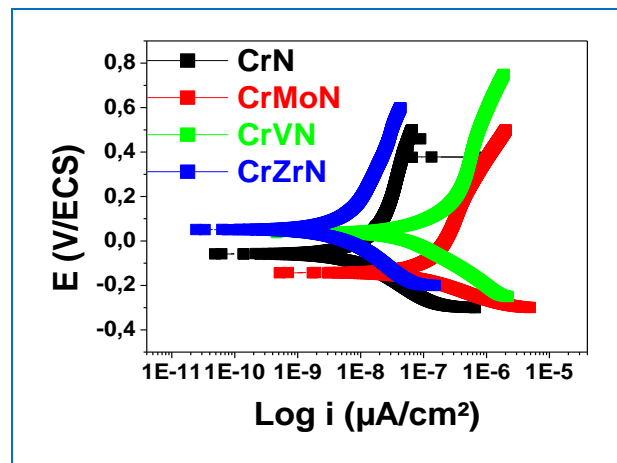
The Tafel polarization curves, shown in Fig. 1 allow finding the values of anodic and cathodic

Fig. 1. Potentiodynamic polarization curves of different samples tested.

These curves indicate that the best behavior related to the corrosion rate should be presented by the CrZrN samples because they present the lowest values of corrosion current densities (I_{corr}) as mentioned in Table 2.

Coating	I_{corr} (nA)	E_{corr} (mV)	$V_{corr} \cdot 10^{-3}$ (mm/y)
CrN	19,2	-58,5	14,22
CrZrN	10	51,4	13,97
CrMoN	136	-143	169
CrVN	67,1	37	93,82

The decrease in I_{corr} of films is a great evidence of the improvement in the corrosion resistance.

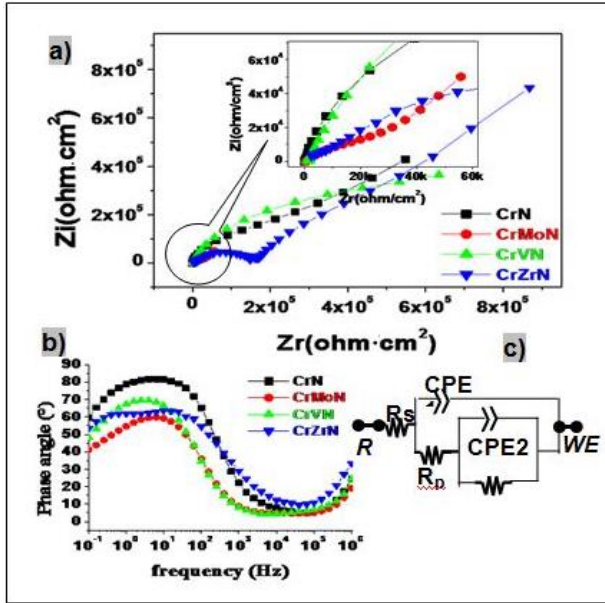
In order to investigate the corrosion performance of PVD hard coating, it was well-known that EIS has found its efficacy [6]. The different shapes of the curves in Nyquist diagrams are obtained as shown in Figure 2(a). The CrZrN coating presents the best corrosion resistance followed by the (CrVN). The CrMoN presents the lowest corrosion resistance. This result confirms the data obtained by potentiodynamic tests (Table 2). In addition, all of the Nyquist plots show two time constants, with a capacitive loop of smaller diameter followed by another capacitive loop of larger diameter. Bode plots of the phase angle as a function of the frequency shown in Fig. 2(b), confirm that the Nyquist's data.

Fig. 2 AC impedance measurements of the coated samples (a) Nyquist impedance diagrams (insert image shows the Nyquist plots at high frequencies), (b) Bode plots and (c) the equivalent circuit model.

From the above mentioned result, it is confirmed that there are effectively two time constants in the experimental frequency bandwidth. Consequently the EIS data indicates the existence of two different interfacial reactions which can be related to the coating/solution interface and substrate/solution interface respectively.

The experimental results are interpreted via developing typical impedance models for electrode surfaces and curve-fitting on the basis of an equivalent circuit using Zview impedance program. A circuit model was proposed to ascribe two sub-electrochemical interfaces generally used in such case [7].

The equivalent circuit (Fig. 2 (c)) consists of the following elements: R_s corresponds to the solution resistance of the electrolyte test between the working electrode (WE), and reference electrode (RE). CPE1 and R_{po} elements are used in parallel to replace the coating dielectrics properties. CPE2 and R_{ct} in parallel are adapted to describe charge transfer at the coating/substrate interface. Results of fitting values obtained by equivalent circuit simulation of different coating configurations indicate that the CrZrN coating has lower CPE1 value and higher charge transfer resistance. On the other hand, the total polarization resistance

The R_p of CrZrN was around 48.10^3 K Ω thus multiplying by factor 04 (four) the R_p value of CrN ($12,15.10^3$ K Ω) indicating their high corrosion resistance. The R_p values for CrVN and CrMoN are 3.10^3 K Ω and $48,23$ K Ω , respectively. These results showed a good agreement with the Tafel potentiodynamic polarization measurements.

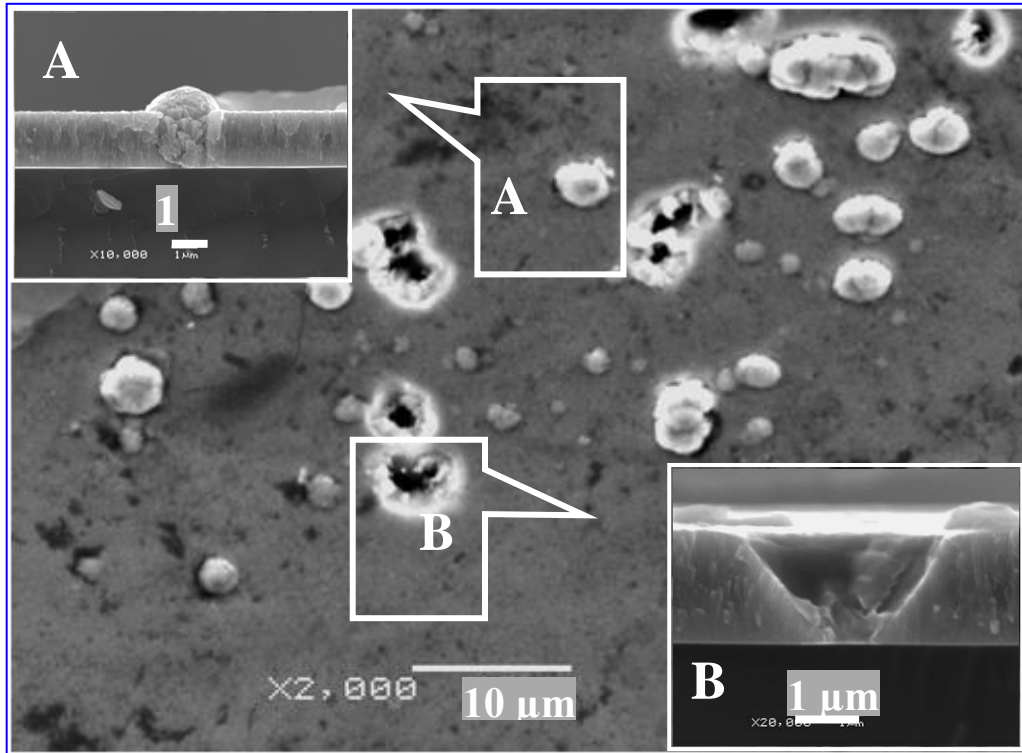
Figure 3 presents an example of the surface morphology of the CrZrN coating after 24 h of immersion and potentiodynamic test measurements in a 0,3 wt. % NaCl solution. SEM images can prove that selective corrosion occurs at growth defect sites. According to Lewis et al [10], a droplet is compositionally metal rich and nitrogen deficient; this defect is anodic with respect to both surrounding coating. It is obvious from Fig. 3, that the corrosive attack occurs with the ejection of droplets (insert image A in Fig. 3) from the coatings which creates a crater (insert image B) at its surface, resulting in direct contact with the substrate.

Fig. 3. SEM micrographs of CrZrN surface. Corrosion damage after potentiodynamic polarisation test; Insert images: cross section view (A) showing droplet and crater in (B).

When compared to similar CrN based coatings, as reported in other works [7-9], our study indicates that all of coatings present better behavior against aggressive chloride ions (Cl⁻). It can be concluded that the different electrochemical behavior may be associated with their different surface defect densities. Our results confirm the remarkable resistance against corrosion in NaCl solution, of CrZrN obtained by Zhang *et al.* [11]. The authors conclude that the additions of Zr into CrN coatings improved their chemical inertness and the corrosion mechanism was due to the slight pitting corrossions, which were mainly localized in the growth defects.
