Kheireddine BOUZID, Nasser Eddine BELIARDOUH, Corinne NOUVEAU - Wear and Corrosion Resistance of CrN-based Coatings Deposited by R.F Magnetron Sputtering - Tribology in Industry - Vol. 37, n°1, p.60-65 - 2015

Wear and Corrosion Resistance of CrN-based Coatings Deposited by R.F Magnetron Sputtering

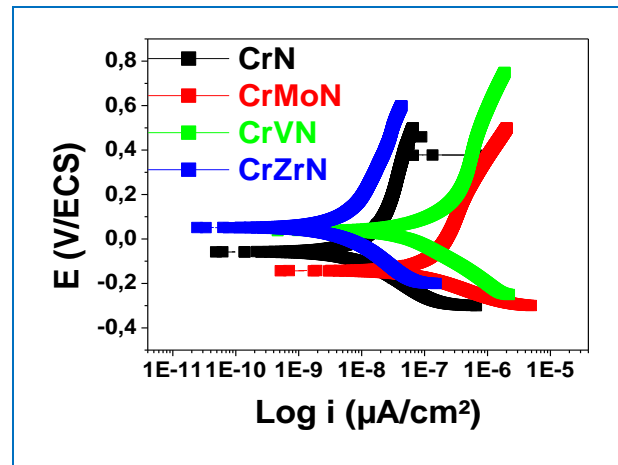
Fig. 1. Potentiodynamic polarization curves of different samples tested.

The Tafel polarization curves, shown in Fig. 1 allow finding the values of anodic and cathodic

These curves indicate that the best behavior related to the corrosion rate should be presented by the CrZrN samples because they present the lowest values of corrosion current densities (I_{corr}) as mentioned in Table 2.
