Arthur MONTI, Abderrahim EL MAHI, Zouhaier JENDLI, Laurent GUILLAUMAT - Mechanical behaviour and damage mechanisms analysis of a flax-fibre reinforced composite by acoustic emission - Composites Part A: Applied Science and Manufacturing - Vol. 90, p.100-110 - 2016

# Mechanical behaviour and damage mechanisms analysis of a flax-fibre reinforced composite by acoustic emission

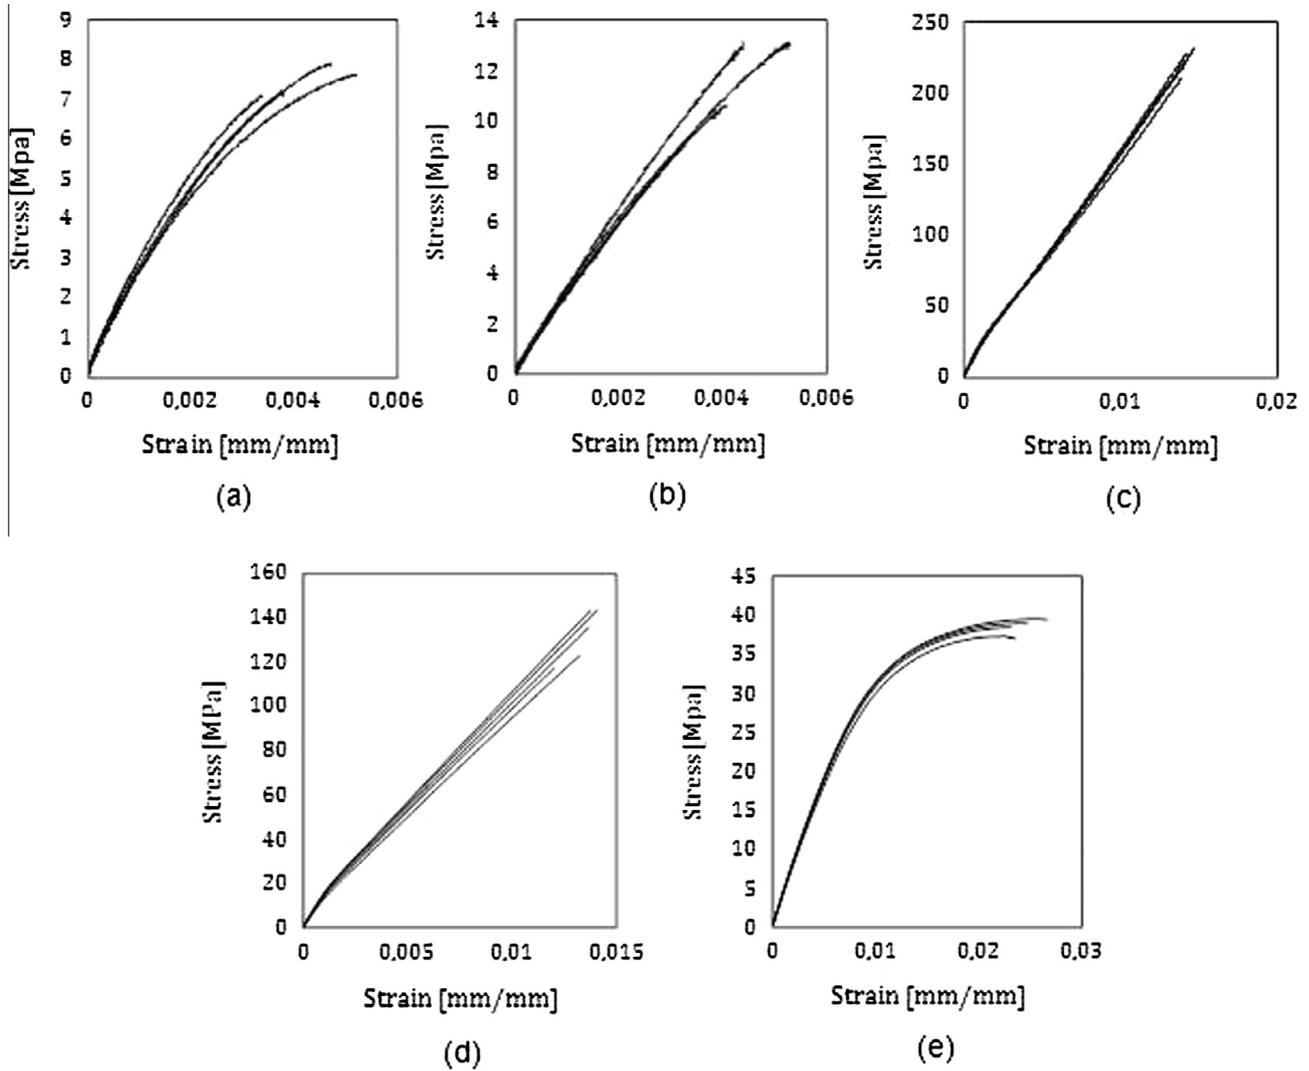
Fig. 2. Monotonic tensile test stress-strain curves for specimens: (a) UD-90, (b) UD-45, (c) UD-0, (d) CR-(0/90) and (e) CR-(+45/-45).

Fig. 2(b) presents typical stress/strain curves obtained by static monotonic tensile tests performed for every kind of specimen. Samples UD-0 and CR-(0/90) (containing fibre aligned with the tensile direction) exhibit a short linear elastic domain followed by a non linear part. This kind of behaviour is not observed for traditional composites. However, it has already been reported for long Natural Fibre Reinforced Polymers in [24,25]. The initial yield point, occurring for a very low deformation level and resulting in an important loss of stiffness is visible on the stress/strain curves. Results of cyclic loading tests performed on UD-0 specimens are reported in Fig. 3a. They revealed the existence of this “knee” visible on the stress/strain curve occurring at a strain level of 0.11%. After this yield point corresponding to a stress level of approximately 25 MPa, the static stress/strain curve appears to be quasi linear. The apparent stiffness even increases slightly. This phenomenon was confirmed by the analysis of the evolution of the tangent modulus presented in Fig. 3b. The tangent modulus was defined at each point of deformation  $\varepsilon_i$  as the slope of the linear fitting of the stress-strain curve in the interval  $[\varepsilon_i - 2.5 \times 10^{-4};$

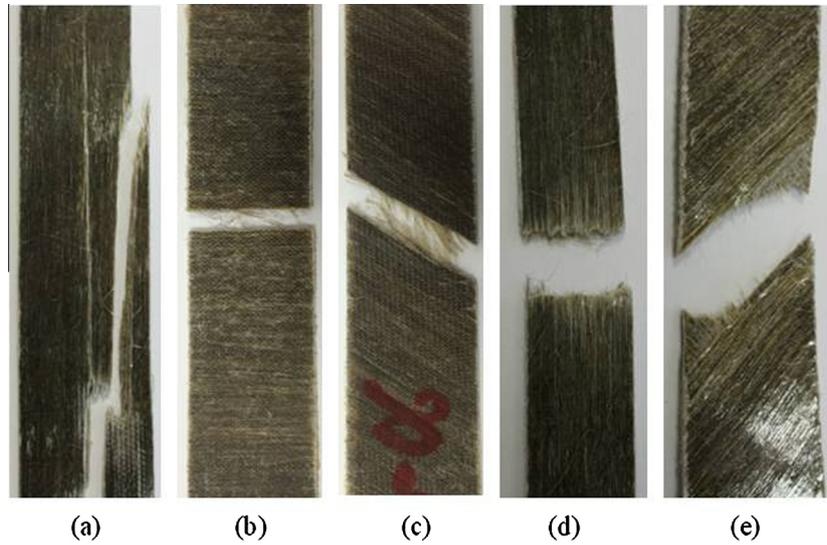
**Fig. 4.** Breakage profiles of the five categories of specimens: (a) UD-0, (b) UD-90, (c) UD-45, (d) CR-(0/90) and (e) CR(+45/-45). (For interpretation of the references to color in this figure legend, the reader is referred to the web version of this article.)

Fig. 4 presents the five kinds of specimen after breakage. At a macroscopic scale, the observations of these failure profiles provided brought a lot of information. Specimen UD-90 failed linearly along the transverse direction whereas specimen UD-45 presented a failure front at 45° with respect to the loading direction. For specimen UD-0 specimen, initial cracks a few millimetres long could be noticed, followed by a propagation of long cracks along the tensile axis. For all these unidirectional specimens, several pulled-out fibres were noticeable even for UD-90. Specimens CR-(0/90) failed perpendicularly with respect to the loading direction. Successive plies with 0° and 90° directions appeared to be delaminated along a few millimetres only (Fig. 4). On the other hand, specimens CR-(+45/-45) failed along two axes orientated at +45° and -45° with respect to the loading axis. Failed specimens exhibited delaminated plies over several millimetres, visible on Fig. 4e.

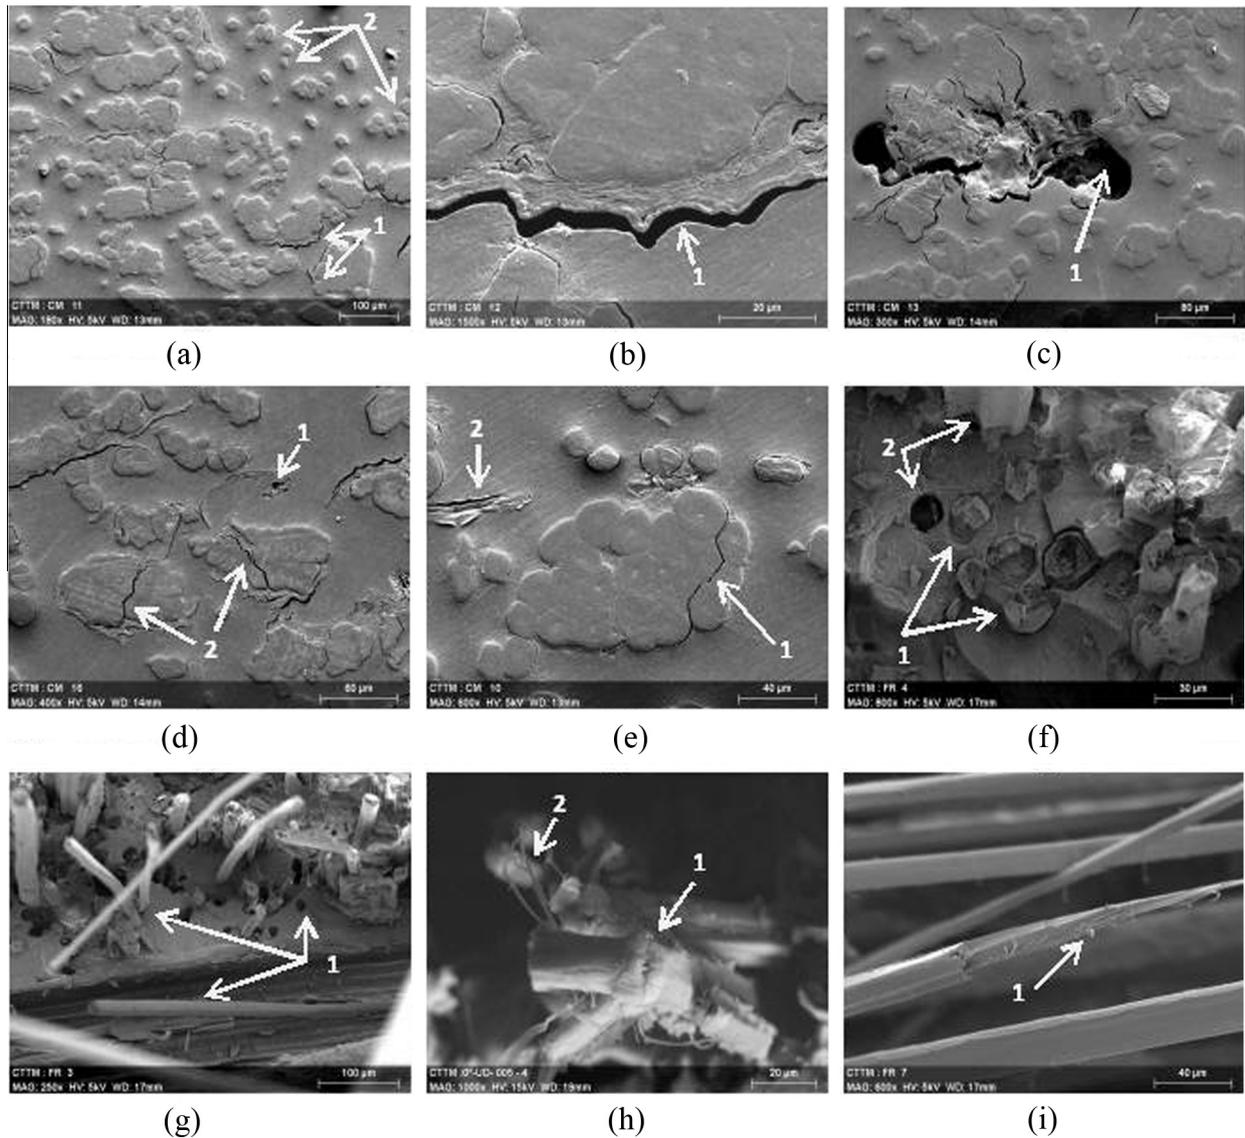
**Fig. 5.** SEM observations of failure profiles and micrographs. (a)-(c) Micrograph of a reference specimen, (d) and (e) micrograph of a specimen loaded to 50% of the failure load and (f)-(i) SEM views of different breakage profiles.

These observations were completed by several microscopic analyses (Fig. 5). First, a micrographic section of a reference untested UD specimen was observed (Fig. 5a-c). Label 1 shows that some bundles are not bonded to the matrix. This is confirmed by a close up presented in (Fig. 5b, label 1), which reveals the existence of layers of organic material that surround the technical fibres. Several cracks can be observed around them. It is hard to know if this interfacial debonding is due to the preparation of the micrographs (specimen cutting and/or polishing) or if it existed before. On the other hand, well separated elementary fibres seem to be correctly bonded to the matrix (Fig. 5a, label 2). On this reference specimen, porosities appeared to be rare. Some 100  $\mu\text{m}$  long porosities were observed close to the material side which was directly in contact with the mould (Fig. 5c.). However, the material core contained a surprisingly limited number of porosities (10–20  $\mu\text{m}$ ) (Fig. 5d, label 1). On the UD specimen loaded to 50% of the breaking load, the number of fibre-matrix interface debonding appeared to be slightly higher (Fig. 5d). In addition, lots of unbounded interfaces were observed between adjacent elementary fibres inside bundles (Fig. 5d label 2 and Fig. 5e label 1), where the matrix could not impregnate the fibres due to their very high density. This may explain the low strength properties of the UD-90 and UD-45 specimens. Some matrix cracks could also be observed but were quite hard to detect (Fig. 5e label 2). Most of the time, they appear to be propagations of initial cracks at the interface of bundles and matrix.

SEM analyses of failure profiles revealed other damage mechanisms. Some well separated fibres broken very close to the matrix were observed on UD-0, CR-(0/90) and CR-(+45/-45) specimens (Fig. 5f label 1), indicating that the fibre-matrix interface is good for elementary fibres. Several pulled-out fibres were observed on every kind of specimen, especially on CR-(0/90) and on CR-(+45/-45) (Fig. 5f label 2 and Fig. 5g label 1). In this last case, the length of delamination was very great. Moreover, some of the pulled out fibres were damaged. Transverse cracks could be noticed (Fig. 5h label 1), especially on kink band areas. Peeled fibres were also observed (Fig. 5h label 2), as well as torn fibres (Fig. 5i). This indicates that complex failure mechanisms can be observed at the fibre scale.

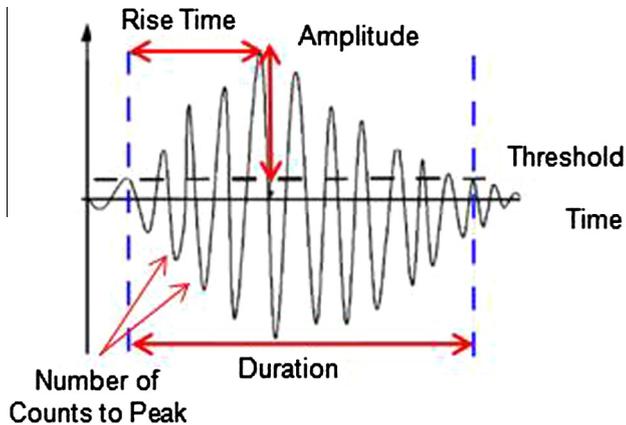
Fig. 6. Acoustic emission burst features. (For interpretation of the references to color in this figure legend, the reader is referred to the web version of this article.)

The acoustic emission data was processed with NOESIS and MATLAB software. Five temporal parameters of the acoustic signals were selected for the classification of the data sets: amplitude, rise time, duration, absolute energy and number of counts to peak. After multiple initial trials, these parameters have proved to allow a good repeatability of the data clustering. They are illustrated in Fig. 6.

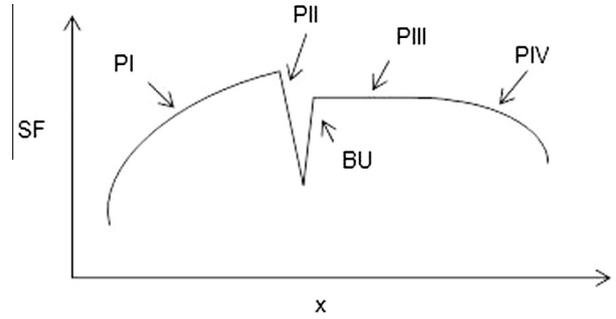
Fig. 7. Possible behaviour of the Sentry Function.

domains (Fig. 7). An increasing area, noted  $PI(x)$ , a sudden drop function  $PII(x)$ , a constant function  $PIII(x)$ , a decreasing part  $PIV(x)$  and a bottom-up one  $BU(x)$ . Phase PI corresponds to the mechanical energy storing phase, which increases continuously while the material remains undamaged. Then the cumulative acoustic energy increases with the number of failure mechanisms, provoking a decrease of the PI slope. For major damage events, a high quantity of mechanical energy suddenly converted into acoustic energy is visible as a PII part. The slope of the Sentry Function becomes zero or less when the material has totally lost its ability to store mechanical energy. This moment is visible by a PIII or PIV function. A BU curve indicates that an event (such as strengthening) suddenly induced a new mechanical energy storage capacity of the material.

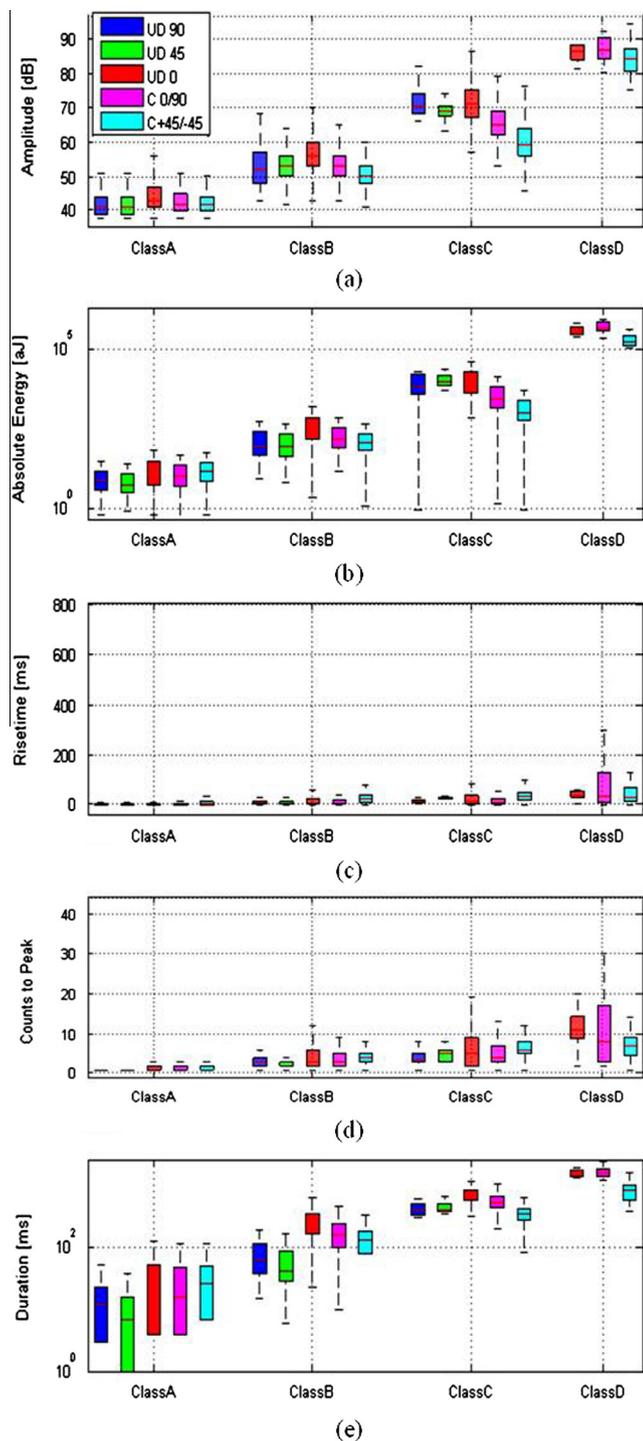
**Fig. 9.** Statistical dispersion of the AE classes for every classification feature. (a) Amplitude, (b) absolute energy, (c) rise time, (d) counts to peak and (e) duration. (For interpretation of the references to color in this figure legend, the reader is referred to the web version of this article.)

The AE classes shown previously were obtained by an unsupervised pattern recognition algorithm, which means that they constitute the best separation of the data regarding mathematical considerations, without really taking physics into account. As a consequence, to see if the class named “A” in a specific configuration was the same as the one also called “A” in the four other cases, the average properties of the classes of every specimen in every configuration were compared, as well as their statistical spread. Fig. 9 shows box and whiskers plots of the four AE classes for the five types of specimens tested and according to the five classification features chosen. The borders of the box correspond to the first quartile  $q_1$  and the third quartile  $q_3$ . The second quartile (or median) is the line cutting through the box. The whiskers indicate the lower and upper values located in the interval  $[q_1 - 1.5(q_3 - q_1), q_3 + 1.5(q_3 - q_1)]$ . Values outside this interval, considered as outliers, were not printed. It is clear that classes A and B present quite similar statistical characteristics for every specimen configuration and for every classification parameter. Class D presents more spread regarding number of counts to peak and rise time. These two features are very sensitive to undesired concatenated signals which may not have been totally filtered by the timing acquisition parameters previously defined. As a consequence, extreme values are probably responsible for this abnormal dispersion. AE class C presents more differences between the different specimens and features. However, this spread may have been emphasized by the huge difference in the number of vector hits between the different specimens. Regarding the different loading configurations, this may also indicate that class C cannot be attributed to a unique damage mechanism. Fig. 10 presents a comparison of the average values of the selected features in the five specimen configurations. The star diagrams clearly show that acoustic signatures can be attributed to each class. The average properties for each specimen are indeed very similar, despite the differences noticed previously regarding their statistical dispersion.
