Maxime SAGNARD, Romain ECAULT, Laurent BERTHE, Kay BRUNE - Development of the symmetrical laser shock test for weak bond inspection - Optics and Laser Technology - Vol. 111, p.644-652 - 2019

Development of the symmetrical laser shock test for weak bond inspection

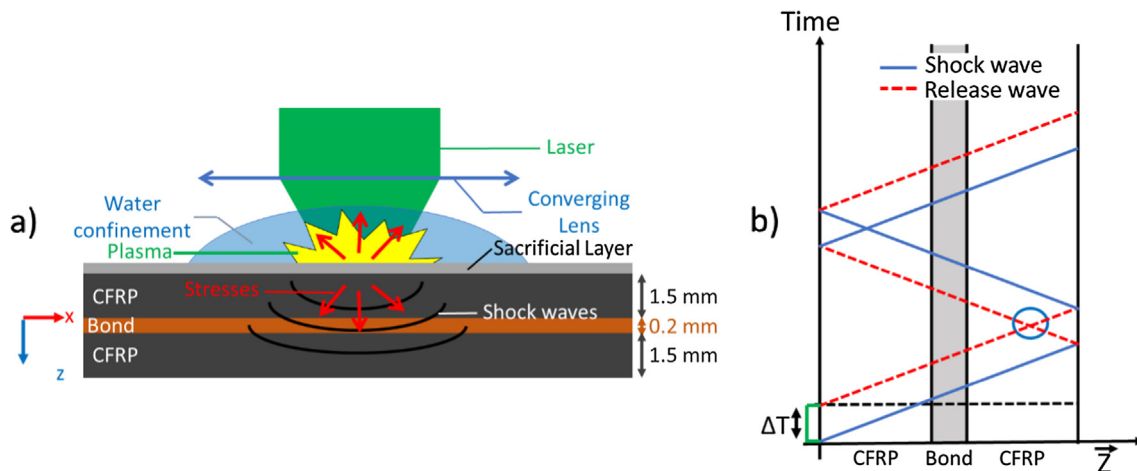
Fig. 1. (a) Representation of a typical LASAT experimental setup and (b) Space-time diagram of a single shot LASAT.

The LASAT uses a laser pulse to generate shock waves within a test sample. Upon reaching the surface of the specimen, the laser creates a dense plasma through the vaporisation of a few micrometres of material. By expanding, the high-pressure plasma transmits part of its energy to the sample in the form of shock waves. Fig. 1(a) depicts this laser shock phenomenon on a bonded Carbon Fibre Reinforced Polymer (CFRP) sample. The sacrificial layer (in grey) is an aluminium adhesive tape (35 μm) which serves two main purposes. It primarily protects the sample from being partially vaporised, instead, it is the aluminium which is sublimated to generate the plasma. Secondly, the pressure generated by this technique highly depends on the laser/matter interaction. By always using the same sacrificial layer, one ensures the interaction – and thus the loading – is the same regardless of the sample material.

The space/time diagram Fig. 1(b) describes the shock wave's

behaviour within the material. The front of the shock wave is represented using solid lines. The release wave, that sets the material back to its initial state, is represented using dotted lines. The shock wave travels all the way to the back-face of the sample and turns into a release wave. Upon crossing the initial release wave, the reflected shock wave generates a high tensile stress (full circle). For a given material, the position of this high tensile stress simply depends on the shock duration which is defined by the laser's pulse duration ΔT .

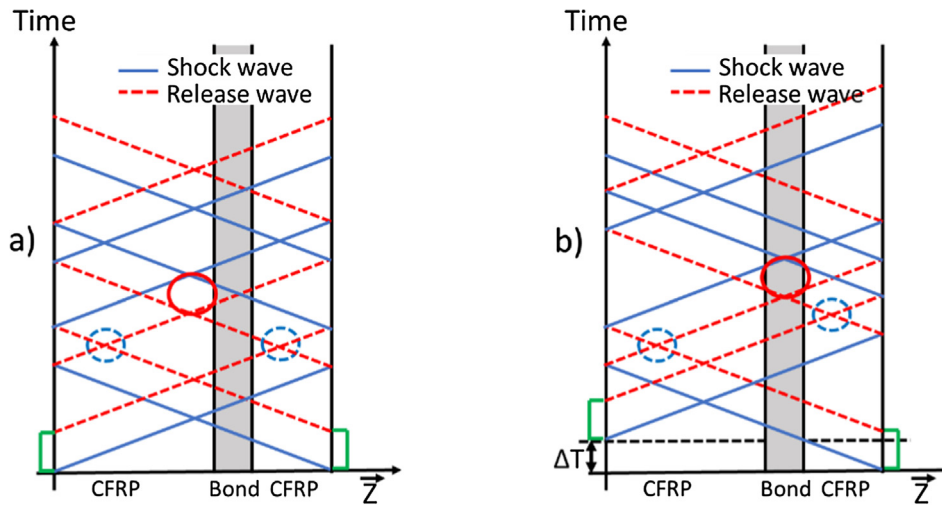
Fig. 2. Time/space diagram of S-LASAT shots: (a) without time delay and (b) with a time delay.

The Symmetrical LASer Shock Adhesion Test (S-LASAT [19,20]) is proposed to overcome this limitation. This technique consists of generating shock waves from both sides of the tested specimen. As for the single shot setup, high tensile areas are generated on each opposite side of the sample (dotted circles in Fig. 2(a)). However, a higher tensile stress is created at the intersection of the two reflected shock waves (solid circle) and its location does not exclusively rely on the pulse duration.

The high tensile stress location can be shifted by applying a time delay between each laser pulse (Fig. 2(b)). The required time delay can be calculated using Eq. (1):

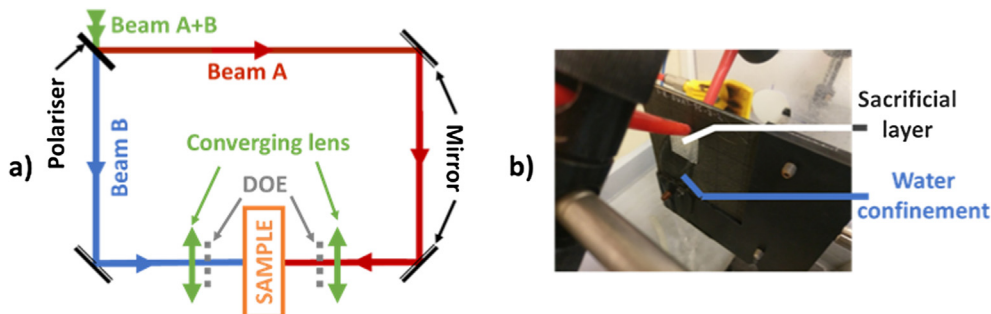
Fig. 3. (a) Schema of the experimental setup. (b) Close up on the sample setup.

A Nd:Yag laser is used to generate a pulse of 7 ns which can deliver up to $2 \times 7 \text{ J}$. To create a symmetrical shot, the Gaïa laser used on the Hephaïstos platform is composed of two lasers which beams are polarised by 90° from one another. Thanks to a polariser, two distinct beams, referred to as Beam A and Beam B, are created and transported through optics to both sides of the tested sample (Fig. 3(a)).

Prior to the shot, the tested area was protected using an aluminium adhesive tape, and the zone was confined using a water trickle to make sure at least 1 mm of water covered the sample during the test (Fig. 3(b)).

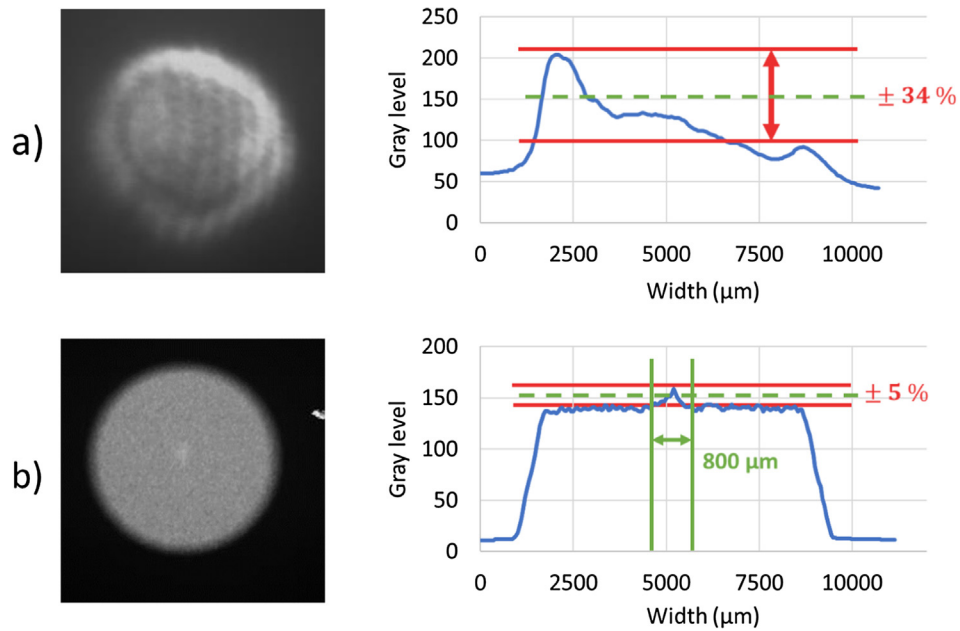
Fig. 4. Spatial repartition of the laser intensity on beam A (a) before DOE were included in the experimental setup and (b) after DOE were included in the experimental setup.

Compared to the last work [13], Diffractive Optical Elements (DOE) were added on both beam paths. This optics makes for a better control of the spatial repartition of the pressure on top of the sample. These serve to break down the initial laser beam, and reform it to assure a good homogeneity of the laser at the focal spot. Fig. 4(a) shows the laser repartition, at the focal spot, with and without DOE. One can a wide important intensity variation before the DOE ($\pm 34\%$ compared to the mean value). Moreover, this variation occurred over the whole spot area. After these optics were included in the experimental setup, a much smoother repartition can be observed (Fig. 4(b)), very close from a top-hat signal, with only a small and very localised intensity variation.

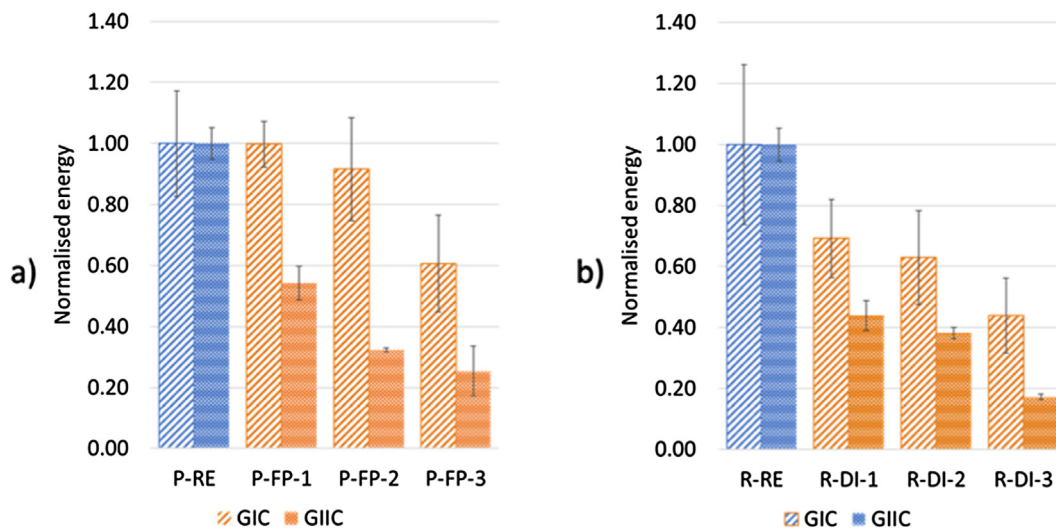
Fig. 5. Mechanical tests for: (a) the production reference sample (P-RE) and the three levels of finger print contamination, low (P-FP-1), medium (P-FP-2) and high (P-FP-3) – (b) the repair reference sample (R-RE) and the three levels of de-icing fluid contamination, low (R-DI-1), medium (R-DI-2) and high (R-DI-3) [22,23].

Fig. 5(a) summarizes the mechanical test results obtained for the production reference, P-RE, sample (blue) and the finger print contamination (orange), and Fig. 5(b) for the repair reference, R-RE, sample (blue) and de-icer contamination (orange). To ease later

comparison with the LASAT, all values have been normalised by the reference sample value. Hence the de-icer results have been normalised using the sound repair sample threshold, and the finger print one by the reference production sample.

Both the GIC and GIIC tests show a general decrease of the bond strength after the contamination. However, because the range of GIC tests' uncertainty bars for a sound and a contaminated sample were overlapping, no direct conclusion could be drawn out. GIIC tests were more consistent and confirmed the loss of adherence/mechanical strength of the contaminated samples.

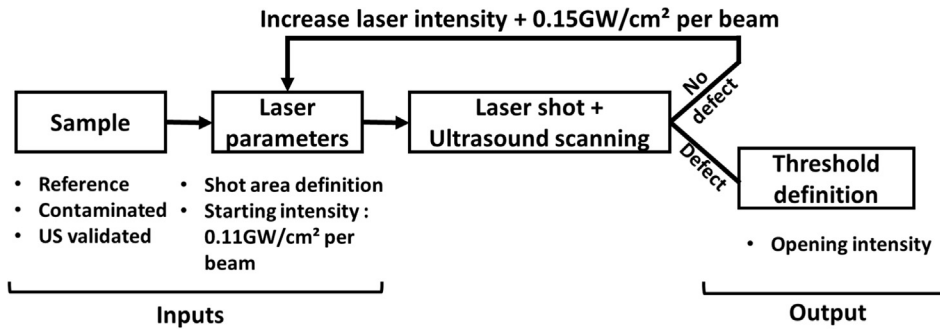
Fig. 6. Block scheme of the experimental procedure.

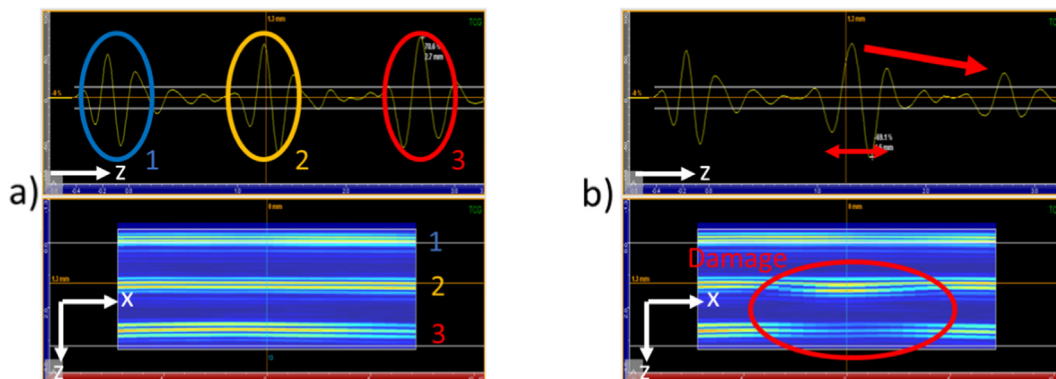
Fig. 7. A-Scan and B-Scan of the bonded CFRP assembly: (a) no damage (b) with damage.

Ultrasounds cannot go through empty area, typically here disbondings. The signal is blocked, and little to no information is available after the opening. With A-Scan, it can be spotted by a loss of amplitude of one of the echoes. For example, the A-Scan from Fig. 7(b) shows a loss of signal from the back-face echo (3) as well as a widening of the bond echo. The B-Scan confirms the damage location on the bond, and thus, the occultation of the signal below it. Each time the sample was scanned from both sides to assure no defaults were hidden by the damaged bond.

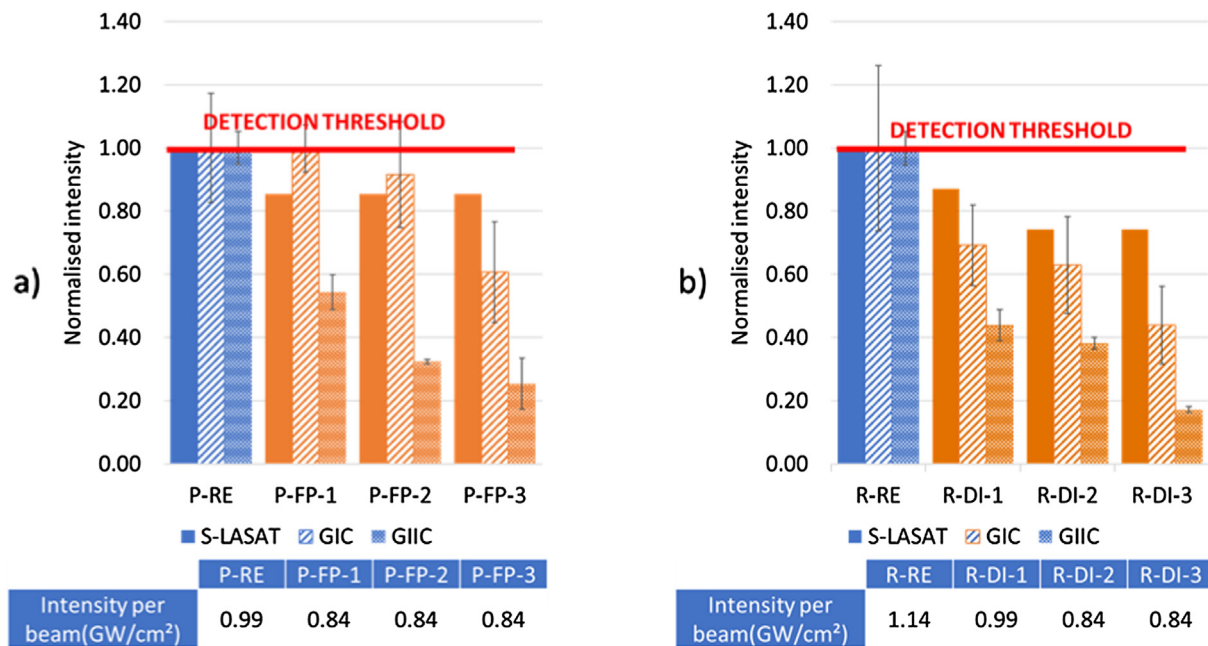
Fig. 8. Normalised results comparison between S-LASAT and the mechanical tests for: (a) the production reference sample (P-RE) and the three levels of finger print contamination, low (P-FP-1), medium (P-FP-2) and high (P-FP-3) – (b) the repair reference sample (R-RE) and the three levels of de-icing fluid.

Results for the finger print and the di-icer contaminations are presented in Fig. 8. To confirm the ability of the S-LASAT to spot a specific contamination, the measured energy required to open the faulty bond must be lower than the one obtained for the reference sample. Since data has been normalised, a contamination correctly isolated must be below the 1.0 mark (represented by the red line entitled “detection threshold” in Fig. 8).

As the GIC and GIIC test showed, the contamination of the sample modified the adherence strength of the sample. The S-LASAT showed the same results: a contaminated bond requires less laser intensity loading to be opened than a healthy one. The same observation was made for both contaminations.

In the case of the finger print sample, the technique did not differentiate the three levels of contamination. However, unlike standard mechanical tests that apply a constant load increase, the LASAT was performed using a load step, limiting the results’ accuracy. A smaller intensity step size could give more precise results. However, even with

such intervals, the technique was able to differentiate the second and third level of the de-icer contamination.

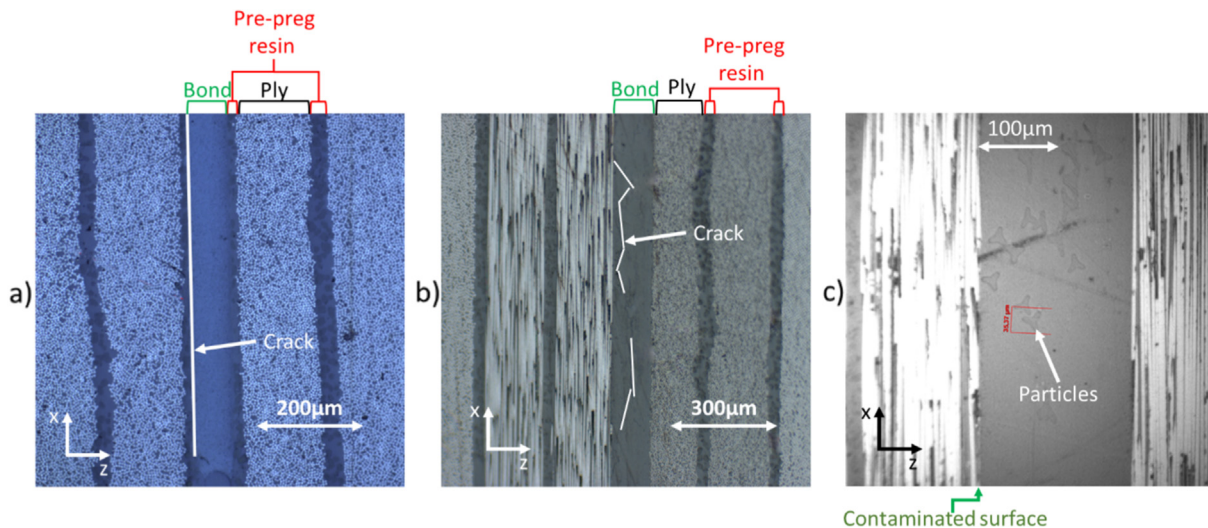
Fig. 9. Photomicrographs of the bond after damage created by S-LASAT: (a) production reference sample [13], (b) repair reference sample [13], and (c) highest degree of de-icing fluid contamination.

Important differences have been spotted however when comparing the damage patterns of the repair and production reference samples. In the production reference sample, the disbonding seemed to propagate mainly between the epoxy from the pre-impregnated CRFP and the

bond (Fig. 9(a)). However, cracks appeared primarily in the centre of the bond for a repair sample (Fig. 9(b)). The difference of bonding surfaces (CFRP fibres vs epoxy) could explain this variance as well as the presence of the knit carrier within the production bond.

Following the same study process, micrographs were realised on both sets of contaminated samples. The damage inside the FP contaminated samples was similar to the one observed before: creation of a disbonding between the epoxy from the pre-impregnated CFRP and the bond. However, no clear crack pattern was found for DI samples, instead microcracks were observed. This type of defect is harder to detect using linear ultrasounds and may not be spotted in the case of a lower contamination. A closer study of the specimen also revealed particles probably from the Safeway KF (Fig. 9(c)).

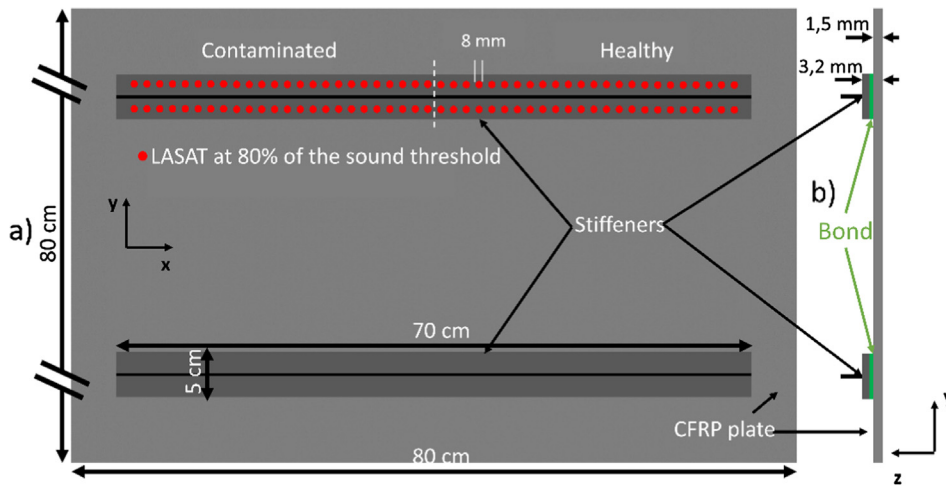
Fig. 10. Production panel: (a) front view with laser shot position and (b) side view with specified thicknesses.

A350 panels have been produced/recovered to test the technique using real parts. The production sample is an $800 \times 800 \times 1.5$ mm CFRP plate on which two $700 \times 50 \times 1.7$ CFRP stiffeners were bonded (Fig. 10). The plate is made of 14 prepreg layers with the following lay-up: $[+45/90/0/90/+45/0/90]_s$. On one half, the stiffeners have been bonded without contamination, and on the other half of the plate both the de-icing fluid and the finger print solution have been applied on the stiffeners' surface before the bond. The goal will be to assess the quality of the bond holding the stiffeners to the CFRP plate. Only the upper stiffener has been tested.

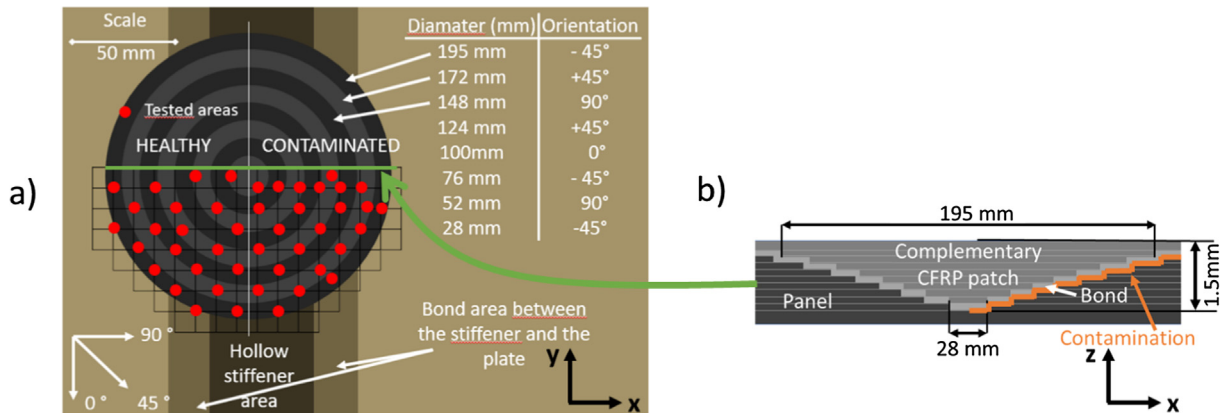
Fig. 11. (a) figure of the shot pattern realised on the repair panel and (b) cross-section of the repair patch geometry.

The repair panel has been cut out of a A350 structure. The middle part of the sample has been grinded all the way to the fibres in a conic shape. Half of the surface was contaminated with both finger print and de-icing fluid solutions (Fig. 11(b)). The hole created in the panel was then patched, starting from the centre to the edge, with the missing CFRP ring (cf. Fig. 11(b)) while keeping the original lay-up of the part (ring diameter and orientation in Fig. 11(a)). The composite was then cured by GMI's tool ANITA EZ0901 hot bonder.

This part had hollow stiffeners on one side, making it impossible to test in this area using a symmetrical shot configuration. It is represented by the dark bar on Fig. 11(a): the darker section is the hollow part and the lighter sections on either side show the areas where the stiffener is assembled onto the panel. Thus, there is a total of three different areas on the patch. The first one only features the repair patch. The S-LASAT

can be applied normally (Fig. 11(b)). The second area above the hollow part was tested using the single shot setup since only one face was available. The third one features both the patch and the zone where the stiffeners have been bonded. These areas then have two bonds: the first one between the plate and the stiffener, and a second one between the plate and the repair patch. S-LASAT can be used, but the extra thickness coming from the stiffeners must be considered.

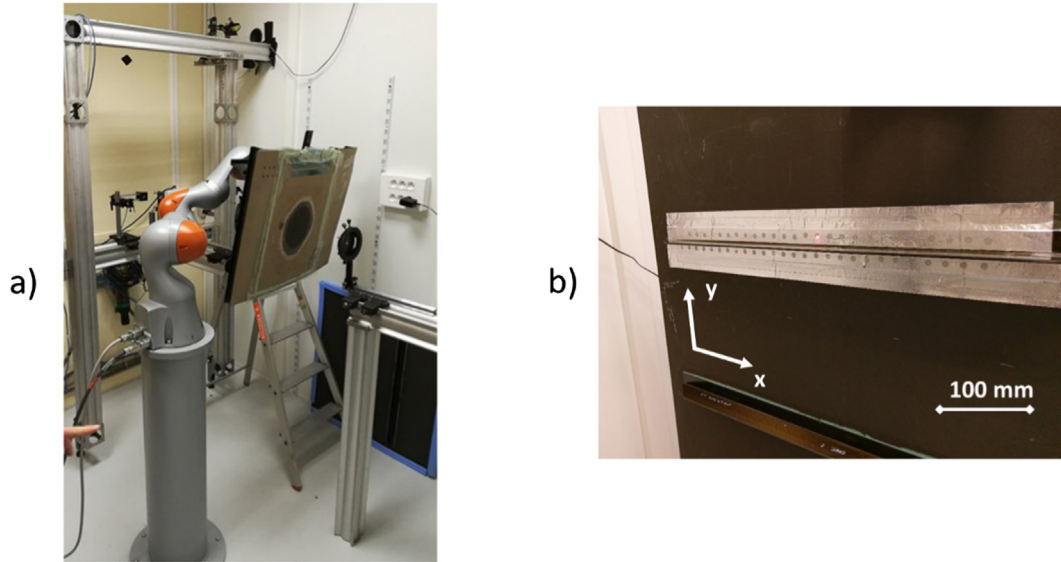
Fig. 12. (a) New experimental setup with the repair panel placed on the robot and (b) one of the stiffener of the production panel after laser shots.

They are covered by the transparent confinement tape. The “dots” are areas that have been test using S-LASAT. This panel is ready to undergo a full ultrasonic scan to find the opened areas.

These parts were too big to fit into the initial experimental setup. A robot has been installed to move the piece around, and the optics had to be rearranged (Fig. 12(a)). The water confinement was not feasible either. Instead, a solid constraining material in the form of a thick transparent adhesive layer was used. Its confinement capabilities are comparable to the water in the intensity range $0-3 \text{ GW/cm}^2$. Tests on the coupon sample have also validated this choice. The sacrificial layer is the same as before. Fig. 12(b) is a picture of the production panel. Two bands of sacrificial aluminium tape were placed on the stiffener.
