Lamice DENGUIR, José OUTEIRO, Vincent VIGNAL, Rémy BESNARD, Guillaume FROMENTIN  
- On the optimization of the cutting conditions for an improved corrosion resistance of OFHC copper - In: 8th CIRP Conference on High Performance Cutting (HPC 2018), Hongrie, 2018-06-25  
- Procedia CIRP - 2018

8th CIRP Conference on High Performance Cutting (HPC 2018)

## On the optimization of the cutting conditions for an improved corrosion resistance of OFHC copper

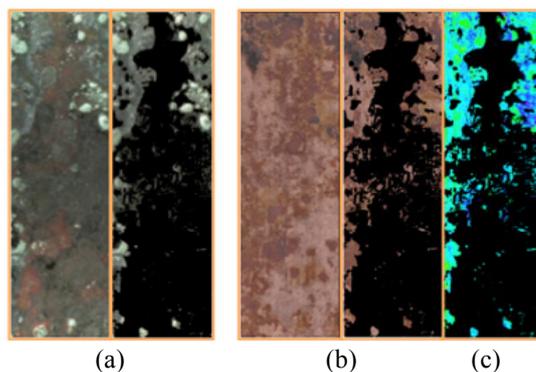
Fig. 1. Evaluation of the volume of copper dissolved by  $\text{mm}^2$  covered by atacamite.

- Isolation of green zones (covered by atacamite) starting from a photo of the oxidized surface as shown in Figure 1a.
- Starting from the image of the cleaned surface, isolating topographies of zones corresponding to those covered by green before the cleaning as shown in Figure 1b.
- Visualization of the topography corresponding only to the filtered zones as shown in Figure 1c. Level 0 corresponds to the mean plan of the freshly machined surface, before the aging test ( $R_a < 800 \text{nm}$ ).
- The program calculated the volume of copper that has removed (valleys) under the zones previously covered with atacamite, and divided it by the green analyzed surface, which gave a mean value of the depth of the dissolved substrate.

oxidation reaction per  $\text{mm}^2$  covered by atacamite (the green color) was quantified. In fact, the oxidized surface was taken in photo by a high-resolution microscope *Keyence<sup>TM</sup>*. Then, the surface was cleaned from oxides and taken again into photo. The topography was measured by optical microscope *Alicona<sup>TM</sup>* using the variation of focal distance technique. The volume of *OFHC* copper that disappeared from the oxidized surface was calculated by treating automatically the images under *Matlab<sup>®</sup>* (cf. Figure 1) using a script developed for the study making the following tasks:

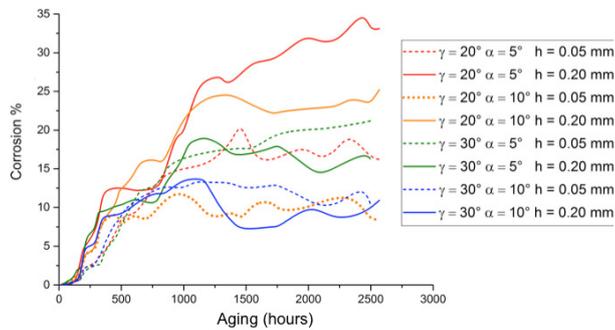
Fig. 2. Corrosion evolution under saline atmosphere for surfaces obtained by orthogonal cutting at  $V_c = 90$  m/min.

Figure 5 shows a non-negligible influence of the cutting conditions in on the evolution of the corrosion of *OFHC* copper surfaces, especially after 700 hours. under saline atmosphere. In fact, for the surfaces generated with a tool having the same rake angle of  $20^\circ$ , a raise in the uncut chip thickness accelerates the corrosion (cf. Figure 2). Nevertheless, this phenomenon is not seen when the rake angle is  $30^\circ$  where the uncut chip thickness seems to have no influence. On the other side, whatever the rake angle and the uncut chip thickness are, the raise of the flank angle from  $5^\circ$  to  $10^\circ$  shows a better influence on corrosion resistance. As observations are not enough to reveal the existing relationships between the cutting conditions and corrosion resistance, further analysis is needed to reveal their impact on the surface integrity responsible for this behavior.

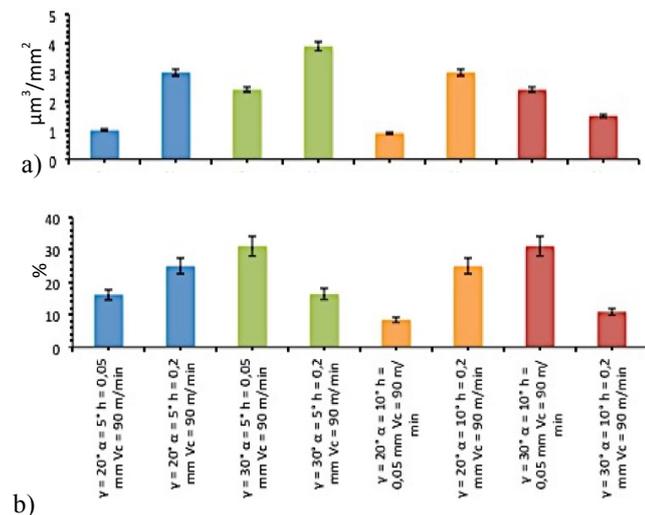
Fig. 3. (a) Mean in-depth degradation induced by oxidation at the end of the aging test under saline atmosphere, and (b) percentage of the oxidized surfaces at the end of the aging test under saline atmosphere.

Comparing the percentage of oxidized surface at the end of the aging test under saline atmosphere (cf. Figure 3b), the following remarks can be drawn: i) The least covered surface by atacamite is the least damaged under the green oxide ( $\gamma = 20^\circ$ ;  $\alpha = 10^\circ$ ;  $h = 0.05$  mm;  $V_c = 90$  m/min); ii) The most covered surface by oxides is not necessarily the one knowing the worst in-depth degradation ( $\gamma = 30^\circ$ ;  $\alpha = 5^\circ$ ;  $h = 0.05$  mm;  $V_c = 90$  m/min).

To explain degradation under the green surface, in-depth topography is measured under the oxide once it is removed. The removed volume per surface unit reflects the mean in-depth degradation under the oxide. Results are represented in Figure 3.

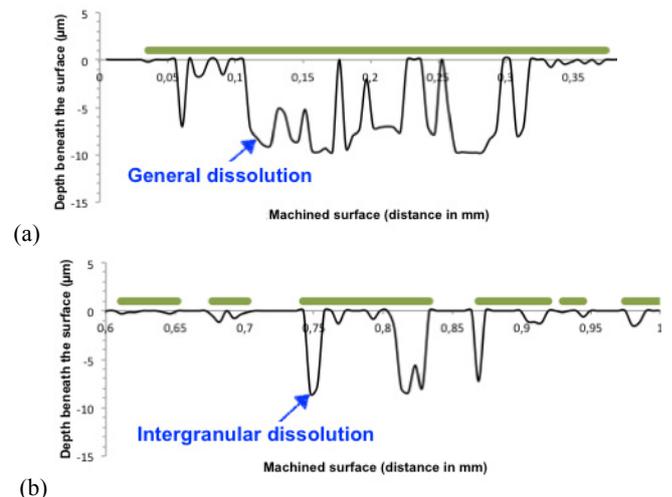
A unidirectional profile measured in the oxidized region was taken from every analyzed surface to identify the shape profile under the oxide. It was measured only under the green areas (represented by the green lines in Figure 4 as an example). The used in-depth resolution is 78 nm and the horizontal resolution is 5  $\mu\text{m}$ . According to the obtained profiles, it is remarkable that under the green areas two types of cavities can prevail: large cavities with plate valleys (corresponding to generalized dissolution, cf. Figure 4.a) and thin and deep cavities (corresponding to intergranular corrosion cf. Figure 4.b) in the borders of the green area.

Fig. 4. Profiles under the green zones for surfaces obtained by the conditions  $\gamma = 30^\circ$ ,  $\alpha = 5^\circ$ ,  $h = 0.2$  mm and  $V_c = 90$  m/min. Part of the analyzed profile presenting generalized dissolution (a) and intergranular corrosion (b).

The cavities depth varies under the surfaces covered by the green oxide, what witnesses a non-uniform dissolution happening on the same surface. These observations under the oxides allow the corrosion process analysis explaining the surface damage in the presence of saline atmosphere as follows [12]. Inside the droplets, copper dissolution leads to the formation of the ions  $\text{Cu}^+$  or  $\text{Cu}^{2+}$  in aqueous solution. Associated to anions  $\text{Cl}^-$  already present in the droplet, they constitute the green compound  $\text{CuCl}$ . With high chloride concentration, they can even produce the ions of  $\text{CuCl}_2^-$ . On the other side, cations  $\text{Cu}^{2+}$  can be hydrolyzed to form atacamite  $\text{Cu}_2(\text{OH})_3\text{Cl}$ . This reaction, consuming molecules of  $\text{H}_2\text{O}$ , produces protons  $\text{H}^+$ , decreasing the pH. As the droplet stagnates in the surface, the pH diminishes with the generation of atacamite. A previous study [11] has demonstrated that pH lower than the limit of copper dissolution can be rapidly reached leading to a generalized dissolution and to intergranular corrosion. The electrons issued from the dissolution reduce the oxygen inside the droplet. As the solubility of oxygen inside water is high, the cathodic reaction continues, and the dissolution evolves into cavities. Then, what makes a machined surface more active than the other just by manipulating the cutting conditions?

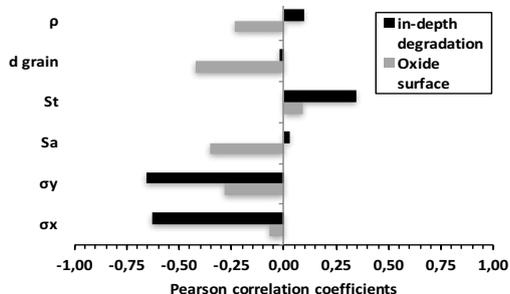
Fig. 5. Pearson correlations between the surface integrity measured parameters and the in-depth degradation and oxide surface at the end of the aging test in salt fog atmosphere.

To answer that question, the relationship between the surface integrity parameters (surface residual stresses in the cutting direction  $\sigma_x$  and in the transversal direction  $\sigma_y$ , the roughness  $S_a$  and  $S_t$  parameters, the grains size  $d_{\text{grain}}$  and the dislocations density  $\rho$ , all detailed in Table 1) and corrosion in terms of the oxide surface area and the surface in-depth degradation are evaluated using the correlation of Pearson technique. The results (cf. Figure 5) show that concerning to the area of the oxide surface is highly sensitive to the grain size  $d_{\text{grain}}$ , then to the surface roughness  $S_a$ , while in-depth degradation is mostly related to the residual stresses. In fact, the preferential dissolution starting sites are the grains boundaries and the peaks of roughness presenting micro-electrodes. So, more grains and more peaks imply greener surface. However, when it is up to the in-depth degradation, tensile stresses will play the major role in continuing and accelerating the dissolution process [12].

As  $S_a$ ,  $d_{\text{grain}}$ ,  $\sigma_x$  and  $\sigma_y$  are the surface integrity parameters identified as the most relevant in this study of the machined surfaces corrosion according to Pearson's correlation coefficients, the analysis of variance ANOVA revealed their relationship with the tested cutting conditions via Fisher indexes, as shown in Table 2. The highest Fisher index related to the roughness  $S_a$  is attributed to the flank angle  $\alpha$ . In fact, unlike the turning operation where the combination of tool geometry and cutting parameters (in particular the feed) generates feed marks, in orthogonal cutting the machined surface is theoretically flat. However, small tool flank angle generates more friction between the tool flank face and the machined surface, resulting into build up and micro-tearing in the later. As a consequence, the value of  $S_a$  raises. Concerning to the residual stresses they are clearly driven by the uncut chip thickness. Indeed, while raising the uncut chip thickness, the residual stresses resulting from the mechanical loading cycle are more tensile [13]. However, concerning to the grains refinement, the impact of the cutting conditions is more complicated, as this phenomenon seems to be sensitive to the interaction of the different parameters.
