Chams Eddine RAMOUL, BELIARDOUH NASSER EDDINE, R. BAHY, Abdelghani DJAHOUDI, Michael J. WALOCK, Corinne NOUVEAU - Surface performances of PVD ZrN coatings in biological environments - Tribology - Materials, Surfaces & Interfaces - Vol. 13, n°1, p.12-19 - 2018

Surface performances of PVD ZrN coatings in biological environments

Zirconium nitride (ZrN) thin films were deposited by reactive RF magnetron sputtering on Ti-6Al-4V and Si (100) substrates for potential use in biomedical applications. The tribological behaviour was evaluated against bovine bone in dry condition using a pin-on-disc apparatus. Abrasion is the primary wear mechanism observed in ZrN/bone contact. The corrosion properties were determined through two electrochemical techniques: potentiodynamic polarization and electrochemical impedance spectroscopy. The coatings with reduced oxygen content provided: (i) good resistance against corrosion when exposed to physiological solution and (ii) better anti-bioadhesion against *Staphylococcus aureus* bacteria.

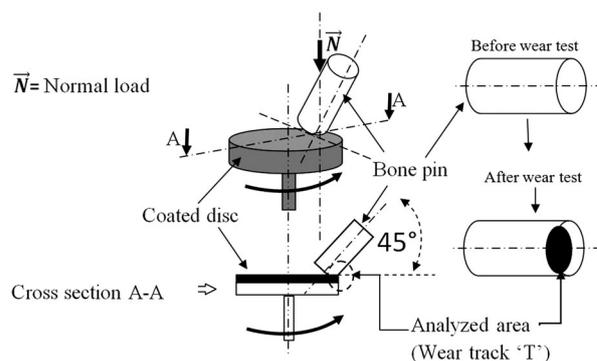
When it is impossible to make a ball geometry, e.g. from organic matter of animal origin (bone, cartilage, etc.), the pin-on-disk configuration provided by [®]CSM Instrument tribometer is perfectly adapted for this case (Figure 1). The pin holder is positioned at 45°; this allows to make several tests with one pin. The tribological test parameters are listed in Table 2.

Figure 1. Schematic of the pin-on-disc tests.

Figure 6 (a–d) shows micrographs of the bone pin wear scars. It appears that the edges of the bone pin (see Figure 1; *analyzed area (Wear track 'T')*) become larger after acting as counterparts against ZrN-coated discs. Wear scars also reveal deformation of the Haversian system, lacunae (crevasses indicated by white narrows), isolated wear particles (black narrows) and entrapped particles (ellipse). EDS analyses, carried out at different locations (isolated as well as entrapped

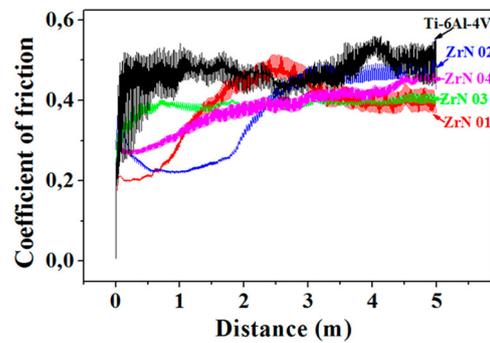
Figure 3 shows the friction coefficient curves of the ZrN films sliding against bovine bone in dry conditions. It shows that the friction coefficients of the four coatings possess similar features, i.e. the friction curves of ZrN films are characterized by two different stages. The first stage represents run-in and ends with a rapid increase of the COF; the second stage was the steady state wear regime.

During dry sliding tests, the following scenario most probably occurs; at the beginning of the wear test, there is a severe material transfer between the coating and the pins, which leads to an increase of the COF. When the steady state is reached, the material transfer is slowly reduced and stabilized after a large percentage of the wear track area is covered with the transferred material. At the steady state, the highest COF value (~ 0.58) was observed for the ZrN-02 coating surface, whereas lower COF values (~ 0.38) were obtained for the other three ZrN coatings (Figure 3). Thus, the COF is fairly high. That is the disadvantage of hard ceramic coatings (ZrN), e.g. their brittleness and relatively high COF. The COF of the uncoated substrate at the

Figure 3. COF of the ZrN coatings sliding against bone counterparts.

steady state was ~ 0.58 . From Figure 3, there is clear evidence that, after 3 m of sliding distance the coatings are destroyed.

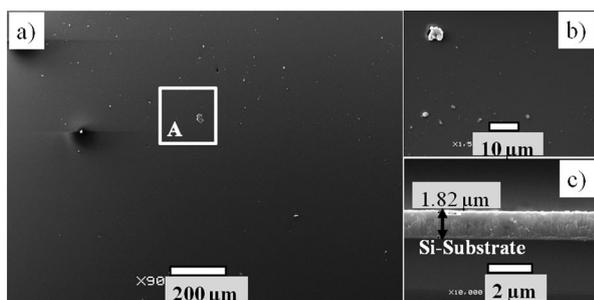
Figure 2 shows SEM images of an as-deposited ZrN coating on a Si substrate. There are some sputtering defects, e.g. pits and droplets, as shown in Figure 2

(a–b). All films have an overall thickness of ~ 1.6 to $1.9 \mu\text{m}$ and exhibit a columnar structure, as shown in Figure 2(c). The surface roughness of the samples is shown in Table 2. No remarkable differences in roughness parameters (R_a , R_q) are observed. The ZrN-01 and ZrN-02 samples have a relatively low oxygen content in comparison to ZrN-03 and ZrN-04.

Figure 2. SEM images of the as-deposited ZrN-01 coating on Si substrate: (a) global view of the surface, (b) magnified image of the region enclosed by the white square (area A) and (c) cross-section image of the same sample.

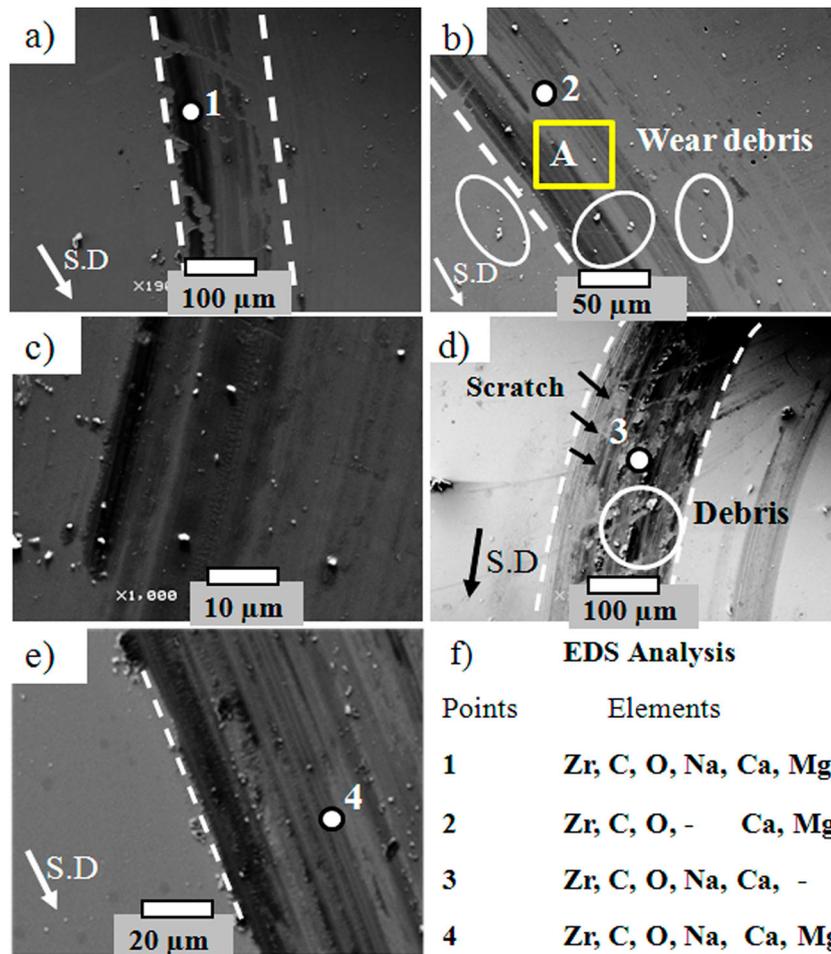
Figure 4 shows the wear tracks of ZrN coatings on Ti-6Al-4V substrates tested against bone pins as counterparts in dry conditions. The primary wear mechanism appears to be abrasion, as shown in Figure 4(a–d). In addition to grooves and scratches parallel to sliding direction, wear debris accumulated in the wear tracks are also observed as deep furrows from trapped particles (Figure 4(c)). The elemental composition of some isolated particles, analysed by EDS, indicates the presence of both bone elements (Na, Mg, Ca, K, etc.) and coating elements (Zr and oxygen) in the adhered film (points 1, 2, 3, 4 in Figure 4(a–e)). So, the wear debris is a mixture of the antagonist pair components. From this, one can conclude that bone adhesion to the disc is the second wear mechanism observed in the ZrN/bone contact pair. SEM analysis also revealed some areas within the wear track where the coating did not appear to be damaged after the wear tests. No plastic deformation was detected in the wear tracks on any of the coatings.

Figure 4. Wear mechanism of ZrN coatings: abrasion (scratches-grooves) and bone adhesion wear; (a) wear track of ZrN-01, (b) wear track of ZrN-02, (c) zoom of the square A, (d) wear track of ZrN-03, (e) wear track of ZrN-04 and (f) EDS analysis results at points 1, 2, 3, 4; (S.D – sliding direction).

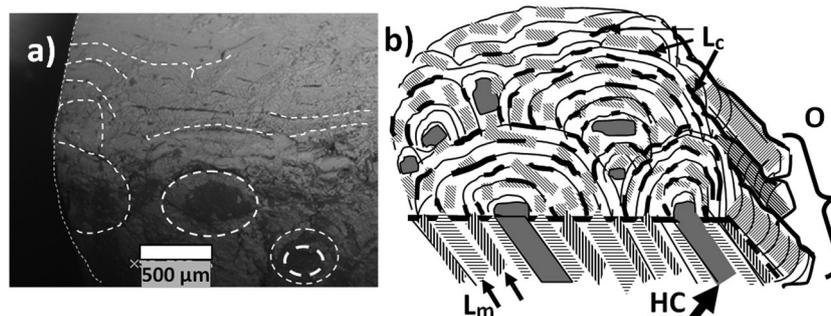
systems or osteons. [6]. The macrostructure of the bone pin specimen (cortical bone) is shown in Figure 5.

Figure 5. (a) SEM micrograph of a bone pin specimen. (b) A schematic diagram illustrating the macrostructure of cortical bone; O – Osteons (Haversian systems), L_m – concentric lamellae, HC – Haversian canal and L_c – lacunae.

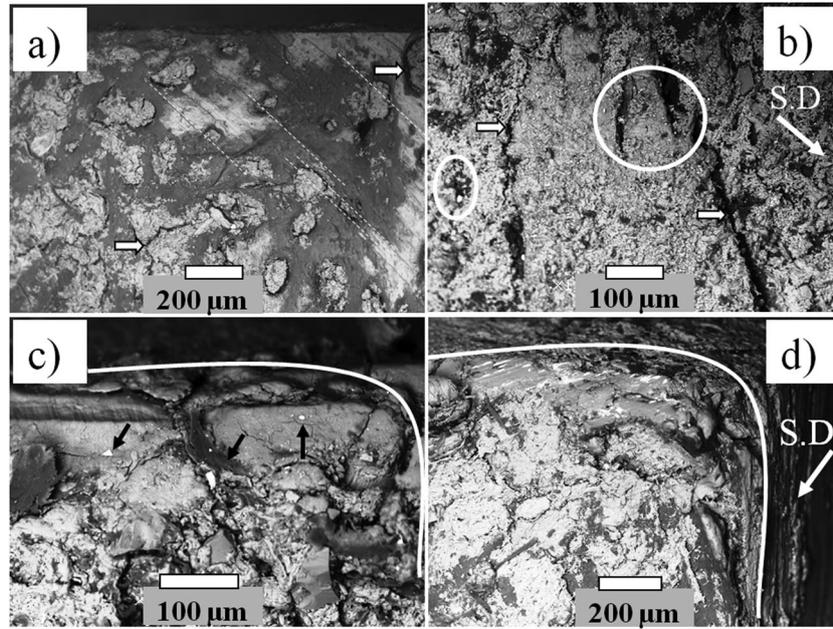
particles) within the wear scars, indicate that a mixture of both the antagonist elements in contact was found. Abrasive wear is the only wear mechanism observed on the bone pins.

When sliding against ZrN-coated discs, segments of the bone pins were initially scraped off by surface asperities along the wear track. This is due to the large difference in mechanical properties between the antagonists in contact. A literature study reveals the average hardness (H) and elastic modulus (E) of cortical bovine bone obtained from nanoindentation in

Figure 6. SEM images of wear scars of bone pins after pin-on-disc tests for: (a) ZrN-01, (b) ZrN-02, (c) ZrN-03 and (d) ZrN-04 (dash lines indicate scratch marks, SD – sliding direction).

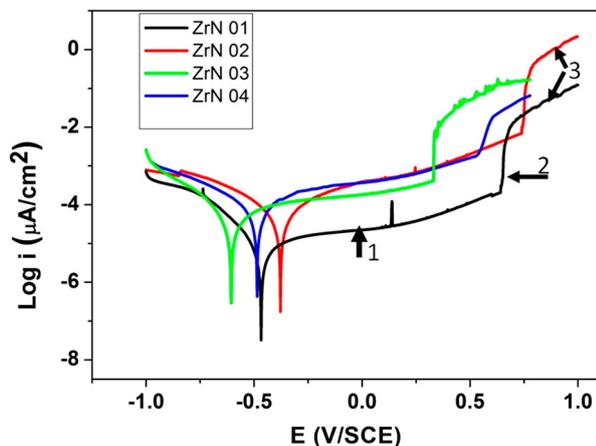
Figure 7(a) shows the potentiodynamic polarization curves (plots of potential vs. log current density) of the ZrN coatings exposed to the PS for 2 h. All specimens form an anodic domain (labelled '1'), which corresponds to the formation of a self-passivating (Zr, N,

Figure 7. Potentiodynamic polarization curves of ZrN coatings in physiological liquid solution.

O) film after being soaked for a period of time. The size of this domain is indicative of the durability of the self-passivating film and the corrosion resistance of each coating. For example, the anodic plateau remained flat from -0.4 up to $+0.65$ V in the case of ZrN-01. The rupture of the passive film occurs in the trans-passivation domain (labelled '2'). In this domain, the current density abruptly increases as the materials start to corrode (labelled '3'). The polarization resistance (R_p) of Tafel curves, which takes into consideration both the corrosion current density and the slopes of polarization curves, can provide a quantitative ranking of coatings resistance to corrosion and can be estimated using the well-known Stern–Geary equation.

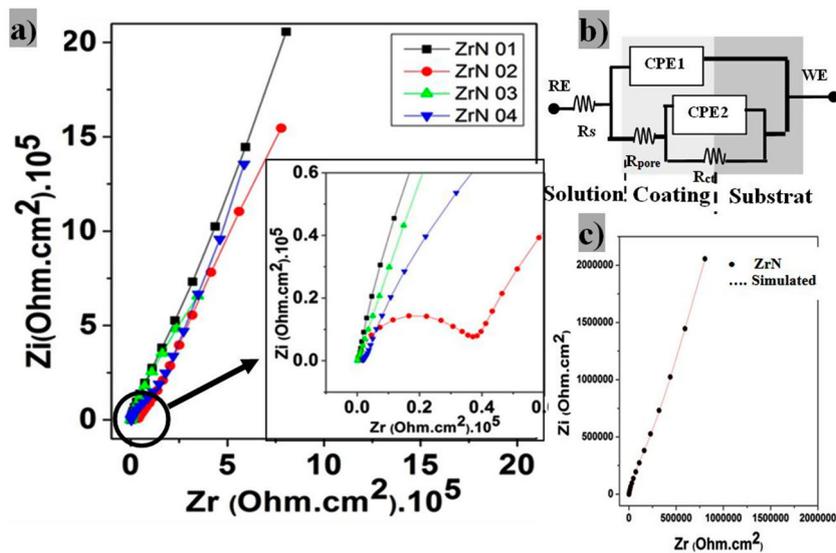
Each sample's impedance was measured after 1 h of immersion in the PS. Nyquist plots of the real and imaginary parts of the impedance are shown in Figure 8(a). The plots show that all tested samples are characterized by two capacitive loops in the high and medium

Figure 8. Electrochemical test results (EIS): (a) Nyquist plots of tested specimen in physiological liquid solution, (b) equivalent circuit model and (c) example of fitting curve (WE = working electrode and RE = reference electrode).

frequency range. By comparing the diameters of the loops in the Nyquist plot, the sample's corrosion properties can be easily evaluated. Larger diameter loops equate to higher corrosion resistance. This analysis supports the previous conclusion: ZrN-01 has the best corrosion resistance of the four tested samples. An equivalent circuit (EC) model, which is shown in Figure 8(b), was selected for quantitative studies. This EC is extensively used in similar situations [9]. Figure 8(c) shows good agreement between the experimental and modelled values. The fitted line was plotted as a dashed line. The fitting errors for each configuration in this study were less than 9%.

In the selected equivalent circuit, R_s represents the electrolyte resistance. The Constant Phase Elements, CPE1 and CPE2, are the double layer capacitance and the coating capacitance respectively. R_{ct} is the charge transfer resistance and R_{pore} represents the pore resistance (and other fails of coating).

The overall corrosion resistance of the coating can be estimated by the sum of all resistances of the circuit model in accordance with the method described by Subramanian et al. [9]. Therefore, using the quantitative data given in Table 4, the ZrN-01 coating presents the highest resistance against corrosion in a physiological liquid solution of the four tested samples, as expected.

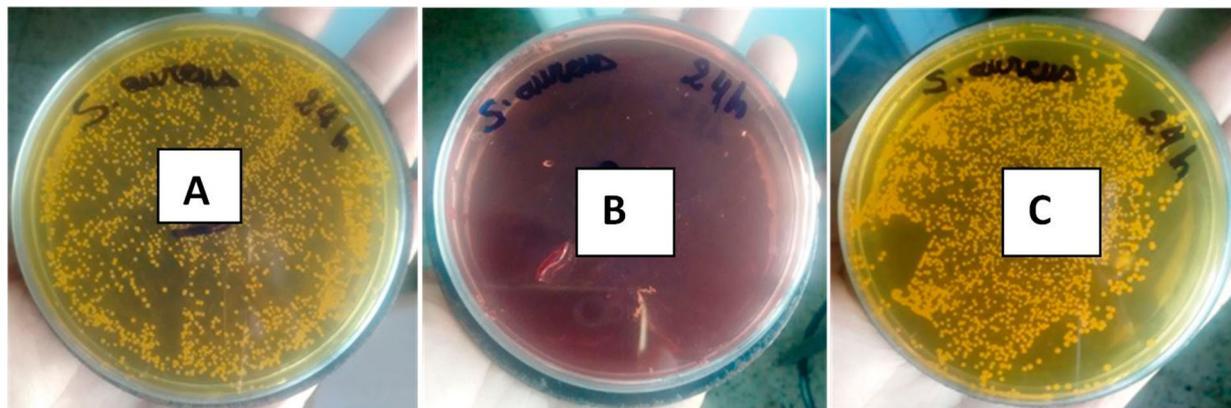
After incubation, the *S. aureus* colonies are clearly visible (Figure 9) and were easily counted. The results indicate that *S. aureus* bacteria were completely killed in specimen B, while the surviving bacterial colonies are 3.2×10^5 (CFU/ml) for specimen A and 5.2×10^5 (CFU/ml) for specimen C. Specimen B and Specimen C have approximately similar surface parameters (i.e. roughness, morphology, etc.) but there is a noticeable difference in the oxygen content of the samples. So, surface morphology effects cannot explain the difference in the biocidal effect of these two specimens (B and C). In addition, it has been reported that a surface roughness $<0.2 \mu\text{m}$ may not affect bacterial adhesion because most bacteria are $>0.2 \mu\text{m}$ [12].

**Figure 9.** *Staphylococcus aureus* colonies grown in sterilized Petri dishes of: (a) specimen A, (b) specimen B and (c) specimen C.
