Detection, localization, and quantification of corrosion damage using Lamb Waves for the structural health monitoring of aluminum aeronautics structures

J. Liegey^[a,b], W. Briand^[a], M. Rébillat^[a], M. El May^[b], O. Devos^[c] & N. Mechbal^[a]

Abstract: Corrosion is a major concern for the aeronautic industry and providing structures with the intrinsic ability to monitor autonomously their health state is a major actual academic and industrial challenge. In this paper, detection, localization, and quantification of a damage representative of a corrosion damage using Lamb waves emitted and received by piezoelectric elements for the purpose of structural health monitoring of aeronautics aluminum structures is addressed. Semi-spherical holes of different sizes representing a calibrated corrosion pit are manufactured on a 2024 aluminum plate with four piezoelectric sensors bonded on it. Lamb waves are then recorded with one element used as an actuator and the other ones being used as sensors. A dedicated recording system provided by Cedrat Technologies is used to acquire Lamb waves data. It is demonstrated on this representative example that by using actual algorithms from the SHM

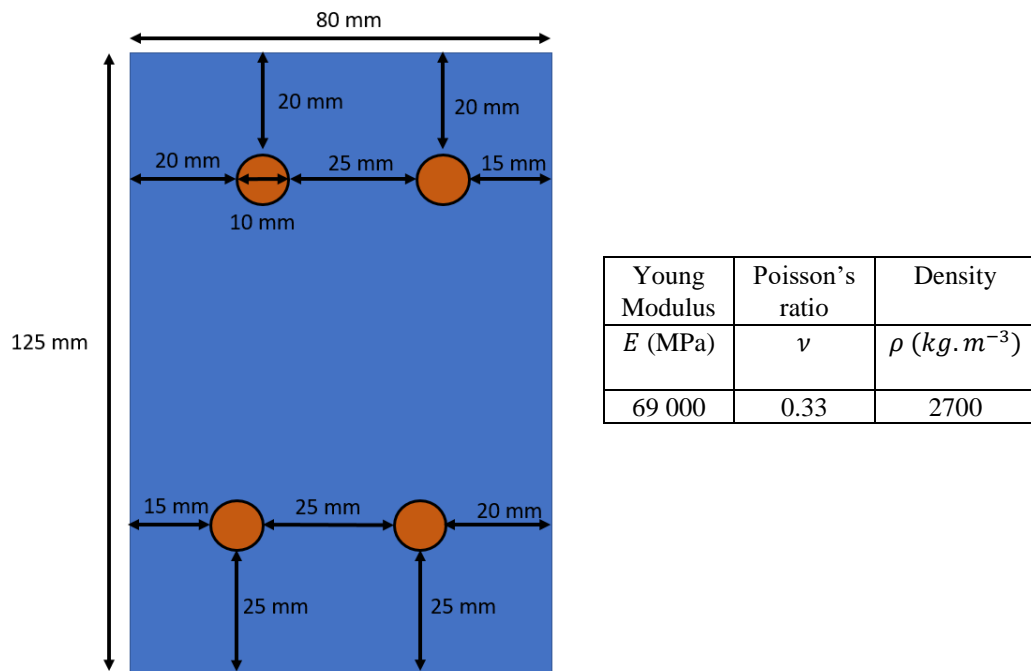
Figure 1 : [Left] Dimensions of the aluminum plate studied within the COQTEL project with the piezoelectric elements position (orange circles). [Right] Material's properties of 2024 aluminum

In this section, details about the experimental setup are presented. The material used is 2024 Aluminum alloy with the material properties provided in Figure 1 by the company Rescoll¹. The studied aluminum plates dimensions are 125×80 mm and 2 mm of thickness (see Figure 2a).

Four piezoelectric transducers were bonded to the aluminum plates and positioned strategically (not symmetric to the center to avoid recording reflected signals) as shown in Figure 1.

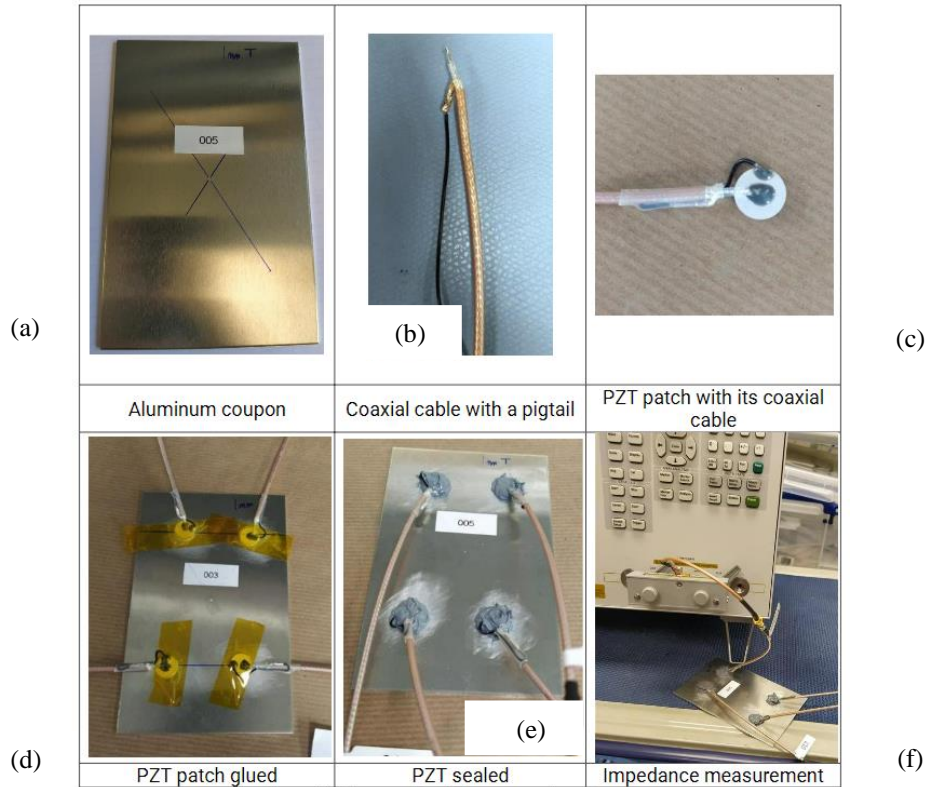
Figure 2 : Experiment set up with PWAS and aluminum plate

The chosen piezoelectric transducers are made up of NCE51 material provided by Noliac and have a 5mm radius allowing them to measure a target frequency bandwidth contained between 50 kHz and 400 kHz using a sampling frequency of 2 MHz. These piezoelectric elements have been bonded on the aluminum coupons by Cedrat Technologies². They are 1mm thick because such thickness allows them to catch more energy than larger thicknesses (like 2 or 3 mm) and not to be too brittle. A coaxial cable of length 150 mm (see Figure 2b and 2c) has been brazed directly on each element in order to optimize the signal to noise ratio. The piezoelectric elements are then bonded to the plate and made waterproof using a specific coating (see Figure 2d&e).

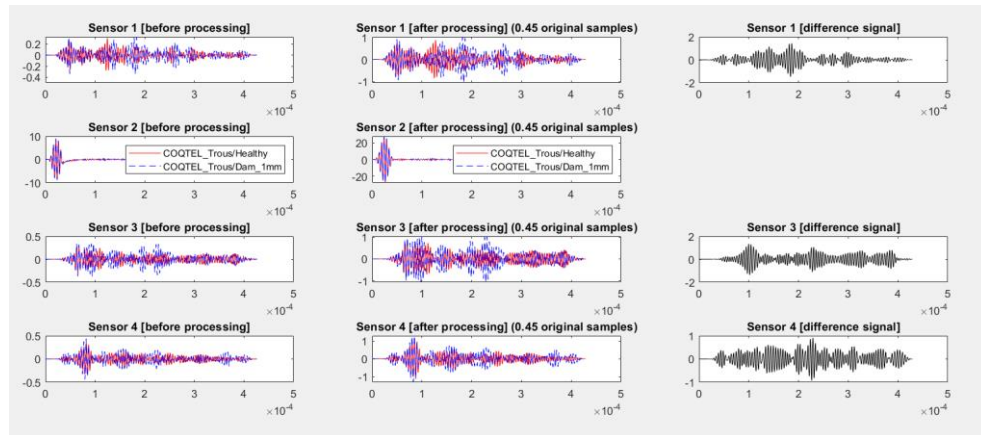
Figure 4 : Signals from plate with 1mm defect at 200kHz and with the piezoelectric element number 2 used as an actuator. On the left column, the signals are raw. In the middle one, the denoised and time aligned reference and current signals are presented. On the right one, the difference signals (*i.e.* the differences between the healthy and damaged signals) are shown.

To exploit the recorded Lamb wave data, signals from the damaged plate are compared to the healthy ones. For example, below are shown the signals received and processed from the plate with the 1mm damage and at 200kHz with the piezoelectric element number 2 being active. On the left column, the signals are raw. In the middle one, the denoised and time aligned reference and current signals are presented. On the right one, the difference signals (*i.e.* the differences between the healthy and damaged signals) are shown.

Given the received signals, a clear difference between the signal associated to corrosion damage and the healthy one can be seen. The hole of 1mm radius and 1mm of depth is thus clearly detectable using Lamb waves and this is also true for the smaller holes. The detection step is thus correctly achieved using Lamb waves.

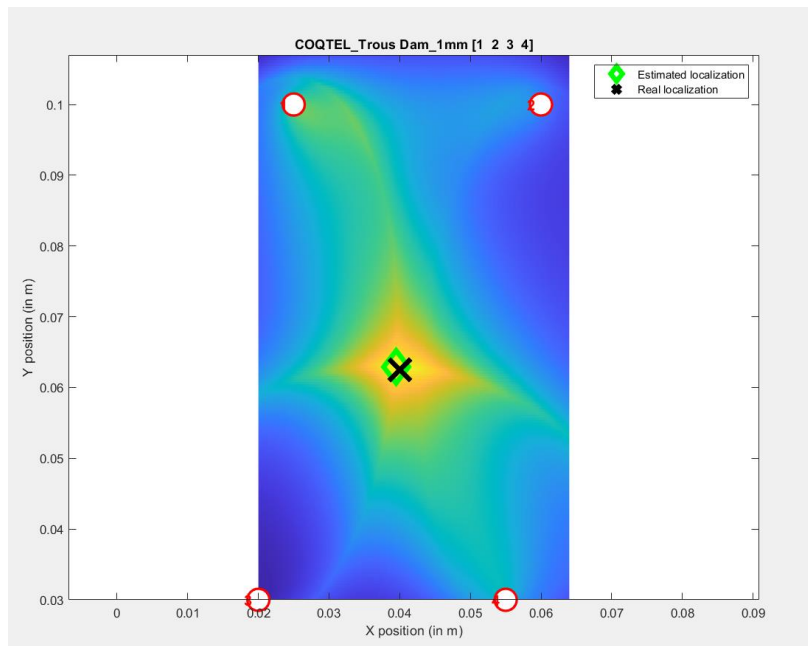
Figure 5 : Damage localization results for the damage of 1mm at 200kHz

To localize the damage, the ponderated ToA method mentioned earlier is used and pictured below. The time of flight corresponds to the time taken by the wave packet to travel from an actuator to a sensor along a given path. It is a feature extracted from the scattered signal that is used for damage localization purposes as it contains information related with damage position. More precisely, the ToA method ponderated using the CC damage index is used. It means that when adding up the ellipse corresponding to each path, they are weighted by the CC value corresponding to each path. In practice, ellipses having a high DI value count more than the one with a lower CC value in the final imaging results. Like the rest of the graphs shown before, the example of the plate with 1mm hole defect is displayed and the frequency sent by the piezoelectric 2 is 200kHz. As the picture below illustrates, the estimated localization damage (green diamond) is very close, if not superimposed, to the real localization of the damage (black "x"). This algorithm also provided correct localization results for the other damage sizes thus validating its effectiveness for corrosion-like damage monitoring.

To quantify the damage, the IPP damage quantification method was used as mentioned earlier. This method consists in computing a damage localization map and in extracting from this map the area above a given threshold (the yellow points in the above figure). When the damage size is increasing, this area is also very likely to increase and thus provide a reliable cue to damage size quantification. A polynomial regression between the area size and the actual damage size then allows to extrapolate to unknown damage sizes. A figure representing the estimated damage size versus the actual damage size is plotted. Only small damage sizes have been used for learning purposes and then the

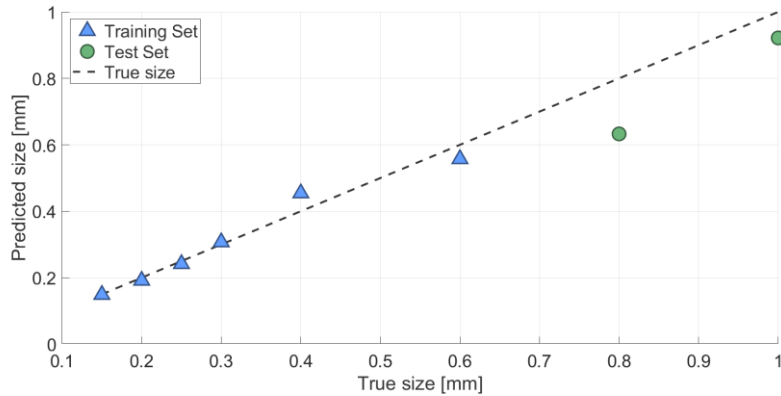
Figure 6 : Example of damage size quantification achieved by the IPP approach. The IPP algorithm has been trained on blue triangle and predicts sizes corresponding to green circles.

ability of the algorithm to extrapolate to larger damage sizes have been assessed. Points close to the diagonal line indicated correct damage size quantification. Learning points are shown in blue and prediction points in green. This example illustrates the fact that such algorithm is able to quantify correctly the size of corrosion-like damages.
