Julie LIEGEY, William BRIAND, Marc RÉBILLAT, Mohamed EL MAY, Olivier DEVOS, Nazih MECHBAL - Detection, localization, and quantification of corrosion damage using Lamb Waves for the structural health monitoring of aluminum aeronautics structures - In: EWSHM2022 ( European Workshop on Structural Health Monitoring) 4-7 July 2022, Italie, 2022-07-04 - EWSHM2022 - 2022

# Detection, localization, and quantification of corrosion damage using Lamb Waves for the structural health monitoring of aluminum aeronautics structures

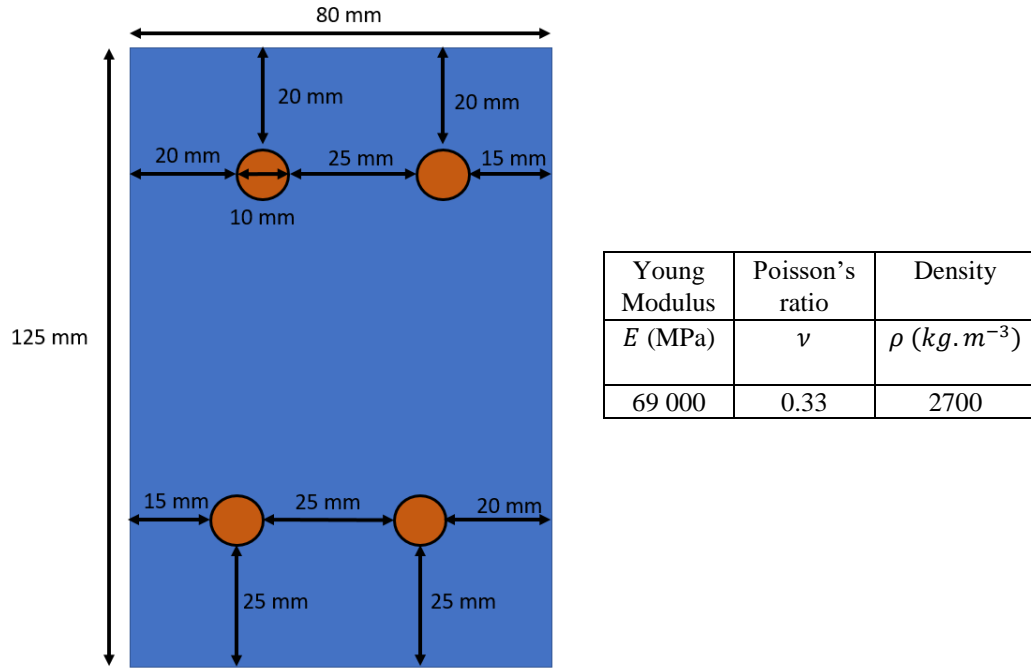
Figure 1 : [Left] Dimensions of the aluminum plate studied within the COQTEL project with the piezoelectric elements position (orange circles). [Right] Material's properties of 2024 aluminum

In this section, details about the experimental setup are presented. The material used is 2024 Aluminum alloy with the material properties provided in Figure 1 by the company Rescoll<sup>1</sup>. The studied aluminum plates dimensions are  $125 \times 80$  mm and 2 mm of thickness (see Figure 2a).

Four piezoelectric transducers were bonded to the aluminum plates and positioned strategically (not symmetric to the center to avoid recording reflected signals) as shown in Figure 1.

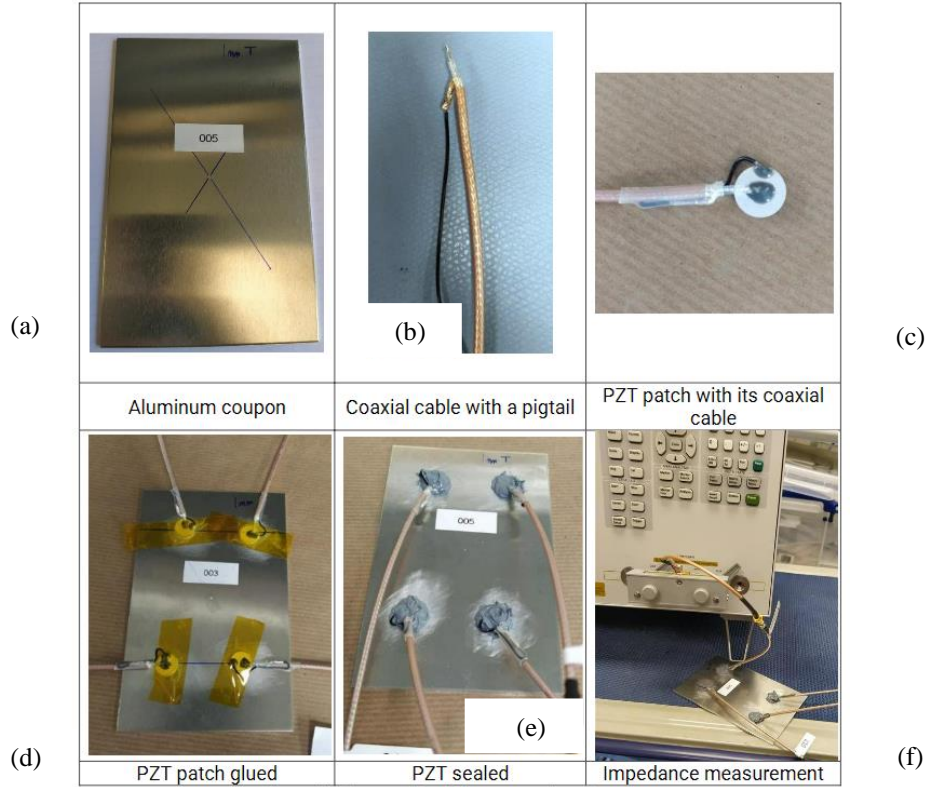
Figure 2 : Experiment set up with PWAS and aluminum plate

The chosen piezoelectric transducers are made up of NCE51 material provided by Noliac and have a 5mm radius allowing them to measure a target frequency bandwidth contained between 50 kHz and 400 kHz using a sampling frequency of 2 MHz. These piezoelectric elements have been bonded on the aluminum coupons by Cedrat Technologies<sup>2</sup>. They are 1mm thick because such thickness allows them to catch more energy than larger thicknesses (like 2 or 3 mm) and not to be too brittle. A coaxial cable of length 150 mm (see Figure 2b and 2c) has been brazed directly on each element in order to optimize the signal to noise ratio. The piezoelectric elements are then bonded to the plate and made waterproof using a specific coating (see Figure 2d&e).

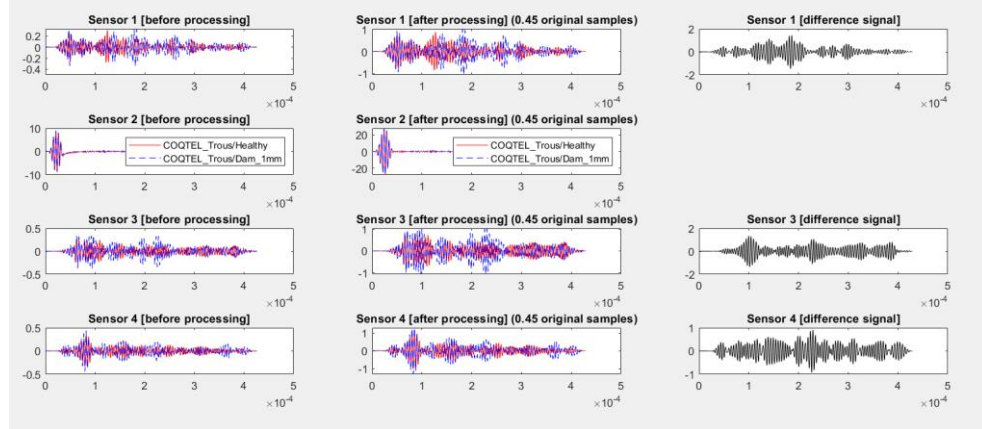
Figure 4 : Signals from plate with 1mm defect at 200kHz and with the piezoelectric element number 2 used as an actuator. On the left column, the signals are raw. In the middle one, the denoised and time aligned reference and current signals are presented. On the right one, the difference signals (*i.e.* the differences between the healthy and damaged signals) are shown.

To exploit the recorded Lamb wave data, signals from the damaged plate are compared to the healthy ones. For example, below are shown the signals received and processed from the plate with the 1mm damage and at 200kHz with the piezoelectric element number 2 being active. On the left column, the signals are raw. In the middle one, the denoised and time aligned reference and current signals are presented. On the right one, the difference signals (*i.e.* the differences between the healthy and damaged signals) are shown.

Given the received signals, a clear difference between the signal associated to corrosion damage and the healthy one can be seen. The hole of 1mm radius and 1mm of depth is thus clearly detectable using Lamb waves and this is also true for the smaller holes. The detection step is thus correctly achieved using Lamb waves.

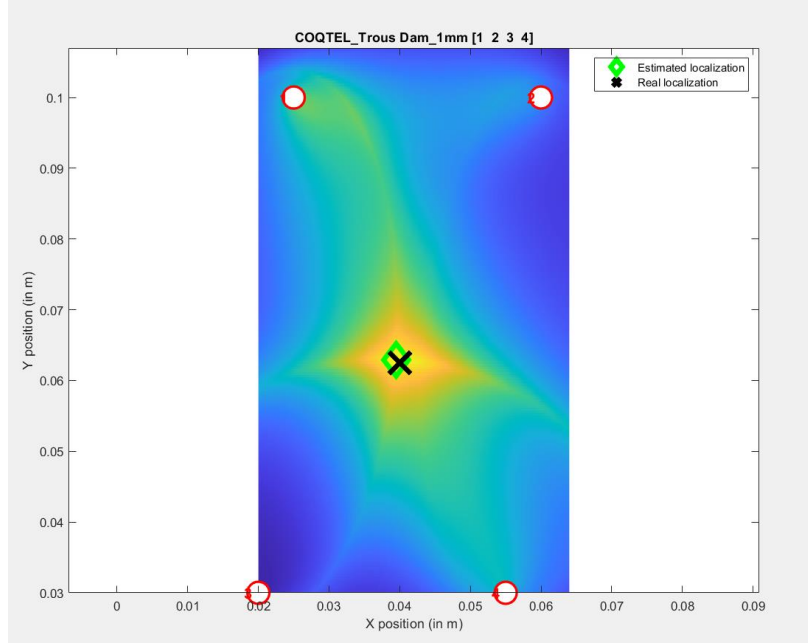
Figure 5 : Damage localization results for the damage of 1mm at 200kHz

To localize the damage, the ponderated ToA method mentioned earlier is used and pictured below. The time of flight corresponds to the time taken by the wave packet to travel from an actuator to a sensor along a given path. It is a feature extracted from the scattered signal that is used for damage localization purposes as it contains information related with damage position. More precisely, the ToA method ponderated using the CC damage index is used. It means that when adding up the ellipse corresponding to each path, they are weighted by the CC value corresponding to each path. In practice, ellipses having a high DI value count more than the one with a lower CC value in the final imaging results. Like the rest of the graphs shown before, the example of the plate with 1mm hole defect is displayed and the frequency sent by the piezoelectric 2 is 200kHz. As the picture below illustrates, the estimated localization damage (green diamond) is very close, if not superimposed, to the real localization of the damage (black "x"). This algorithm also provided correct localization results for the other damage sizes thus validating its effectiveness for corrosion-like damage monitoring.

To quantify the damage, the IPP damage quantification method was used as mentioned earlier. This method consists in computing a damage localization map and in extracting from this map the area above a given threshold (the yellow points in the above figure). When the damage size is increasing, this area is also very likely to increase and thus provide a reliable cue to damage size quantification. A polynomial regression between the area size and the actual damage size then allows to extrapolate to unknown damage sizes. A figure representing the estimated damage size versus the actual damage size is plotted. Only small damage sizes have been used for learning purposes and then the

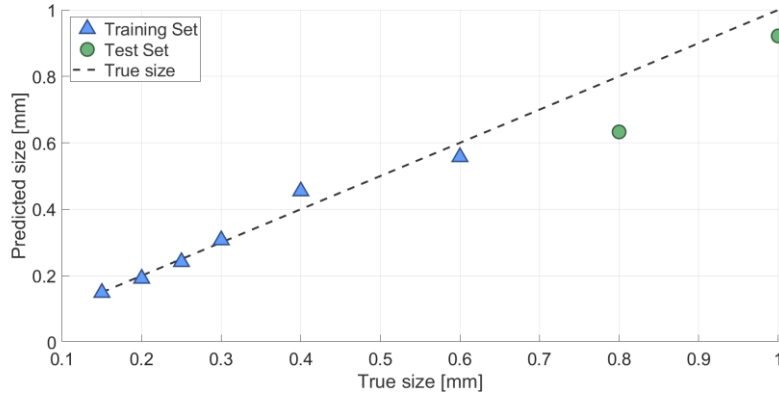
Figure 6 : Example of damage size quantification achieved by the IPP approach. The IPP algorithm has been trained on blue triangle and predicts sizes corresponding to green circles.

ability of the algorithm to extrapolate to larger damage sizes have been assessed. Points close to the diagonal line indicated correct damage size quantification. Learning points are shown in blue and prediction points in green. This example illustrates the fact that such algorithm is able to quantify correctly the size of corrosion-like damages.
