Jean-Eric MASSE, Agnès FABRE - Friction behavior of laser cladding magnesium alloy against AISI 52100 steel - Tribology International - Vol. 46, n°1, p.247-253 - 2012

Friction behavior of laser cladding magnesium alloy against AISI 52100 steel

A. Fabre*, J.E. Masse

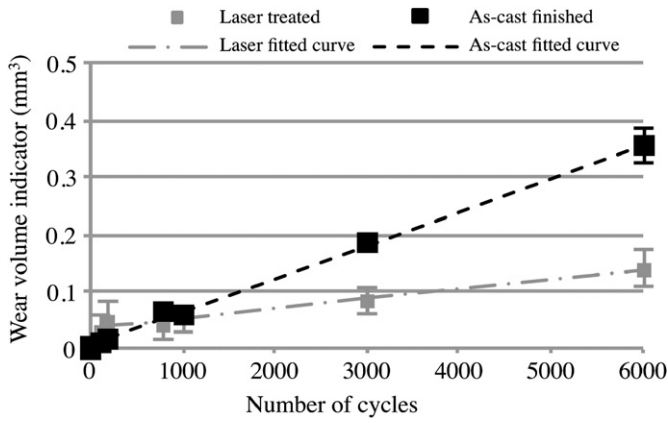
Fig. 5. Wear test results.

Fig. 5 allows us to compare the wear volume indicators after friction tests: analyses were conducted after tests of 10–6000 cycles. For short tests, values of wear volume indicator seem to be higher for the laser treated samples than those obtained for as-cast ZE41 samples. The wear process seems to be the same for the both types of samples: with an accommodation of the tribological system between 1 and 200 cycles of friction, in the case of laser treated ZE41. It seems happening only for few cycles, no more than 100, after test begin for ZE41. In this case the strong increase of wear informs about the accommodation of the contact zone in the friction system.

After the tests between 200 and 6000 cycles of friction, values of wear volume indicator present a linear evolution with the raise of the number of cycles: smaller slope, characterizing a stable wear regime. In Fig. 5, for as-cast ZE41 and laser treated ZE41, results are fitted by linear curves. Profiles of wear tracks on magnesium alloy samples have demonstrated that as-cast ZE41 surfaces wore much faster than laser treated samples after 1000 cycles of friction.

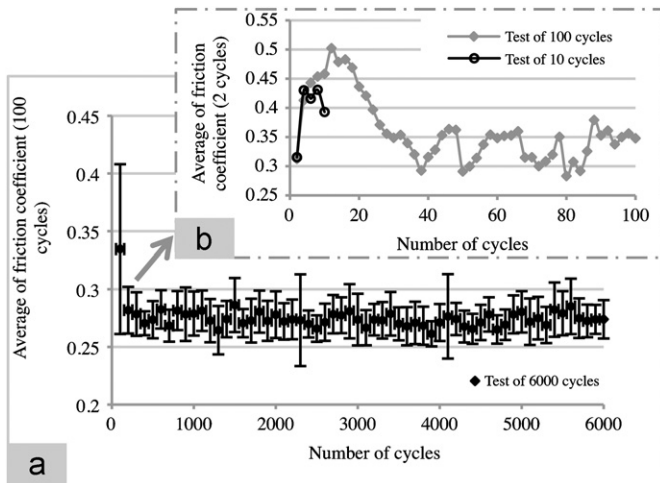
Fig. 7. Friction coefficient evolution: as-cast ZE41 (a) average values for 100 cycles on the test of 6000 cycles and (b) average value for 2 cycles on the test of 100 cycles.

In order to explain the wear process, analysis is conducted on the friction coefficient. Examples of friction coefficient evolution are presented in Fig. 7 for the steel ball sliding on the as-cast sample. In Fig. 7(a), the average value oscillates between 0.27 and 0.28, after 100 cycles until 6000 cycles. This value decreases slowly to the last value near 0.27. After the 20 first cycles, the friction behavior seems to be regular all along cycles between the cycle 22 and 6000. In Fig. 7(b), a main evolution can be observed on the first 20 cycles: after that stabilization appears near to the value 0.3. The accommodation contact zone seems to be realized in the 20 first cycles. The third body appears quickly after few cycles of friction. Some debris is ejected out of the sliding zone because of the reciprocating motion. Wear on the as-cast sample, then, seems to be regular to product third body in order to generate a weak friction coefficient: the accommodation of sliding speed between the ball and the sample on the contact zone is surely done by the movement of the grains of third body.
