Aliasghar BEHNAMGHADER, Reyhaneh Neghabat SHIRAZI, Alain IOST, Denis NAJJAR - Surface Cracking and Degradation of Dense Hydroxyapatite through Vickers Microindentation Testing - In: 2011 International Conference on Mechanical Materials and Manufacturing Engineering (ICMMME 2011), Chine, 2011-07 - Applied Mechanics and Materials - 2011

# Surface Cracking and Degradation of Dense Hydroxyapatite through Vickers Microindentation Testing

**Abstract.** Surface degradation and cracking of dense hydroxyapatite were evaluated through Vickers micro indentation using indentation loads ranged from 25 gf to 2000 gf. Crack lengths, print diameters and the number of lateral cracks and chips were measured using SEM. The crack length-indentation load data were analyzed with regard to the specific relations of Palmqvist and fully developed radial cracks. Crack type transition load from Palmqvist to median crack was experimentally assessed through serial sectioning technique. The analytical estimated transition load, based on the theoretical relation of the indentation load and crack lengths showed a good agreement with one obtained from experimental itinerary. Palmqvist and median cracks were iden

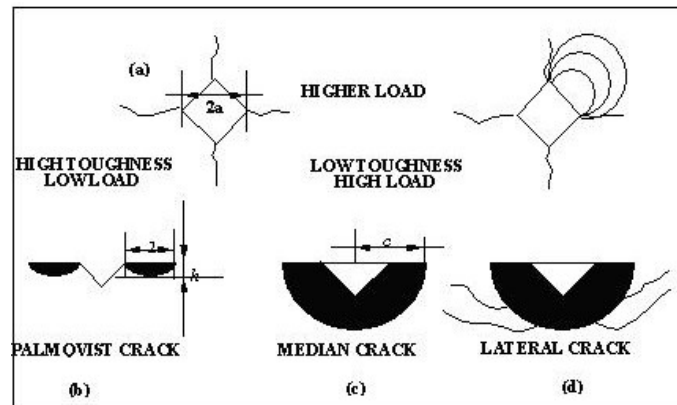
Figure 1: Different types of crack propagation produced by Vickers indentation: a) print diagonal length, b) Palmqvist crack c) median or half-penny crack d) lateral crack.

Calcium hydroxyapatite ( $\text{HA}, \text{Ca}_{10}(\text{PO}_4)_6(\text{OH})_2$ ) has attracted much attention as a substitute material in the preferred hard tissue replacement, especially as a coating in load-bearing orthopedic implants [1,2]. In general, the major limitation for structural applications of phosphate materials is the weak mechanical properties under cyclic fatigue loading in the tissue fluid environment, and inherently brittle nature of these materials [3]. These cyclic loadings can cause the formation of local cracks leading the strength degradation of device. A fundamental understanding of such behavior may be explored through the evaluation of fracture toughness of the material using an indentation test [4,5]. Among the crack system produced by indentation, two distinct types of cracks are formed in a perpendicular plane to the indented surface, radial cracks (Palmqvist and median), while lateral cracks appear underneath and remain parallel to the surface [6,7,8]. The lateral cracks could induce surface degradation of the material following chipping and material removal [9,10]. Different types of crack propagation produced by Vickers indentation is shown in Fig. 1.

Radial cracks could not lead to considerable surface damage compared to lateral ones. From the point of surface fracture view, median cracks are more critical than Palmqvist ones produced under very low contact loads. Considering the fact that median cracks are larger than Palmqvist ones and are formed under the higher contact load, material removal from outer surface locals could be more predictable [11,12]. These conditions are encountered in the wet sliding contacts (scratch and wear circumstances) for the HA-coated implants and bulk bone substitutes before osteointegration is achieved. The interfacial fracture might be accelerated by synovial liquid diffusion from the preprothetic environment to coating-substrate interface via median cracks and other material defects

[3]. After achieving adequate osteointegration, this is the lateral cracking which would take dominant role in deterioration of coating-substrate interface. Hence, it is reasonable to distinguish between Palmqvist and median and between median and lateral crack systems [13,14].

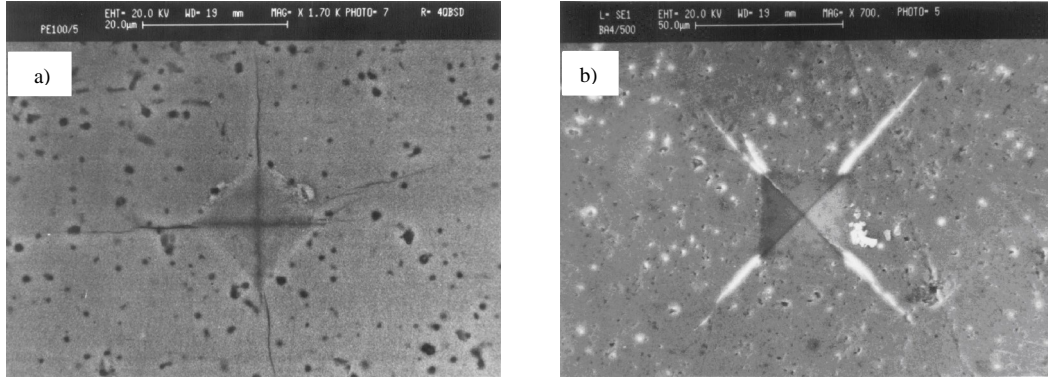
Figure 2: SEM micrographs of a) Palmqvist cracks formed at 100 gf b) Median cracks formed at 500 gf

Different cracks have been identified during SEM observation of indented samples. It consisted of Palmqvist, median and lateral cracks. Fig. 2 illustrates the Palmqvist and median cracks produced in relatively low indentation loads. As reported previously, a threshold load ( $P_t$ ) of around 34 gf can be estimated from the probability for crack apparition studies. Sequential polishing revealed that for  $P \leq 150$  and  $P \geq 200$  gf, the produced cracks were of Palmqvist and median types, respectively. The toughness values evaluated by median system-based equations were from 0.4 to 0.5 MPam<sup>0.5</sup>, whereas they were obtained between 0.8 and 1.1 MPam<sup>0.5</sup> according to Palmqvist system-based equations [15].

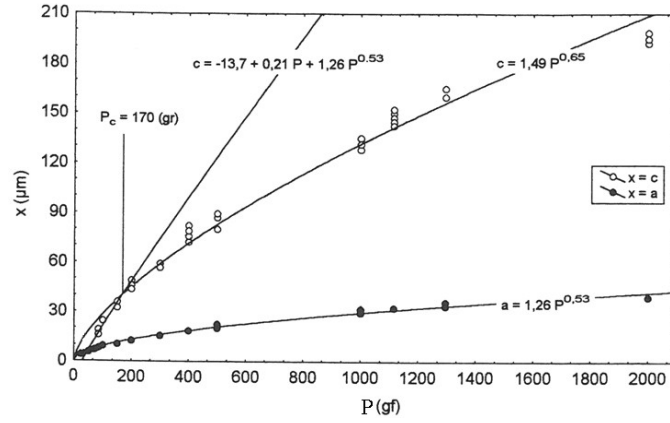
Figure 3: Comparison of the crack and load data with the prediction of Palmqvist crack model and median crack regime.

The Palmqvist to median crack transitional load ( $P_c$ ) obtained by intersection of (4) and (5) relations, is 170 gf (Fig. 3). This is in consistent with the experimental determination of the transitional load by serial sectioning technique which led to a value limited between 150 and 200 gf.

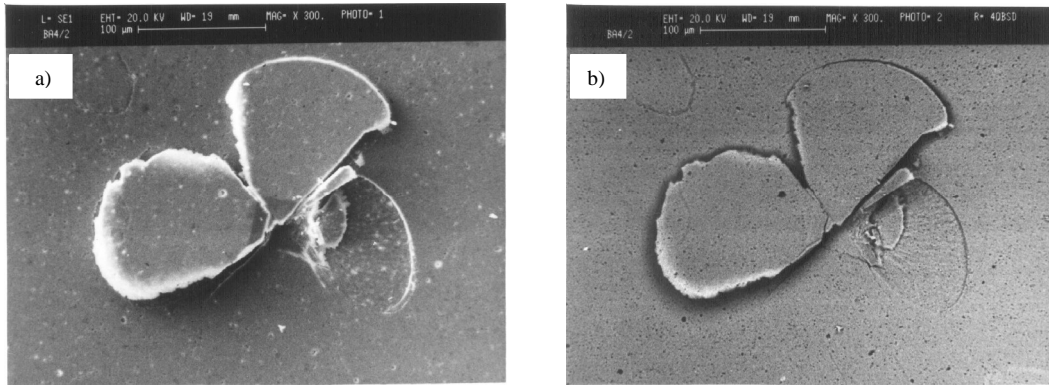
Figure 4: SEM images of two lateral cracks and one chip formed at 1000 *gf* a) SE mode  
b) BS mode

A transition load of around 200 *gf* was found between median and partial lateral cracking. Increasing load, more lateral cracks formed and some of ones produced the chips ejected due to continued extension of the lateral cracks toward the surface. Fig. 4 presents SEM micrograph of a print with three lateral cracking in the four quadrants.

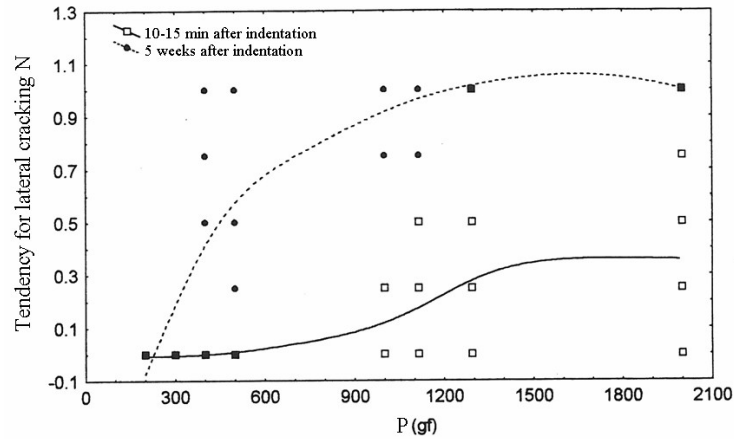
Figure 5: Tendency for lateral cracking as a function of indentation load

$N$  value varies therefore between zero for the absence of lateral crack and 1 if all quadrants are cracking. We considered  $N_{ss} + N_s = 1$  if two or rarely three or four cracks (at subsurface or surface) form, even partially in one quadrant. This equation could exactly imply the lateral crack numbers. Fig. 5 illustrates the calculated values of  $N$  as a function of indentation load between 10-15 min and 5 weeks after indentation. The figure clearly shows the increase of tendency for lateral cracks at high load. It could be seen that this increase is very significant at the first but a steady state situation would be established later. It is due to the exit of lateral cracks to the surface and resulting stress relaxation and crack cessation throughout the formation of chips.
