Andriy VASIN, Yuri GOMENIUK, Audrey RUSAVSKY, Alexey N. NAZAROV, V.S. LYSENKO, Petro M. LYTVYN, O.G. GONTAR, Sergii P. STARIK, S. ASHOK, Corinne NOUVEAU - Nano- and micro-scale morphological defects in oxidized a-SiC: H thin films - physica status solidi (c) - Vol. 10, n°4, p.619-623 - 2013

Nano- and micro-scale morphological defects in oxidized a-SiC:H thin films

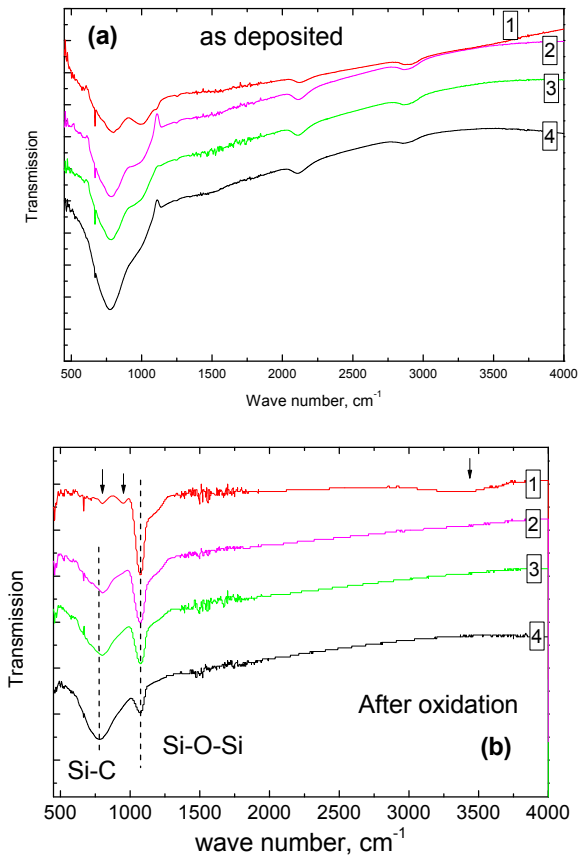
Figure 1 FTIR transmission spectra of as-deposited (a) and oxidized (550 °C) a-SiC:H samples deposited at RF-discharge power of 180 W (1), 200 W (2), 250 W (3), and 330 W (4).

FTIR transmission spectra of as-deposited and thermally treated samples are presented in Fig. 1. Spectra of as-deposited samples (Fig. 1(a)) are composed of four main absorption bands typical for a-SiC:H layers: 800 cm⁻¹ (Si-C stretching), 1000 cm⁻¹ (Si-C-H₂ bending), 2100 cm⁻¹ (Si-H_n stretching), and 2800–3000 cm⁻¹ (C-H_n stretching) [7, 8]. In the 1000–1100 cm⁻¹ region some contribution to the absorption due to oxygen contamination is expected.

It is evident from the figures that the principal effect of increase in discharge power is increase of the relative intensity of the Si-C related absorption band at 800 cm⁻¹, in comparison with the hydrogen related band at 1000 cm⁻¹. It can be interpreted as increase of the concentration of Si-C bonds and decrease of SiC-H_n associated mainly with hydrocarbon radicals in the nano-voids. Such interpretation is in good agreement with increase of the density of the films observed with increasing of discharge power.

The FTIR spectrum of the sample after oxidation in O₂ atmosphere at 550 °C is presented in Fig. 1(b). No Si-H_n (2100 cm⁻¹) and C-H_n (2900–3000 cm⁻¹) stretching vibration bands were detected after dry oxidation. In the spectrum of the sample deposited at lowest discharge power (i.e. lower density of the material) there are four pronounced absorption bands at 446 cm⁻¹, 805 cm⁻¹, 945 cm⁻¹, 1070 cm⁻¹ (with shoulder at 1200 cm⁻¹) all of which known to be related to oxygen bonds: Si-O-Si (symmetrical stretching), Si-OH (stretching), Si-O-Si (asymmetrical

stretching), and O-H (stretching) respectively. One can see that relative intensity of the main silicon-oxygen absorption bond (1070 cm⁻¹) is reduced as the density of the film increases.

In FTIR spectrum of this sample (Fig. 1, spectrum 1) we see only silicon oxide related absorption bands so we can say the a-SiC material is “completely oxidized”. IR absorption cross section of Si-C and Si-O bonds is different but of the same order. From the surface image we see that relative contribution of the volume of island-like regions is quite significant so that we can attribute the absence of the Si-C related absorption in FTIR spectra to the absence of corresponding a-SiC material. Basing on this suggestion we can attribute island-like regions to carbon-enriched highly defective SiO(x) structural fragments.
