Kheireddine BOUZID, Nasser Eddine BELIARDOUH, Corinne NOUVEAU - Wear and Corrosion Resistance of CrN-based Coatings Deposited by R.F Magnetron Sputtering - Tribology in Industry - Vol. 37, n°1, p.60-65 - 2015

Wear and Corrosion Resistance of CrN-based Coatings Deposited by R.F Magnetron Sputtering

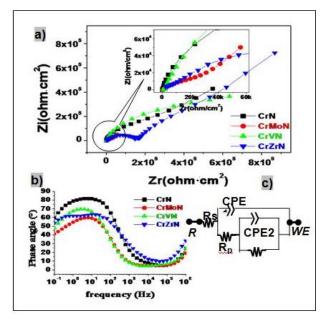
In order to investigate the corrosion performance of PVD hard coating, it was well-known that EIS has found its efficacy [6]. The different shapes of the curves in Nyquist diagrams are obtained as shown in Figure 2(a). The CrZrN coating presents the best corrosion resistance followed by the (CrVN).The CrMoN presents the lowest corrosion resistance. This result confirms the data obtained by potentiodynamic tests (Table 2). In addition, all of the Nyquist plots show two time constants, with a capacitive loop of smaller diameter followed by another capacitive loop of larger diameter. Bode plots of the phase angle as a function of the frequency shown in Fig. 2(b), confirm that the Nyquist's data.

Fig. 2 AC impedance measurements of the coated samples (a) Nyquist impedance diagrams(insert image shows the Nyquist plots at high frequencies), (b) Bode plots and (c) the equivalent circuit model.

From the above mentioned result, it is confirmed that there are effectively two time constants in the experimental frequency bandwidth. Consequently the EIS data indicates the existence of two different interfacial reactions which can be related to the coating/solution interface and substrate/solution interface respectively.

The experimental results are interpreted via developing typical impedance models for electrode surfaces and curve-fitting on the basis of an equivalent circuit using Zview impedance program. A circuit model was proposed to ascribe two sub-electrochemical interfaces generally used in such case [7].

The equivalent circuit (Fig. 2 (c)) consists of the following elements: Rs corresponds to the solution resistance of the electrolyte test between the working electrode (WE), and reference electrode (RE). CPE1 and Rpo elements are used in parallel to replace the coating dielectrics properties. CPE2 and Rct in parallel are adapted to describe charge transfer at the coating/substrate interface. Results of fitting values obtained by equivalent circuit simulation of different coating configurations indicate that the CrZrN coating has lower CPE1 value and higher charge transfer resistance. On the other hand, the total polarization resistance

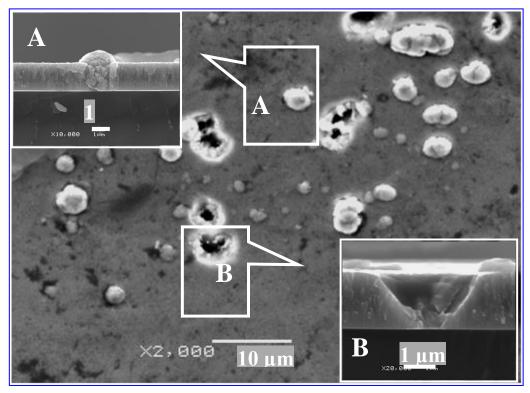
Figure 3 presents an example of the surface morphology of the CrZrN coating after 24 h of immersion and potentiodynamic test measurements in a 0,3 wt. % NaCl solution. SEM images can prove that selective corrosion occurs at growth defect sites. According to Lewis et al. [10], a droplet is compositionally metal rich and nitrogen deficient; this defect is anodic with respect to both surrounding coating. It is obvious from Fig. 3, that the corrosive attack occurs with the ejection of droplets (insert image A in Fig. 3) from the coatings which creates a crater (insert image B) at its surface, resulting in direct contact with the substrate.

Fig. 3. SEM micrographs of CrZrN surface. Corrosion damage after potentiodynamic polarisation test; Insert images: cross section view (A) showing droplet and crater in (B).

When compared to similar CrN based coatings, as reported in other works [7-9], our study indicates that all of coatings present better behavior against aggressive chloride ions (Cl⁻). It can be concluded that the different electrochemical behavior may be associated with their different surface defect densities. Our results confirm the remarkable resistance against corrosion in NaCl solution, of CrZrN obtained by Zhang *et al.* [11]. The authors conclude that the additions of Zr into CrN coatings improved their chemical inertness and the corrosion mechanism was due to the slight pitting corrosions, which were mainly localized in the growth defects.

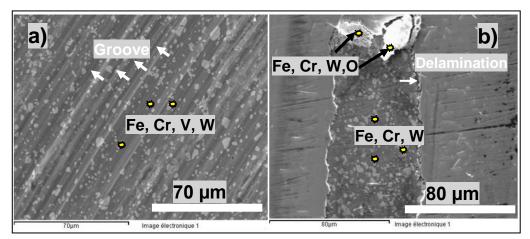
Figure 5 shows the wear scar of CrN and CrVN coatings as an example of SEM observations. The main difference is the fact that plowed grooves along the sliding direction are found on the wear tracks of CrVN, as well as CrMoN and CrZrN as presented in Fig. 5(a).

Fig. 5. SEM micrographs of wear track observed on (a) CrVN and (b) CrN when sliding against WC balls.

The wear scar of the tested ternary coatings shows abrasive marks, pits and excess wear debris. Consequently, the three-body abrasive wear was the dominant wear mechanism as reported by M.S. Priyan *et al.* [14].

No grooves and no scratches are shown inside the CrN wear scar. EDX analysis of wear tracks of ternary nitride coatings reveals the presence of coating's elements (Cr, V, Mo, Zr, N), elements of substrate (Fe) and elements of the counterpart (W). The presence of tungsten is a sign of an adhesive wear. On another hand, absence of oxygen (O) indicates that the wear track is free of oxide. Consequently, the wear mechanism of the ternary coatings seems to be a combination of abrasive and adhesive wear.

In the contrary, SEM investigations of the worn surface of CrN, Figure 5(b), reveal the presence of oxygen (O), in the middle of the wear scar. Consequently the CrN coating suffers a combination of adhesive and delamination wear. It can be noticed that the presence of debris (wear product) inside de wear track can act as a solid lubricant by rolling, and thus reducing the friction. We consider that is the reason why CrN presents lower COF evolution than other ones.
