Effect of Forestry Management and Veneer Defects Identified by X-ray Analysis on Mechanical Properties of Laminated Veneer Lumber Beams Made of Beech

Joffrey Viguier, Bertrand Marcon, Stéphane Girardon, and Louis Denaud

Keywords: LVL; X-ray; High forest; Coppice; Mechanical properties; Beech

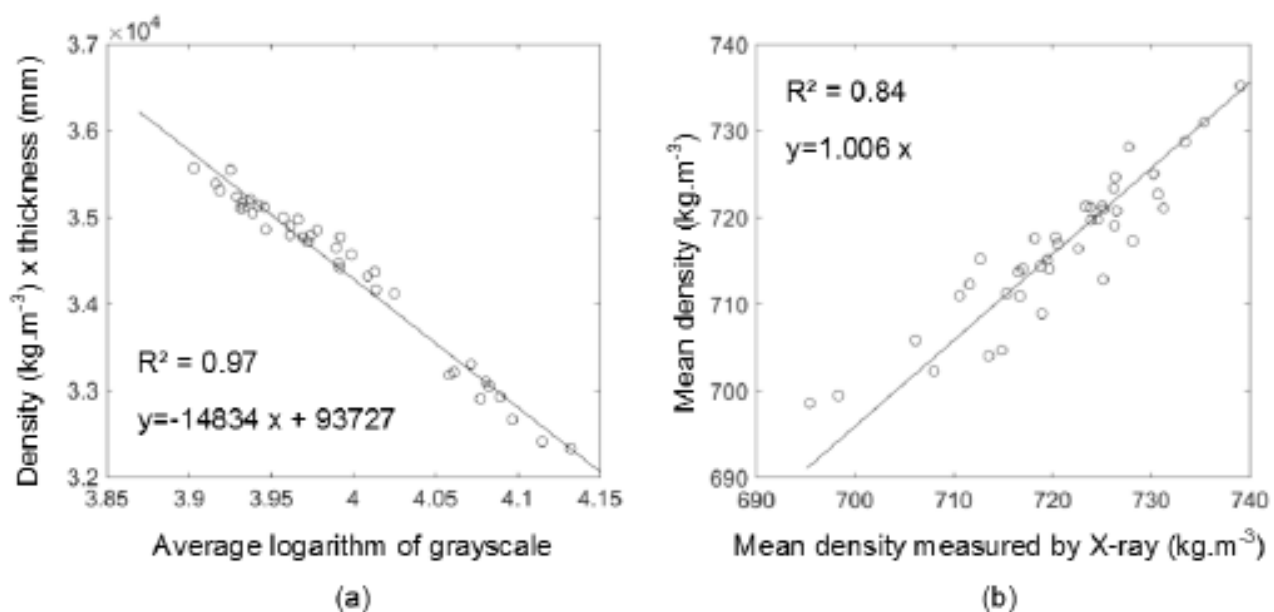
Fig. 5. (a) Results of the calibration process and (b) comparison between average density measured by X-ray and the average density measured by weighing

The results of the calibration process are presented in Fig. 5(a). The average density obtained by measuring and weighing the boards was close to the average density measured by X-ray scanning (Fig. 5(b)) for each beam, which highlights the high accuracy of the X-ray method. Indeed, the coefficient of determination had a value up to 0.84 and the root mean square error was equal to 5.6 kg/m^3 .

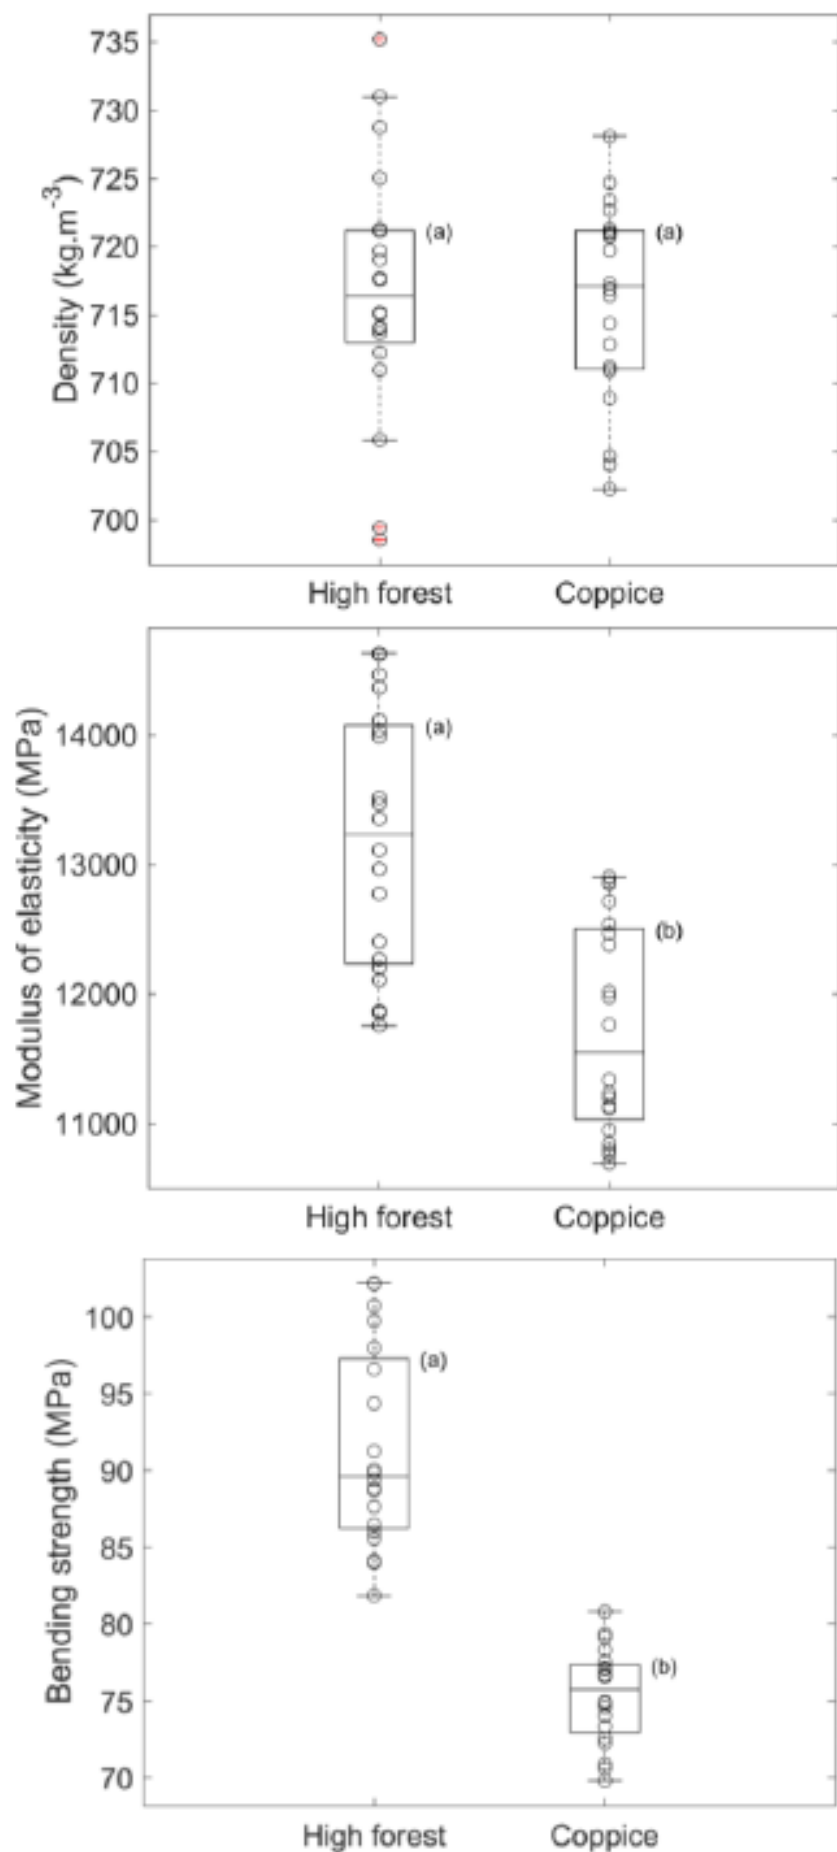
Fig. 6. Influence of the silvicultural practice on the density, the modulus of elasticity, and the bending strength of LVL beams ($n = 40$)

The physical and mechanical properties of the LVL beams produced from wood harvested in high forests and coppice forests are compared in Fig. 6. The p-value of the one-way ANOVA on the density was equal to 0.80; therefore, the difference in terms of density for both practices could not be statistically stated. The average moduli of elasticity were approximately 13,200 MPa and 11,700 MPa for LVL beams made of high forest and coppice forest wood, respectively. The modulus of elasticity for the beams made from coppice wood was on average 11.3% lower than that of beams composed of high forest wood ($p = 9.10^{-6}$). Finally, the same tendency was observed concerning the bending strength, where the difference was 17% ($p = 3.10^{-12}$).

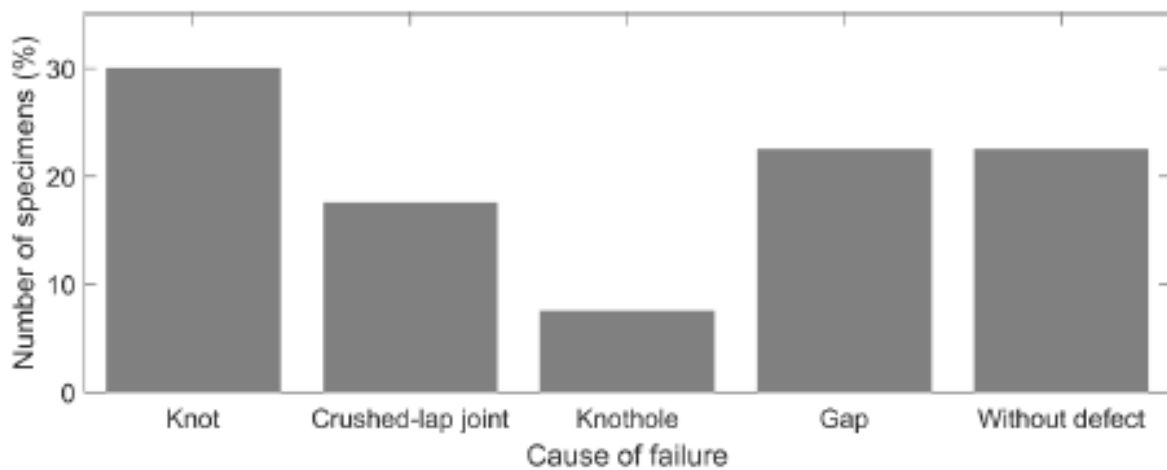
Fig. 7. Distribution of the causes of failure for the 40 beams

The distribution of the failure origins observed on the 40 beams is presented in Fig. 7. In 37.5% of the cases, the failure was due to the presence of a knot, including 30% of knots and 7.5% of knotholes. In 40% of the cases, the failure was due to a defect caused by the manufacturing process; among them, 17.5% were due to crushed-lap joints and 22.5% were due to a gap in the joint. It appeared that the defects involved in the failure were nearly evenly divided between defects resulting from the manufacturing process and those resulting from the innate wood defects. In 22.5% of the cases, the failure occurred in an area where no defect was discernible on the density map. Within these 9 beams, where no defect has been observed, 6 were made from high forest wood and 3 from coppice forest; furthermore, the respective average bending strengths of these two groups were 97 MPa and 80 MPa, respectively. Aside from the influence of the defects, LVL beams made from high forest wood exhibited higher intrinsic mechanical properties than the ones made from coppice wood. Those results only highlighted the distribution of causes of failure but did not indicate the impact of these defects on the bending strength.

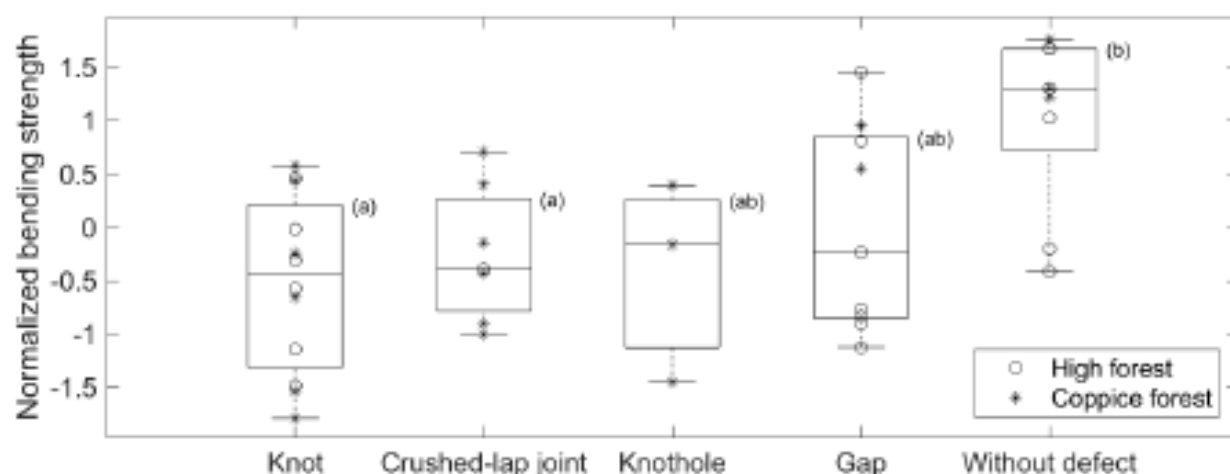
Fig. 8. Bending strength versus the identified causes of failure

Due to the statistical differences in the bending strength observed for the two different forestry management systems, the bending strength was normalized according to the wood origin to be able to compare the influence of each considered defect. This normalization consisted of subtracting the average bending strength over the whole population from the bending strength of each type of wood and then dividing this difference by the population standard deviation. In this way, the effect of the different defects on the bending strength for all samples was compared (Fig. 8).

The analysis of variance (at a significance level of 5%) showed that the average bending strength of the beams with the knots and crushed-lap joints were statistically different from the average bending strength of the beams without any defects. The structural disruption of the layers around the crushed-lap joint (Fig. 4c) may have caused weakness in the cross-section and may have been responsible for the global failures. When the failure was due to the two other types of investigated defects (knotholes and gaps between sheets), there appeared to be no statistical differences between the failure due to their presence and the failure of neat beams. This analysis showed that defects caused by the manufacturing process may have had a similar influence on the bending strength as the innate wood defects.
