8th CIRP Conference on High Performance Cutting (HPC 2018)

On the optimization of the cutting conditions for an improved corrosion resistance of OFHC copper

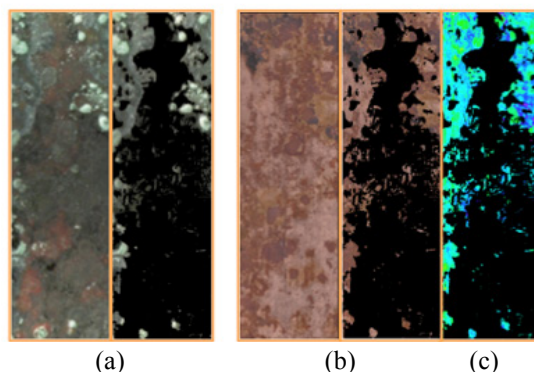
Fig. 1. Evaluation of the volume of copper dissolved by mm^2 covered by atacamite.

oxidation reaction per mm^2 covered by atacamite (the green color) was quantified. In fact, the oxidized surface was taken in photo by a high-resolution microscope *KeyenceTM*. Then, the surface was cleaned from oxides and taken again into photo. The topography was measured by optical microscope *AliconaTM* using the variation of focal distance technique. The volume of *OFHC* copper that disappeared from the oxidized surface was calculated by treating automatically the images under *Matlab[®]* (cf. Figure 1) using a script developed for the study making the following tasks:

- Isolation of green zones (covered by atacamite) starting from a photo of the oxidized surface as shown in Figure 1a.
- Starting from the image of the cleaned surface, isolating topographies of zones corresponding to those covered by green before the cleaning as shown in Figure 1b.
- Visualization of the topography corresponding only to the filtered zones as shown in Figure 1c. Level 0 corresponds to the mean plan of the freshly machined surface, before the aging test ($R_a < 800 \text{ nm}$).
- The program calculated the volume of copper that has removed (valleys) under the zones previously covered with atacamite, and divided it by the green analyzed surface, which gave a mean value of the depth of the dissolved substrate.

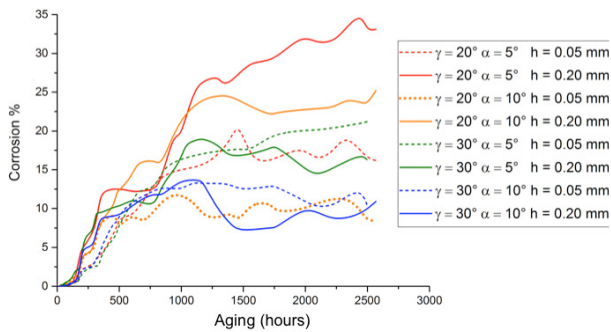
Fig. 2. Corrosion evolution under saline atmosphere for surfaces obtained by orthogonal cutting at $V_c = 90$ m/min.

Figure 5 shows a non-negligible influence of the cutting conditions in on the evolution of the corrosion of *OFHC* copper surfaces, especially after 700 hours. under saline atmosphere. In fact, for the surfaces generated with a tool having the same rake angle of 20° , a raise in the uncut chip thickness accelerates the corrosion (cf. Figure 2). Nevertheless, this phenomenon is not seen when the rake angle is 30° where the uncut chip thickness seems to have no influence. On the other side, whatever the rake angle and the uncut chip thickness are, the raise of the flank angle from 5° to 10° shows a better influence on corrosion resistance. As observations are not enough to reveal the existing relationships between the cutting conditions and corrosion resistance, further analysis is needed to reveal their impact on the surface integrity responsible for this behavior.

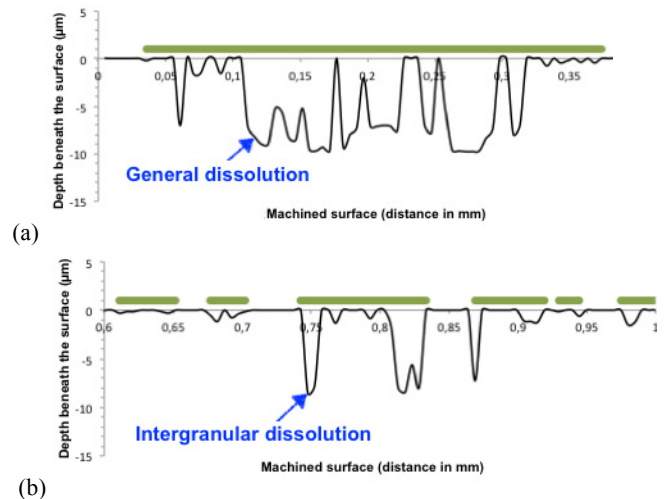
Fig. 4. Profiles under the green zones for surfaces obtained by the conditions $\gamma = 30^\circ$, $\alpha = 5^\circ$, $h = 0.2$ mm and $V_c = 90$ m/min. Part of the analyzed profile presenting generalized dissolution (a) and intergranular corrosion (b).

A unidirectional profile measured in the oxidized region was taken from every analyzed surface to identify the shape profile under the oxide. It was measured only under the green areas (represented by the green lines in Figure 4 as an example). The used in-depth resolution is 78 nm and the horizontal resolution is 5 μm . According to the obtained profiles, it is remarkable that under the green areas two types of cavities can prevail: large cavities with plate valleys (corresponding to generalized dissolution, cf. Figure 4.a) and thin and deep cavities (corresponding to intergranular corrosion cf. Figure 4.b) in the borders of the green area.

The cavities depth varies under the surfaces covered by the green oxide, what witnesses a non-uniform dissolution happening on the same surface. These observations under the oxides allow the corrosion process analysis explaining the surface damage in the presence of saline atmosphere as follows [12]. Inside the droplets, copper dissolution leads to the formation of the ions Cu^+ or Cu^{2+} in aqueous solution. Associated to anions Cl^- already present in the droplet, they constitute the green compound CuCl . With high chloride concentration, they can even produce the ions of CuCl_2^- . On the other side, cations Cu^{2+} can be hydrolyzed to form atacamite $\text{Cu}_2(\text{OH})_3\text{Cl}$. This reaction, consuming molecules of H_2O , produces protons H^+ , decreasing the pH. As the droplet stagnates in the surface, the pH diminishes with the generation of atacamite. A previous study [11] has demonstrated that pH lower than the limit of copper dissolution can be rapidly reached leading to a generalized dissolution and to intergranular corrosion. The electrons issued from the dissolution reduce the oxygen inside the droplet. As the solubility of oxygen inside water is high, the cathodic reaction continues, and the dissolution evolves into cavities. Then, what makes a machined surface more active than the other just by manipulating the cutting conditions?
