# A competition between the contour and hatching zones on the high cycle fatigue behaviour of a 316L stainless steel: Analyzed using X-ray computed tomography

Keywords:
Powder bed fusion
Laser
Austenitic stainless steel
Fatigue
Defect
Pore

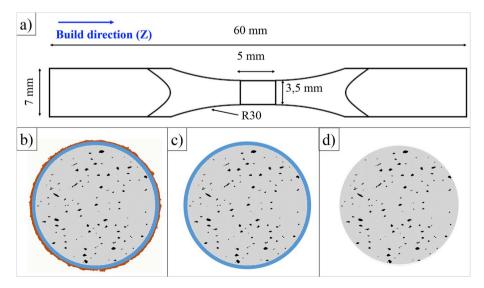
Fig. 1. a) Fatigue sample plan with as-built dimensions b) as-built gauge section drawing after fabrication, (c) gauge section after grinding and (d) gauge section after turning. Orange is the rough surface of the contour, the rest of the contour layer is in blue, and hatching pores are indicated in black. (For interpretation of the references to colour in this figure legend, the reader is referred to the Web version of this article.)

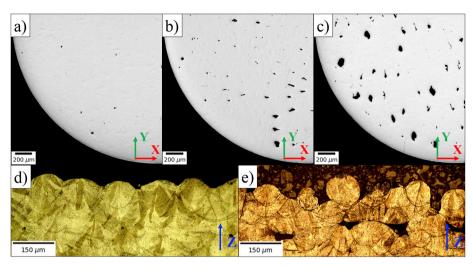
Fig. 2. a), b), c) Optical micrographs in the building plane (X–Y) of respectively samples from set A, B and C. d), e) Optical micrographs taken along the building direction Z after etching of sample from sets A and C respectively.

As shown in Fig. 2a)-c), the majority of the defects are lack-of-fusion with irregular shapes. Some of the rounder smaller defects, more noticeable in sample A Fig. 2 a), are assumed to have originated from residual gas in the powder or humidity. As expected, the biggest pores were obtained under the highest scanning speeds, for which the melt pool width and depth were slightly reduced, thus reducing the bead overlap. Additionally, excessive speeds can induce Rayleigh instability [43] that makes melt pools irregular in shape. Small variations in width or height at high scanning speeds will then cause the melt pools to spheroidize locally under the capillary pressure, and induce more lack-of-fusion defects than at lower speeds, as illustrated in Fig. 2d) and e).

The X-ray computed tomography scans of the fatigue samples prior testing show the same trend, with sample C having the highest amount of porosity, as seen Figs. 2 and 3. On the one hand, those defects are distributed randomly and homogeneously in the bulk volume. On the other hand, as observed on the micrographs Fig. 2a)–c), a near-zero porosity density is evidenced within the contour zones on the computed tomography scans Fig. 3a)–c), regardless of the hatching conditions.

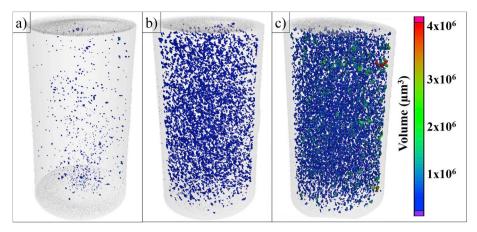
Fig. 3. Reconstructed CT with pore volumetric analysis of a) Sample A7, b) Sample B5, c) Sample C2. Cylinder diameter is 3.3 mm with a 6.5 mm height.

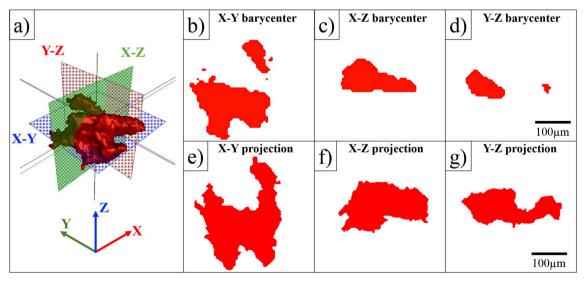
Fig. 4. a) 3D reconstructed pore with projection planes at barycentre, b) c) d) area projected along the three main planes at the barycentre of the defect, e) f) g) total area projected along the three main planes outside of the defect.

Romano et al. [40] described several ways to assess the porosity size distribution extracted from computed tomography data such as (1) using the cubic root of the volume of each defect or (2) using the square root of its projected area on a reference plane. However, the area extracted from a pore in 3D will be larger than the area obtained with 2D

methods. First, one large interconnected pore can appear as a group of smaller pores in two dimensions, thus reducing the measured size of the largest pore in 2D. Additionally, the observed area of a defect in 2D along a plane is always inferior or equal to the projected area of the same whole 3D defect along the same plane. Using the square root of the projected area will often yield dimensions larger than the ones deduced from 2D observations. An example of this difference is illustrated Fig. 4 for the 3 main projection planes. The 3D pore population is characterized using the square root of the measured area on the XY plane (Fig. 5 b) and c)) as an equivalent diameter. This approximation yields to the highest porosity diameter values and enables better discrimination between porosity rates in SLM. Fig. 4 also confirms that lack-of-fusion defects are usually larger on the plane perpendicular to the building direction (X—Y plane) than on other projection planes, as observed in Ref. [40].

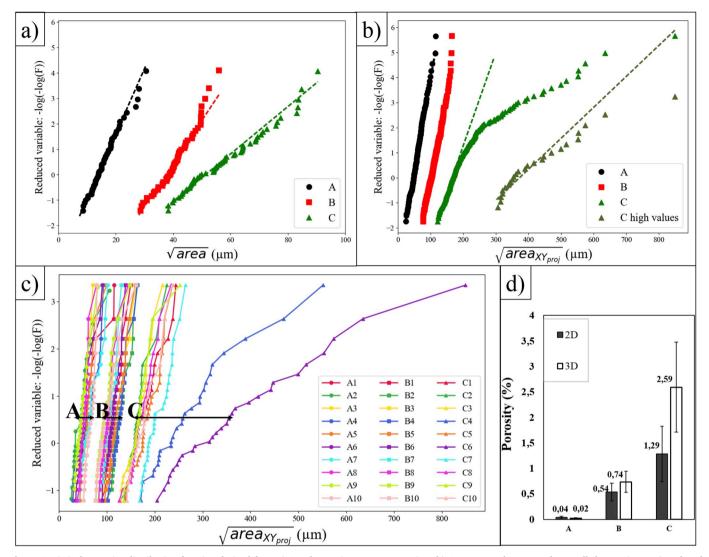
Fig. 5. Statistical pore size distribution function derived from a) 2D observations on cross sections b) 3D computed tomography on all the specimens c) Reduced variable plot from computed tomography data for each specimen d) Porosity amount derived from analysis of optical images and volumetric data.

The size distribution of the samples measured in 2D and 3D, along with their associated Gumbel fit in dotted lines are displayed Fig. 5a) and b). The trend between the sets is in accordance with the optical observations Fig. 2a)–c). The largest defects in the set C correspond to the flattest curves (highest  $\beta$ ) with the highest offset along the  $\sqrt{area}$  axis (highest  $\lambda$ ). This indicates a higher probability to encounter large defects, along with a more scattered defect size distribution, among the largest defects in the subsurfaces (Fig. 5 a)) or subvolumes (Fig. 5 b)) chosen. The size distribution probability of each sample measured in computed tomography is shown Fig. 5 c) and the areal and volumetric porosity extracted from 2D and 3D datasets are presented in Fig. 5 d). From the porosity measurements and observations from the literature for similarly porous 316L samples fabricated with SLM [12], little to no variation between sets is expected in their yield strength or ultimate tensile strength.

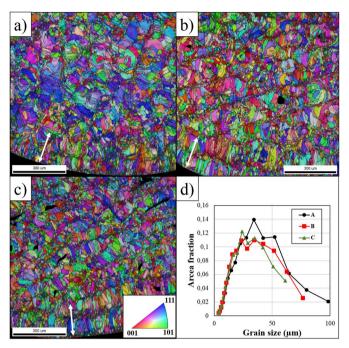
**Fig. 6.** a) Sample A Indice Pole Figure (IPF), b) Sample B IPF, c) Sample C IPF on the fabrication plane. d) Grain size histogram for the three samples. White arrows indicate the contour, grains are outlined in black for a  $15^{\circ}$  orientation difference. Dark zones inside the microstructure are lack-of-fusion pores.

EBSD measurements were carried out post mortem on fatigue samples XY planes (Fig. 6) to analyse possible microstructural

differences that could impact fatigue properties. The average grain size measurements was shown to be 34  $\pm$  22  $\mu m$ , 29  $\pm$  18  $\mu m$  and 27  $\pm$  15  $\mu m$  for respectively sets A, B and C. In the rest of the study the grain size will be therefore considered equal for the three different batches. The contour microstructure is visible from the difference in grain morphology and measures more than 100  $\mu m$ , in full accordance with the illustrations in Fig. 1b) and c). The grains in the contour are smaller and oriented towards the center of the specimen, which is perpendicular to the laser scanning direction, as expected for high scanning speeds [44]. No specific grain alignment is observed in the hatching area, as the laser scanning direction is rotated at each fabrication layer.

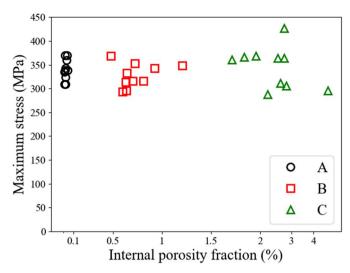
Fig. 7. Variation of Maximum stress (MPa) with internal porosity fraction (%).

The results of the fatigue tests (Fig. 7) show the recalculated final maximum stress compared to the porosity amount measured in computed tomography. Most of the fatigue limits at  $10^6$  cycles fall between 300 and 400 MPa, which correlates well with the results of Zhang et al. [12] for 316L samples tested in the identical conditions and fabricated using good SLM parameters. While results from the literature show that the porosity rate can impact fatigue properties for SLM + post-machining 316L samples with open porosities [46], no clear impact of the internal porosity rate (between 0.02% and 2.7% in volume) or defect

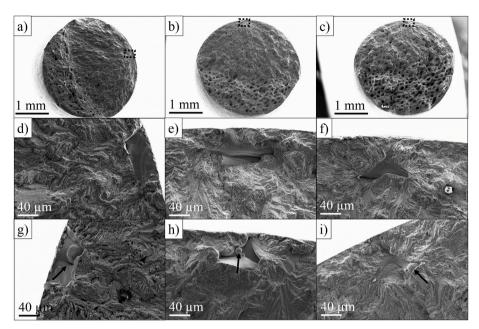
Fig. 8. Fracture surfaces of a) Sample A7, b) Sample B2, c) Sample C7. d), e), f) Enlarged views of initiation sites in the black boxes in respectively a), b), and c). g), h), i) Mirror fractures surfaces of images d) e) f) respectively. Black arrows indicate unmelted or partially melted particles.

The SEM fracture surfaces (Fig. 8) show crack initiation sites located near the surface of the samples for the three different sets. Those cracks initiated at the edge of one specific open pore at the surface before becoming the main propagation cracks. Few multiple crack initiation sites have been observed and the position of the critical pores can be clearly identified by following the typical river patterns.

Those pores are located within the double contour and their  $\sqrt{area}$  is between 40 and 110 µm, with an average circularity of 0.5  $\pm$  0.2. They are shallow, have sharp angles and are flat on one side, while the other side is more tortuous with some unmelted particles as indicated in

Fig. 8d)-i), which suggests lack-of-fusion porosities. The large number of pores evidenced in the bottom part of Fig. 8b) and c) are irregular lack-of-fusion pores that became round during the plastic final failure phase.

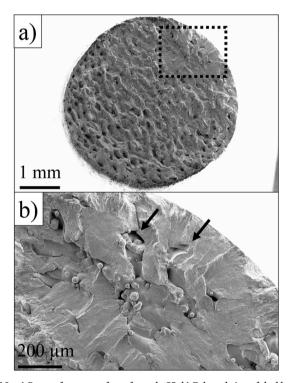
**Fig. 10.** a) Bottom fracture surface of sample C5, b) Enlarged view of the black box in a). Critical pores are indicated by a black arrow.

A subsurface crack initiation in the hatching zone was only observed in sample C5 (Fig. 10). The pores at the origin of the crack initiation are believed to be the ones indicated by the black arrows in Fig. 10 b). Those two pores are likely to have interacted with one another, during the crack initiation, as defined by the neighbour proximity limit

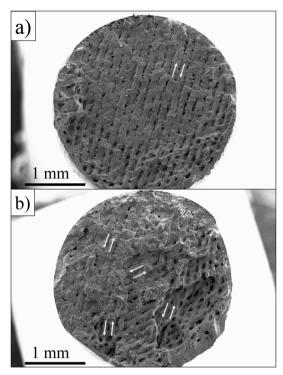
**Fig. 11.** a) Bottom fracture surface of sample C4, b) Bottom fracture surface of sample C6. The white arrows indicate the melt pool scanning directions at one or several fractured layers.

The samples C6 and C4 showed particularly low fatigue performances as their rupture occurred during the first and second loading step (300 and 320 MPa) respectively. As illustrated by Fig. 11, no specific initiation site was shown on a contour pore. The fracture surfaces show that a complete delamination occurred at one or several layers, all comprising a high amount of porosity. Large linear lack of fusion pores are clearly visible between the melt pools lines

on Fig. 11 a), indicated by white arrows. Several lines of lack-offusion with different orientations are visible on Fig. 11 b) between the melt pools created at different scanning angles, as fracture occurred at several heights.

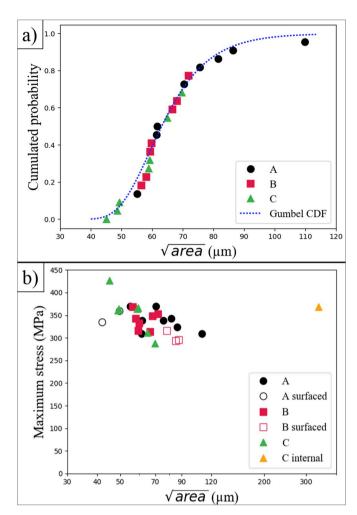
**Fig. 12.** a) Critical defect size on the three sample sets with Gumbel cumulative distribution function fit, b) Kitagawa diagram of all the samples.

The critical defect dimensions of the 22 samples where the crack initiated in the contour zone have been reported on a probabilistic plot (Fig. 12 a)). The  $\sqrt{area}$  distribution of the three sets follows correctly the probabilistic distribution described by Gumbel cumulative distribution function in Eq. (1). One can deduce that as the different sets have complementary critical defect dimension distribution, they can be considered in a single distribution. It is well confirmed on the Kitagawa diagram (Fig. 12 b)) that the global fatigue properties of samples from sets A, B, C are mostly driven by the critical defects dimensions, and not the porosity distribution in each sample. It was indeed shown Fig. 7 that porosity was not impacting the fatigue life at 10<sup>6</sup> cycles. By combining the results from all the sample sets, despite their differences in internal porosity amounts, a global decrease in fatigue performances is observed with increasing critical near-surface pore size. The presence of internal subsurface pores appears far less detrimental on the fatigue performances, as mentioned by Beretta and Romano [48]. The only subsurface crack initiation evidenced occurred on a pore cluster with a  $\sqrt{area}$ value of more than 380 µm, with fatigue performances similar to the 50-90 µm range for surface pores (orange triangle in Fig. 12 b)).

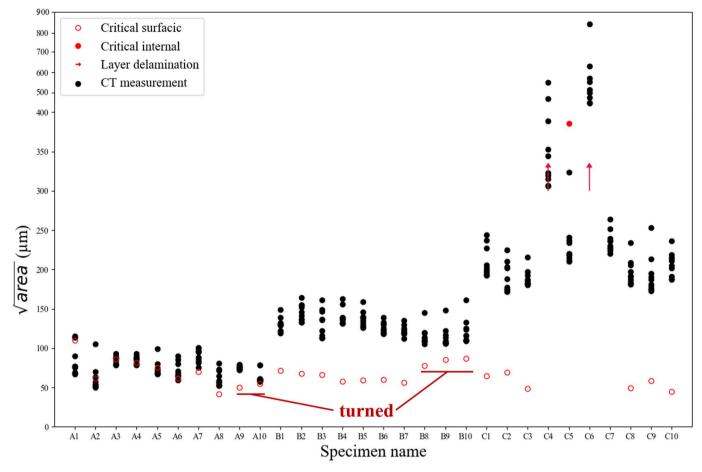
Fig. 13. Dimensions of the largest ten defects detected by computed tomography and of the critical defect measured post mortem.

Fig. 13 compares  $\sqrt{area}$  values on the XY plane of the 10 largest defects detected in computed tomography with the critical defect  $\sqrt{area}$ identified in the post-mortem analysis. Comparison of the average defect sizes is summarized Table 5. Interestingly, for set A of ground and polished specimens, the ratio between the critical defect size and the average internal defect size among the 10 largest defects detected in computed tomography is very close to 1. This ratio rises to 2.1 and 3.6 for sets B and C respectively, showing that despite very large internal pore distribution, the fatigue properties are still driven by the small surface pores. It has been well observed in high cycle fatigue that internal defects are less harmful than surface defects. The internal defects are known to drive fatigue properties at lower stresses in very high cycle fatigue at 10<sup>7</sup> cycles and above [49]. In high cycle fatigue, the different defect sensitivity between surface and core can be attributed to different origins: mechanical effect, environmental effect and microstructural effect. Stress concentration is known to be higher at or close to the surface, and is at the origin of the stress intensity factor equations developed by Murakami [50] for internal and surface defects of any shape. The deleterious impact of air on the fatigue properties is mostly attributed to hydrogen embrittlement in steels [51]. Lower fatigue performances in air compared to vacuum have been observed in

Table 4 shows a noticeable drop in fatigue performances for the turned samples B8 to B10. On the contrary, the endurance limit of the turned samples A9 and A10 did not drop compared to the other nonturned sets. From Fig. 13, it can be observed that the critical defect dimensions after turning are not modified for set A, but increased for set B. The hatching defects dimensions that became connected to the surface in both sets correspond indeed to the respective defects population characterized in 2D and 3D. The  $\sqrt{area}$  plots indicated a 20–120 µm range for set A and 80–170 µm range for set B. As a result, the hatching defects of set A that became connected to the surface have dimensions similar to the lack-of-fusion defects located in the double contour. As the hatching defects in the set B were larger, the defects connected to the surface after turning had higher dimensions than most of the other critical defects in the contour. This resulted in a lower fatigue

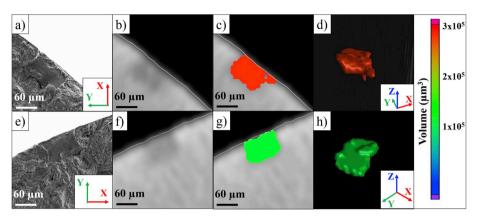
Fig. 14. a) b) c) d) Critical pore in sample B4 observed with and SEM, after computed tomography reconstruction, pore detection, and 3D rendering respectively. e) f) g) h) Critical pore in sample B5 observed with and SEM, after computed tomography reconstruction, pore detection, and 3D rendering respectively.

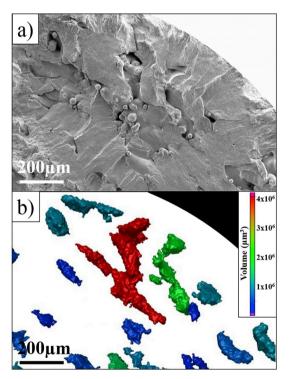
**Fig. 15.** a) Crack initiation area on Sample C5, b) 3D visualization of the projected area of the defects in the same zone in computed tomography at the same magnification.

Subsurface crack initiation occurred on a cluster of pores that was observed before fatigue testing on the computed tomography measurements. The red pore in Fig. 15 b) was measured to have the highest projected area on the XY plane along with the highest volume. It likely interacted with the green pore that is comprised among the ten largest pores.

As the exact origin of crack initiation cannot be established, and considering the vicinity of the two main pores, it is likely that they interacted together. The total  $\sqrt{area}$  was measured at roughly 380 µm, thus showing a high threshold for subsurfacic crack initiation to occur.

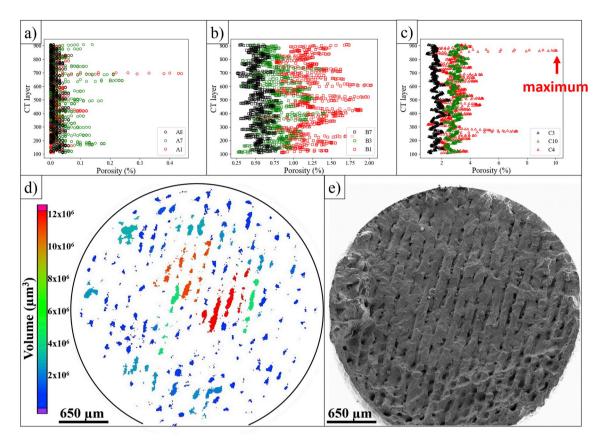
Fig. 16. a) b) c) Porosity ratio at each computed tomography layers for three samples in each sample set (A, B, C respectively). d) 2D visualization of the defects in sample C4 computed tomography at the position of the maximum porosity layer e) Bottom half of the fracture surface in sample C4.

an optical method. However, using this method, it is possible to assess the porosity variability inside each sample. Maximum, average and standard deviation of the layer porosity are displayed Table 4. The slice porosity has been plotted for the three experimental sets in Fig. 16a)-c). The 3 samples in each set were chosen to illustrate low, average and high porosity distributions. All analyzed samples show highly variable layer porosity along the building direction, without clear physical explanation for the occurrence of local porosity peaks in the samples. In the set A, high porosity peaks can be observed on some samples such as A1. As the porosity rate remains low, the occasional and random presence of a few pores can drastically modify the porosity rate. In the set B, some variation in porosity between samples have been evidenced but no correlation between the layer porosity and fatigue properties or failed layer was found. In the set C, some samples exhibited extremely porous layers, with porosity reaching more than 10%. In the case of sample C4, as failure occurred in the sample gauge, it was possible to retrieve the failed layer in computed tomography, which correlated perfectly with the position of the failed surface observed on the sample post-mortem. This layer also includes the pore with the largest dimensions. Using the same technique, the maximum layer porosity of sample C5 was retrieved with a peak value at 7.4%, and the layer corresponded to the failed fracture surface Fig. 15. However, the sample C5 did not show reduced fatigue properties compared to the other sets.

The maximum computed tomography layer porosity measured for samples C4 and C6 were respectively 10.1 and 15.3%, and all the other samples from the same set where cracking initiated in the contour showed maximal layer porosity amounts between 2.5 and 4.5%. One can conclude that in the frame of this study, considering the material used and the contour quality obtained, the critical layer porosity density is between 7 and 10%. Below this value, the porosity density of the bulk has no effect in fatigue resistance and the fatigue behaviour is controlled by the contour
