Bessam ZERAMDINI, Salah MEZLINI, Mohamed EL MANSORI, Ali MKADDEM - Evaluation of tribothermal effectiveness of TiAlN-based bilayer coatings in cutting fiber-reinforced polymers - Tribology International - Vol. 103, p.176-186 - 2016

# Evaluation of tribothermal effectiveness of TiAlN-based bilayer coatings in cutting fiber-reinforced polymers

This work addresses the tribological reliability of TiAlN-based PVD coatings face to TiN-based CVD coating in cutting FRP. Wear and linear pin-on-plate tests were conducted on both glass/epoxy and carbon/epoxy composites for investigating wear progression and apparent friction, respectively. The TiAlN location shows great role in controlling wear upon PVD coatings. While abrasion was found dominating the wear mechanisms upon the flank face irrespective to coating type, PVD coatings demonstrate better ability to dissipate severe cratering. Although the all coatings showed close behavior against carbon/epoxy, TiAlN/AlCrO coating revealed great vulnerability against glass/epoxy resulting in extended AlCrO layer failure. While wear substantially reduces the thermal conductivity, PVD coatings kept roughly better conductivities than CVD coating as

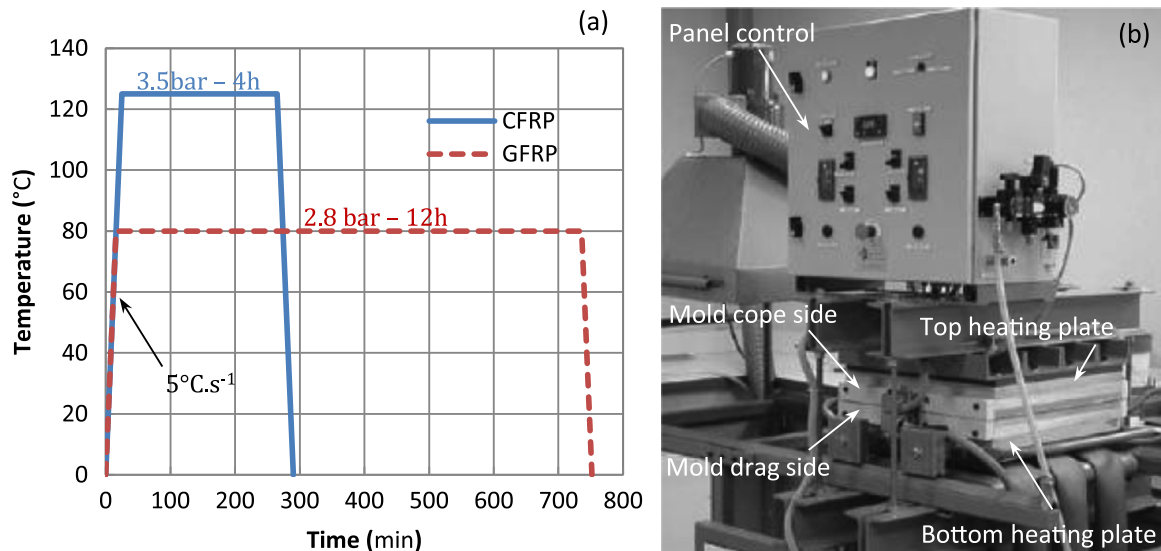
Fig. 1. (a) Press-molding machine, and (b) typical cure cycles used for the fabrication of the considered composites.

The composite panels were firstly prepared at room temperature in 400 × 400 mm mold using hand lay-up technique. The cure cycle [24,25] for each used composite was adjusted so as to ensure the best technical solution avoiding deflection of the panels during cooling stage (Fig. 1a). Then, the panels were introduced in a press molding machine to undergo the required cure cycle (Fig. 1b).

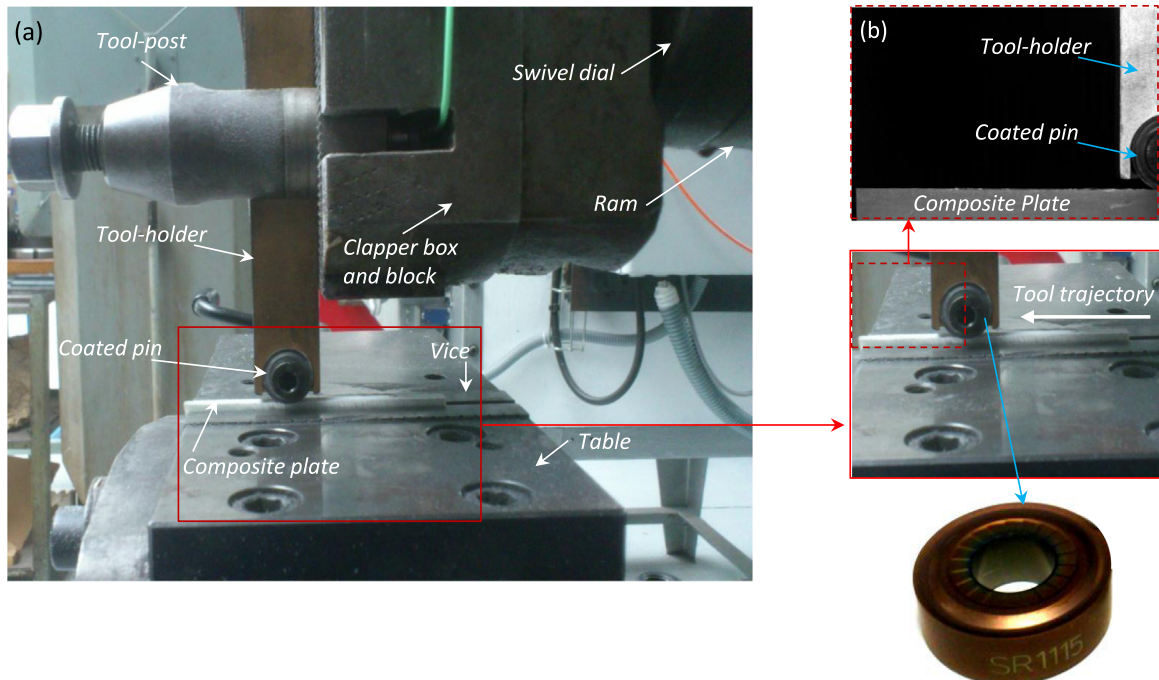
**Fig. 2.** Experimental set-up used for friction study. (a) Main machine parts, and (b) testing configuration.

Sliding contact between the cylindrical insert and the top side of the specimen results from the relative motion between the fixed table and the shaper ram. Before each test, the top side of the specimen was pre-trimmed to ensure the tool-plate interface to be rectilinear. This ensures a continuous and constant contact pressure during testing step. The fiber orientation ( $\theta$ ) and applied contact pressure ( $P$ ) are variables. The former was adjusted by means of Kistler piezoelectric dynamometer (model 9255B) connected to an acquisition device. The sliding speed ( $V_s$ ) and contact width ( $w_c$ ) were adjusted to cutting speed and cutting feed used in wear tests, respectively (Table 4). The tool-holder and pin-on-plate system are illustrated in Fig. 2.

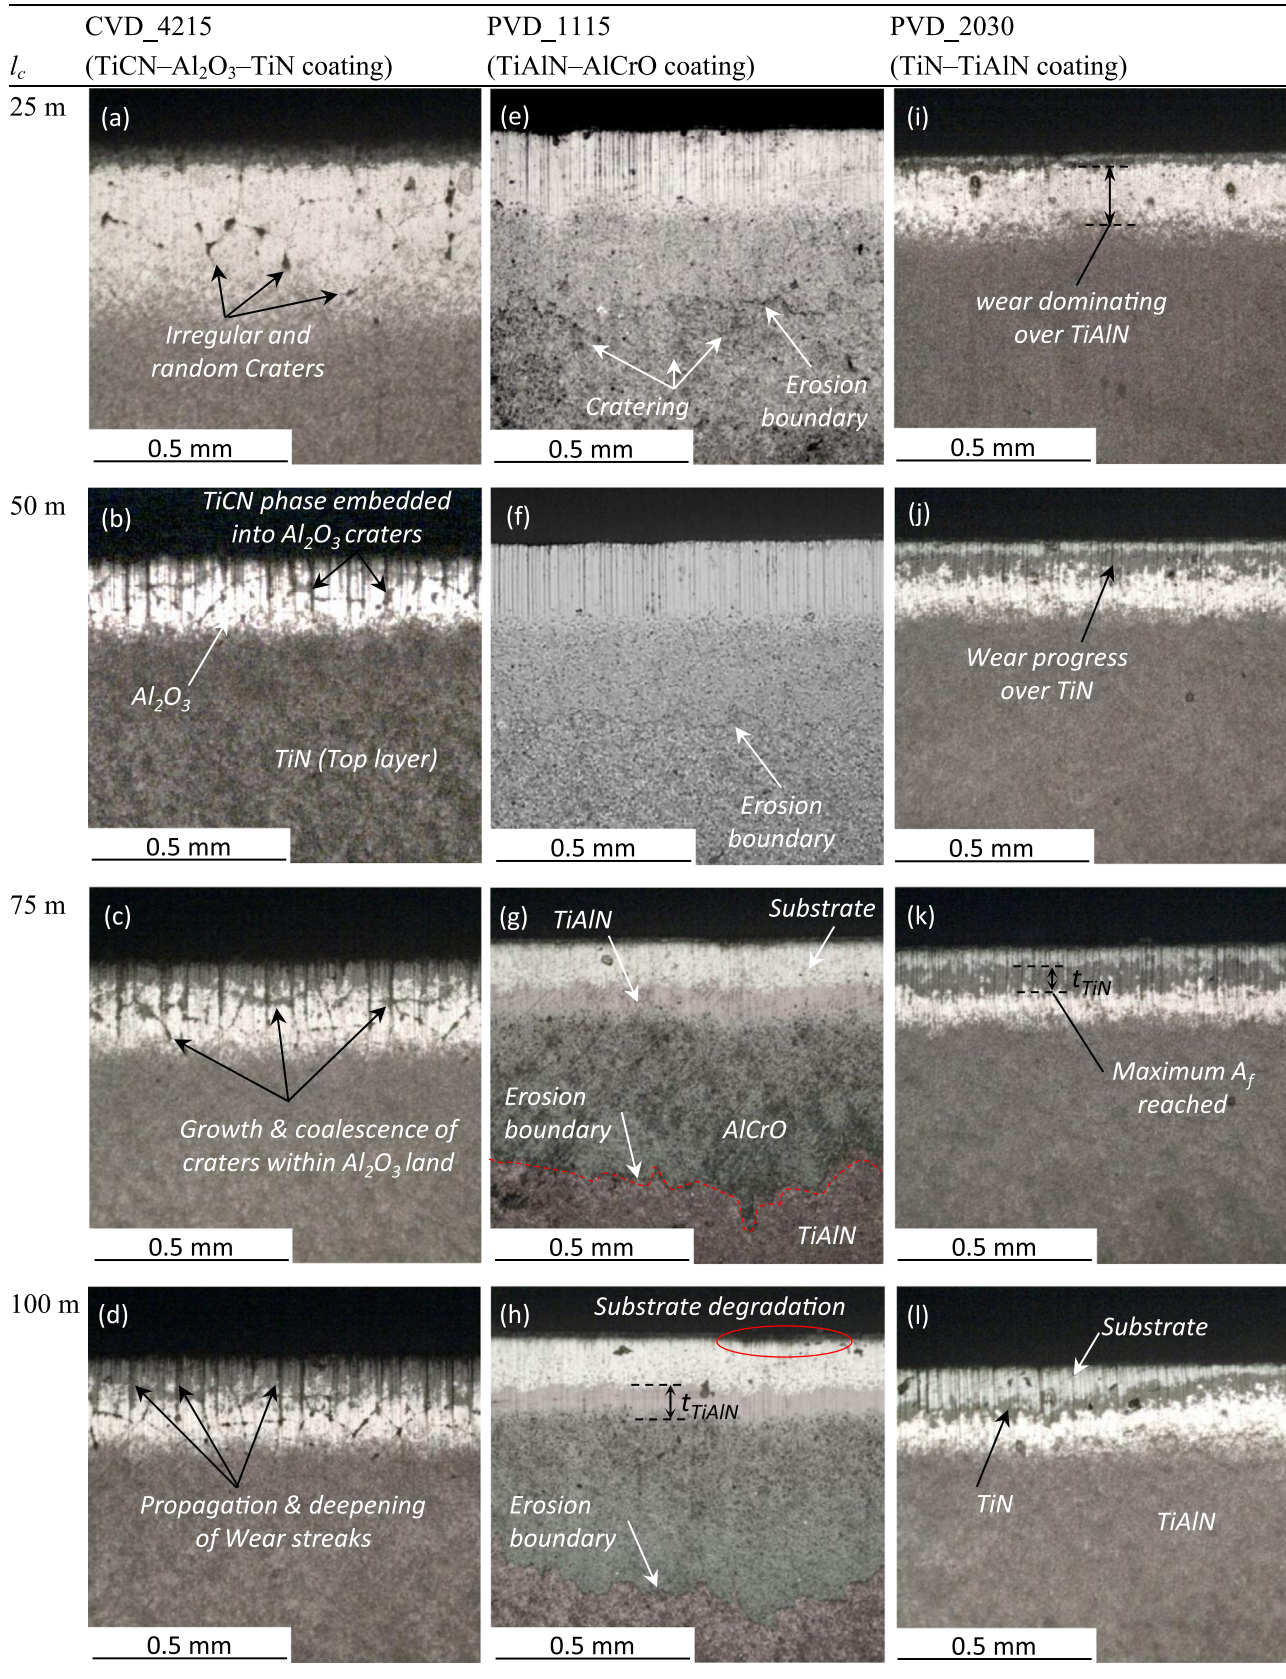
**Fig. 3.** Optical micrographs of worn inserts vs. cutting length obtained from GFRP cutting tests ( $\theta = 45^\circ$ ).

that flank wear commonly dominates upon the studied inserts (Fig. 3). However, worn area and wear patterns observed on CVD coatings were found neatly different from those observed on PVD coatings. The wear mechanisms induced substantially due to abrasive fibers, acts differently upon the coating layers because of various coating properties. The rapid onset of irregular streaks on the CVD coating reflects a *hard* abrasion that takes firstly place on TiCN layer before reaching the cemented carbide substrate. While the former coating exhibit discontinuous and randomly oriented wear patterns (Fig. 3a–d), TiAlN–AlCrO PVD coating shows continuous streaks oriented parallel to the tool trajectory. This implicitly refers to the abrasion mode operating on that PVD coating. At early cutting stage ( $l_c \leq 50$  m), the material removal still remains localized throughout the outer coating layer made of AlCrO (Fig. 3e–f). Once that layer was fully removed ( $l_c \geq 50$  m), the sharp edges of cut fibers come into contact with the intermediate layer made of TiAlN, which forces wear to progress toward the substrate (Fig. 3g and h). The micrographs make it possible to distinguish the substrate from the two coating constituents. After 1 min-working period, the coating set completely fails and the damage reaches the substrate. Besides, when abrasion develops close to the tool-tip, *erosion* mechanisms extends along the frontiers of the AlCrO layer (see Fig. 3g and h). The observations show fine cratering throughout the worn area, which attributed to the adhesion level between the two coating layers. It can be outlined that PVD technique allows, mostly, better adhesion of coating phases to the substrate, and to each other than CVD one. Following the specifications of the supplier, TiAlN–AlCrO and TiN–TiAlN PVD coatings are classified as with '*medium*' and '*high*' adhesion, respectively. It appears that adhesion of TiAlN–AlCrO to the substrate is not high enough to efficiently resist the action of abrasive glass fibers. However, adhesion between the two coating layers seems to be so enough so that to reduce wear to a local cratering mechanisms acting in TiAlN intermediate layer. The relatively good adhesion at TiAlN/AlCrO interfaces is essentially attributed to the ultra-fine grains constituting the coating layers as mentioned in the coating specifications. This grain grade is crucial for reaching a thickness of 2  $\mu$ m in such a coating. The coating thickness has tendency to increase with the grain number. An increase in grain number through the thickness multiplies the interfaces at grain boundaries which relatively alters adhesion quality and favors, in turn, premature degradation of the coating. Nevertheless, the deep streaks observed on the CVD worn land result practically in the relatively coarse grains forming the coating layers. As obvious, the failure of grain boundaries is neatly more probable than breaking-up a grain itself. Unexpectedly, the TiAlN–AlCrO coated insert exhibited good ability to produce neat GFRP surfaces in spite of its high vulnerability to degradation. From observations, it was revealed that the former has the sharpest cutting edge as compared to the other considered inserts.

wear development. From the micrographs of Fig. 3i–l, the TiN intermediate layer shows relatively narrow worn area while the top TiAlN layer undergoes early material removal owing to severe abrasion. Contrary to the two other inserts, the TiAlN layer succeeds at preventing wear to penetrate into the following coating to the detriment of wide superficial worn area, up to cutting length approximating 25 m (micrograph of Fig. 3i). This patently proves the ability of TiAlN to delocalize wear when operating in aggressive contact conditions as governed by sharp glass fibers. The intermediate layer i.e. TiN, however, demonstrates ability to localize material removal at the maximum until advanced cutting stage (Fig. 3l). By inspecting the TiN worn area, it was noticed that material removal doesn't evolve perfectly linearly versus cutting period since the TiN worn area fraction ( $A_f$ ) increases faster within 25–50 m than out of this domain. Nevertheless, it is virtually certain that abrasion regime on the coating set fluctuates from *severe regular* to *severe irregular* upon the two extreme constituents i.e. the substrate and the top layer. However,

However, the abrasion mode acting particularly on alumina phase switches from *discontinuous irregular* (Fig. 3a–d) to *continuous regular* (Fig. 4a–d), when the cut structure changes from GFRP to CFRP, respectively. When operating with CVD coating against CFRP, the substrate stands out because of the failure of fully coating set, at approximately 60 s cutting period.

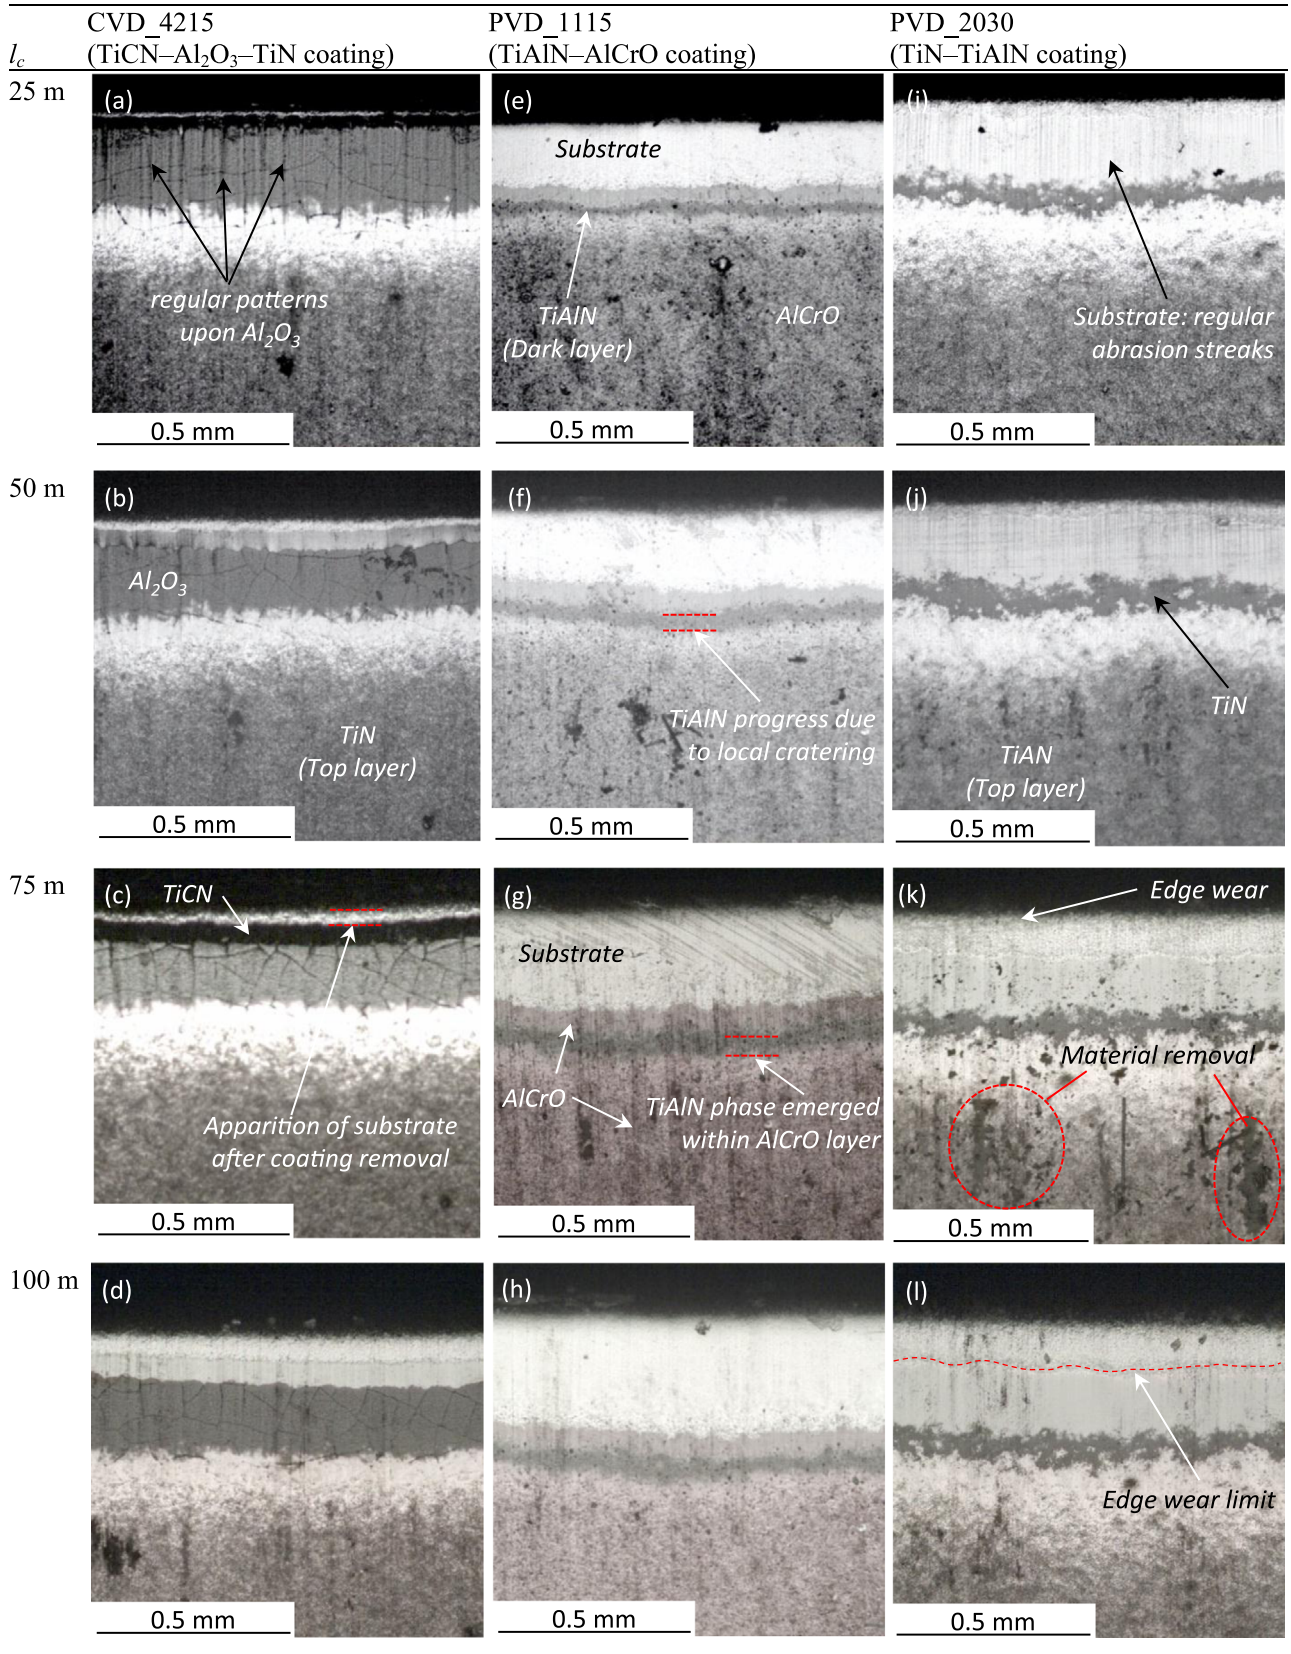
**Fig. 4.** Optical micrographs of worn inserts vs. cutting length obtained from CFRP cutting tests ( $\theta = 45^\circ$ ).

As for CFRP cutting, abrasion still remains dominating the flank wear upon all the used coatings. The examination of CVD coating reveals more vulnerability of TiN layer against CFRP than against GFRP. The top layer is released so early so as to transfer rapidly wear to the intermediate layer made of Al<sub>2</sub>O<sub>3</sub>. The former undergoes hard abrasion resulting in regular and pronounced wear patterns that appear as soon as cutting starts (Fig. 4a). The examination of worn CVD inserts reveals that CFRP cutting induces flank wear values of approximately 1.5 to 1.8 times higher than GFRP cutting while  $l_c$  ranges in 25–100 m.

PVD coatings (Fig. 4i–l). However, it was found that wear mechanisms dominating the coating behavior upon TiN–TiAlN are, from one hand, (i) more severe, and, from the other hand, (ii) different to those

observed on TiAlN–AlCrO. In fact, material pulls out through the TiAlN top layer, and the cutter edge rounds-off along the substrate (Fig. 4k–l). This results, in turn, in relatively neat different worn area fractions of TiAlN phase in the two PVD inserts.

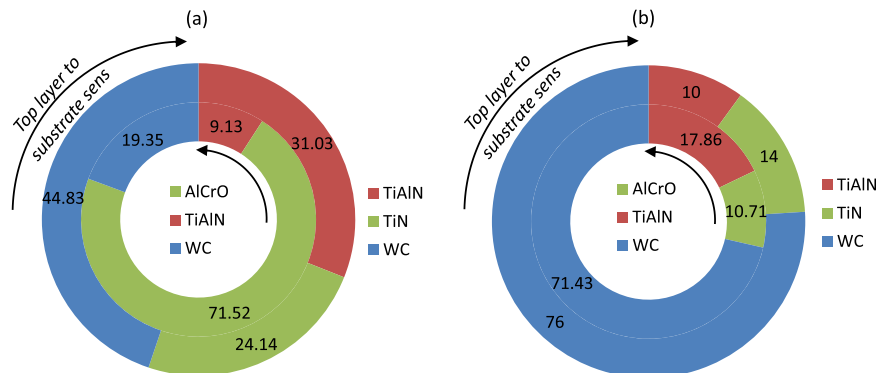
Fig. 5. Worn area fraction measured upon coating layers of each PVD insert at  $l_c=100$  m. (a) GFRP cutting tests, and (b) CFRP cutting tests.

(Fig. 5a), where  $t$  is the composite plate thickness. At top location, hence, such a layer acts to delay, at maximum, wear to reaching the intermediate layer as practically observed in TiN–TiAlN insert. As for intermediate location, it exhibited the shallowest and closest worn area which reflects its ability to moderate wear progression (i) firstly, by dissipating abrasion actions progressing from the top layer, and (ii) secondly, by delaying, accordingly, the substrate to enter into contact with the cut fibers.

Irrespective to the insert used, the WC-Co substrate exhibits the most area fraction against CFRP because of relatively rapid removal of superior coating layers. Once these former fully disappear, the fibers enter in contact with the substrate allowing hence abrasion to develop within the active zone. In the case where the TiAlN layer occupies the intermediate location, the coating set shows better performance in protecting the substrate against GFRP than against CFRP. In fact, the coating set was found able for dissipating more than 80% of generated wear ( $A_{f_{coat}} = A_{f_{top}} + A_{f_{int}}$ ) when operating face to GFRP composite

compared to only 29% face to CFRP. The same conclusion might be outlined when TiAlN occupies the top layer since the whole coating area fractions ( $A_{f-Coat}$ ) obtained in cutting GFRP and CFRP are, respectively, 55% and 24%. This indicates the high vulnerability of PVD coating to resist the carbon fiber aggressiveness.

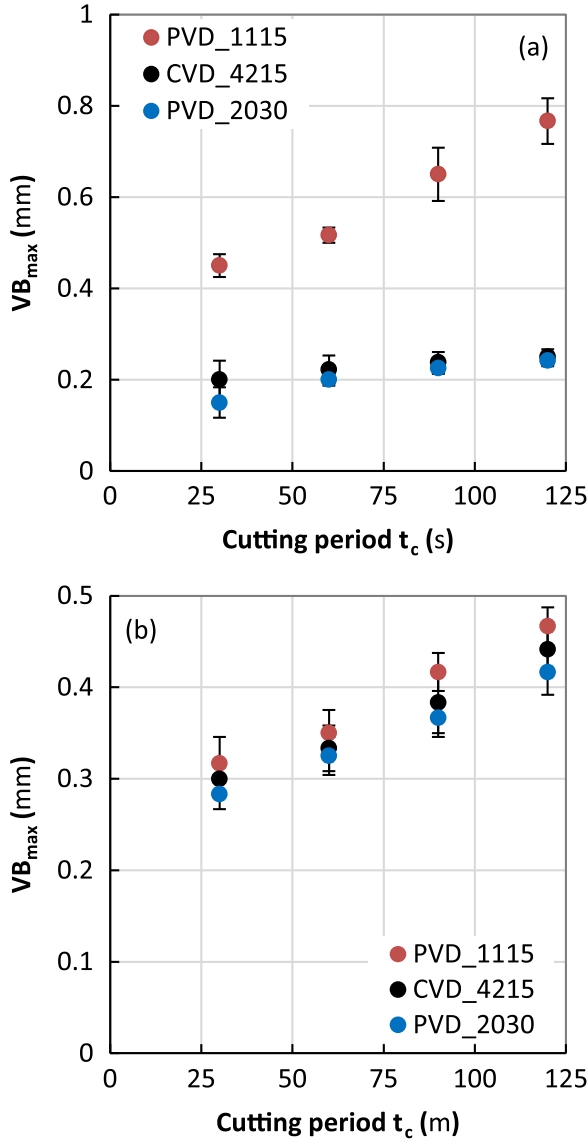
**Fig. 6.** Flank wear measured upon considered inserts ( $\theta = 45^\circ$ ). (a) GFRP wear tests, and (b) CFRP wear tests.

Fig. 6a and b show the maximum flank wear measured over the studied inserts. From tendencies, it is easily to distinguish the typical behavior of TiAlN–AlCrO versus GFRP if compared to the two other coatings.

The wear rate,  $W = \frac{VB_{max}}{t_c}$  where  $t_c$  is the cutting lifetime, resulting from CFRP cutting tests was intentionally calculated for investigating the resistance to wear of the three inserts. The obtained values of  $W$  show very close behavior between CVD and PVD insert. The wear rate is virtually constant for the three coated inserts since the values range in  $0.0015\text{--}0.0017\text{ mm s}^{-1}$ . The discrepancies were, however, found significantly larger when the inserts operates versus GFRP since  $W$  exhibits wide variation range i.e.  $0.0006\text{--}0.0036\text{ mm s}^{-1}$ . Referring to the former values,

TiAlN–AlCrO coating records a wear rate versus GFRP of about two times higher than the rate obtained versus CFRP. This reflects, in turn, the vulnerability of such a coating set because of a premature failure of the top layer by effect of erosion. The CVD and TiN–TiAlN PVD coatings proved better efficiency to resist the wear progression within the cutting period.

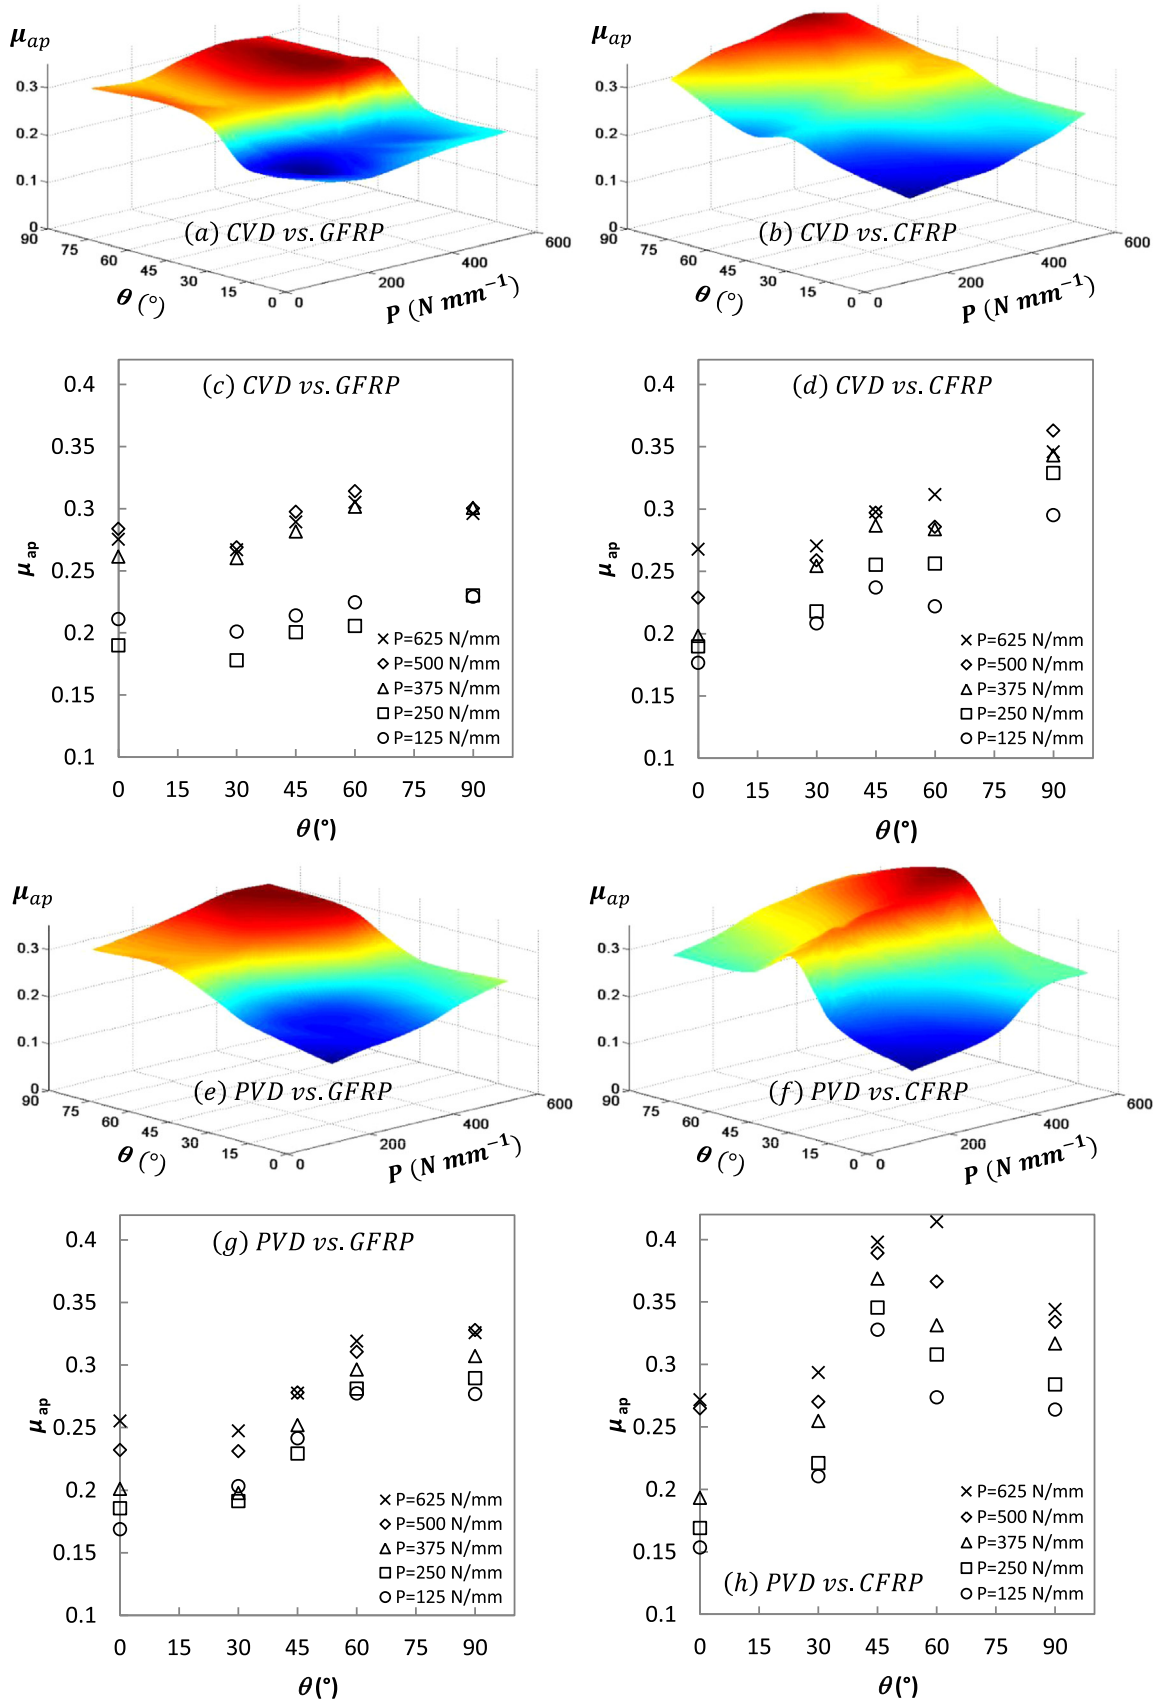
**Fig. 7.** Typical friction maps and friction evolutions obtained upon GFRP, and CFRP (SD:  $0.086 \pm 0.03$ ). (a–d) CVD coating response, (e–f) PVD coating response.

The measurements performed for GFRP plates using the two coating types lead to comparable plots (Fig. 7a and e). The apparent friction coefficient was found more sensitive to fiber orientation than pressure since  $\mu_{ap}$  exhibits a non-linear behavior versus  $\theta$  marking thus an inflection transition about  $45^\circ$  along all pressure range. The friction values are as high as  $\theta$  and  $P$  are high. However, the variation gap appears more significant versus fiber orientation. The highest friction values were recorded within  $60\text{--}90^\circ$ . In such an orientation range, the number of cut fibers in contact with the tool is relatively high which explains, in part, the rise observed in apparent friction. However,  $0^\circ$ -fiber orientation shows the lowest values because the fiber circumferential surface favors sliding while fiber cut sections enhances adherence.

While CVD-on-CFRP tests (Fig. 7b) yield a tendency roughly similar to those obtained on GFRP, the PVD-on-CFRP tests (Fig. 7f) doesn't lead to a so neat similitude with the map shown in Fig. 7b. It is worth noting that friction resulting in PVD coating fluctuates in larger ranges irrespective to fiber type (Table 6).

The friction range owing to PVD-on-GFRP tests records an enlargement of about 9.5% while PVD-on-CFRP tests lead to a three times higher percentage, namely 27.3% (Fig. 7g and h). The sensitivity of friction interval to the coating type can be respectively expressed for the two studied composite as,

Thus, the PVD coating looks more beneficial for cutting low fiber oriented structures regardless the fiber type and pressure. At relatively high fiber orientations, the CVD coating overcomes the PVD one (see Fig. 7c and d). This was essentially attributed to the further vulnerability of PVD coating against cut fibers acting in block for generating premature removal of coating layers. It should be mentioned, moreover, that PVD deposited layers are 7 to 9 times thinner than CVD deposited one which expose them to higher failure risk although their better adhesion to the substrate.

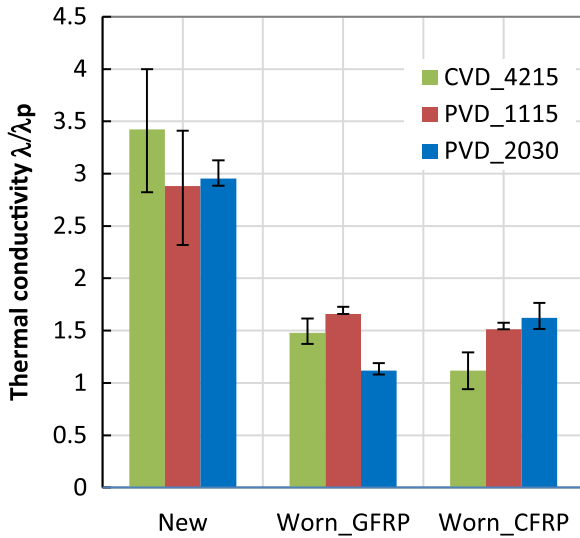
**Fig. 8.** Thermal conductivity values obtained on the considered inserts by AFM scratch tests at new and worn ( $l_c=100$  m) states.

At new state, the three studied inserts commonly show higher relative thermal conductivity than that obtained at worn state (Fig. 8). In fact, there is no appreciable difference between thermal conductivities of the two PVD coatings at the new state. As obvious, the measured values at new state refer to the thermal conductivities of the top layer. The  $\lambda$ -values fall by approximately 50% after 120 s working period whatever the fiber type. This entails that wear process dominates the structure effect as for thermal conductivity variation.

As a proof, it was typically mentioned in open literature that  $\lambda_{TiN}$  is relatively higher than  $\lambda_{TiAlN}$  [29] which fits to the obtained results upon new inserts. A part of the lost coating, as particles or debris because of wear mechanisms, will be transferred to the composite cut area. This should play, somehow, to vary likely the thermal properties of the composite constituents [2]. In this case, the cut composite acts as thermal dissipater face to coating layer which explains, in some way, the drop in the thermal conductivity values observed upon all the studied inserts.
