Jinyang XU, Chao LI, Ming CHEN, Fei REN, Mohamed EL MANSORI - An investigation of drilling high-strength CFRP composites using specialized drills - International Journal of Advanced Manufacturing Technology - Vol. 103, n°9-12, p.3425-3442 - 2019

An investigation of drilling high-strength CFRP composites using specialized drills

Keywords High-strength CFRP composites · Drilling · Specialized drills · Drilling-induced damage · Hole quality · Tool wear

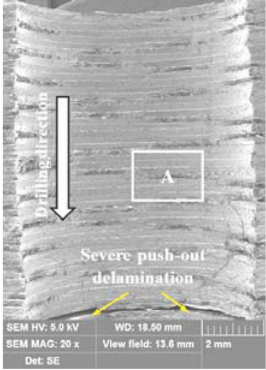
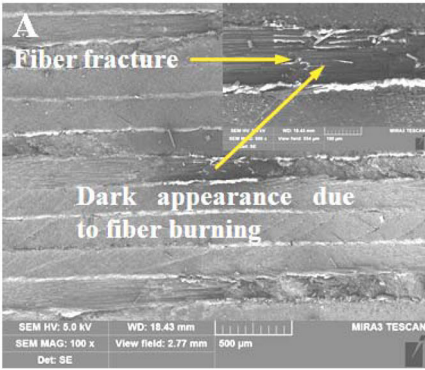
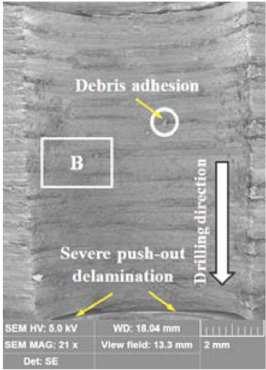
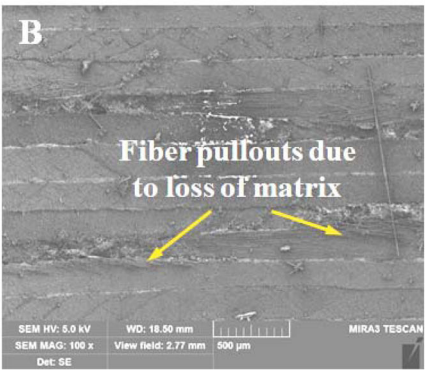
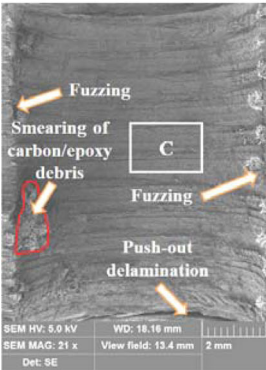
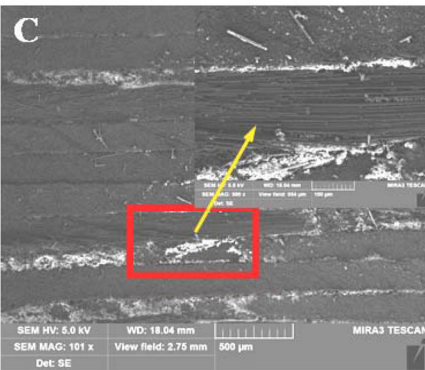
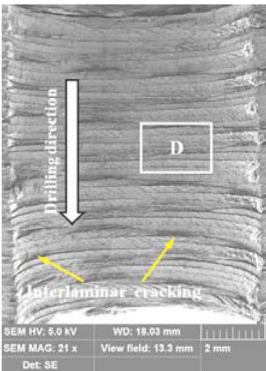
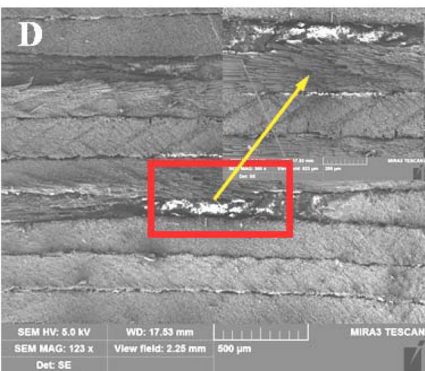
Fig. 11 SEM morphologies of the CFRP holes produced by the dagger drills under different spindle speeds

As for the dagger drills, the cut CFRP hole surfaces are the poorest with a large amount of drilling-induced damage including fiber fractures, microcracking, push-out delamination,

resin adhesion, and fuzzing as depicted in Figs. 11 and 12. Interlaminar cracking is clearly visible between adjacent plies through the SEM examinations of drilled holes. Severe

temperatures with the drilling depth. The inspections of the magnified views of the hole morphologies indicate that the poorly cut surfaces for the dagger drill often reside within plies

having a -45° fiber orientation being featured by quantities of exposed fibers with a minimal degree of residual resin materials while neatly cut surfaces fully covered with matrix are
