Detection, localization, and quantification of corrosion damage using Lamb Waves for the structural health monitoring of aluminum aeronautics structures

J. Liegey^[a,b], W. Briand^[a], M. Rébillat^[a], M. El May^[b], O. Devos^[c] & N. Mechbal^[a]

Abstract: Corrosion is a major concern for the aeronautic industry and providing structures with the intrinsic ability to monitor autonomously their health state is a major actual academic and industrial challenge. In this paper, detection, localization, and quantification of a damage representative of a corrosion damage using Lamb waves emitted and received by piezoelectric elements for the purpose of structural health monitoring of aeronautics aluminum structures is addressed. Semi-spherical holes of different sizes representing a calibrated corrosion pit are manufactured on a 2024 aluminum plate with four piezoelectric sensors bonded on it. Lamb waves are then recorded with one element used as an actuator and the other ones being used as sensors. A dedicated recording system provided by Cedrat Technologies is used to acquire Lamb waves data. It is demonstrated on this representative example that by using actual algorithms from the SHM

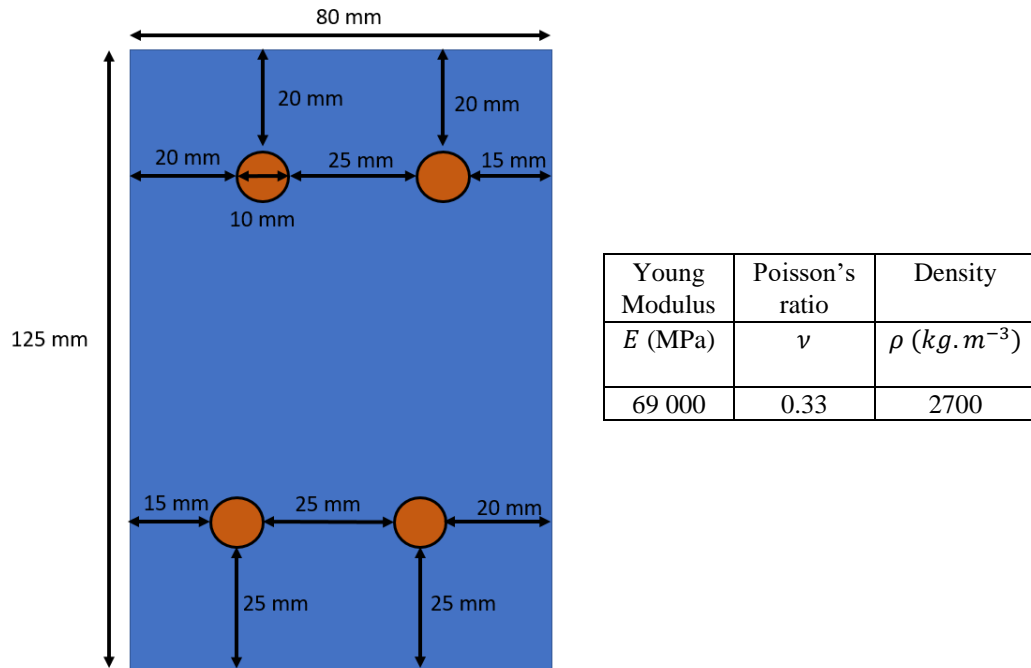
Figure 1 : [Left] Dimensions of the aluminum plate studied within the COQTEL project with the piezoelectric elements position (orange circles). [Right] Material's properties of 2024 aluminum

In this section, details about the experimental setup are presented. The material used is 2024 Aluminum alloy with the material properties provided in Figure 1 by the company Rescoll¹. The studied aluminum plates dimensions are 125×80 mm and 2 mm of thickness (see Figure 2a).

Four piezoelectric transducers were bonded to the aluminum plates and positioned strategically (not symmetric to the center to avoid recording reflected signals) as shown in Figure 1.

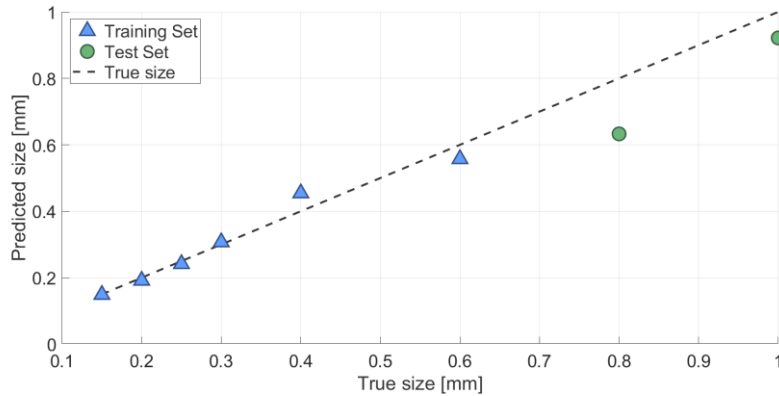
Figure 6 : Example of damage size quantification achieved by the IPP approach. The IPP algorithm has been trained on blue triangle and predicts sizes corresponding to green circles.

To quantify the damage, the IPP damage quantification method was used as mentioned earlier. This method consists in computing a damage localization map and in extracting from this map the area above a given threshold (the yellow points in the above figure). When the damage size is increasing, this area is also very likely to increase and thus provide a reliable cue to damage size quantification. A polynomial regression between the area size and the actual damage size then allows to extrapolate to unknown damage sizes. A figure representing the estimated damage size versus the actual damage size is plotted. Only small damage sizes have been used for learning purposes and then the

ability of the algorithm to extrapolate to larger damage sizes have been assessed. Points close to the diagonal line indicated correct damage size quantification. Learning points are shown in blue and prediction points in green. This example illustrates the fact that such algorithm is able to quantify correctly the size of corrosion-like damages.
