Samuel RODRIGUEZ, Victor GAYOUX, Eric DUCASSE, Michel CASTAINGS, Nicolas PATTEEUW - Ultrasonic imaging of buried defects in rails - NDT&E International - Vol. 133, p.102737 - 2023

Ultrasonic imaging of buried defects in rails

The present work addresses the ultrasonic NDT of rails, more precisely of the rail foot. The practical constraint is that transducers must be located on the rail head, whereas the region of interest is the rail foot. Thus, there is no direct acoustic path between the transducers and the region of interest. As classical delay and sum methods cannot be applied to such cases, the goal of the paper is to numerically assess the potentiality of the topological imaging method to investigate the rail foot. Three specific typical rail foot defects are investigated, namely, longitudinal vertical cracks, corrosion pits and rail injuries. Simulating eight transducers with different polarizations, the images obtained show that the detection and approximate location of the various defects are possible.

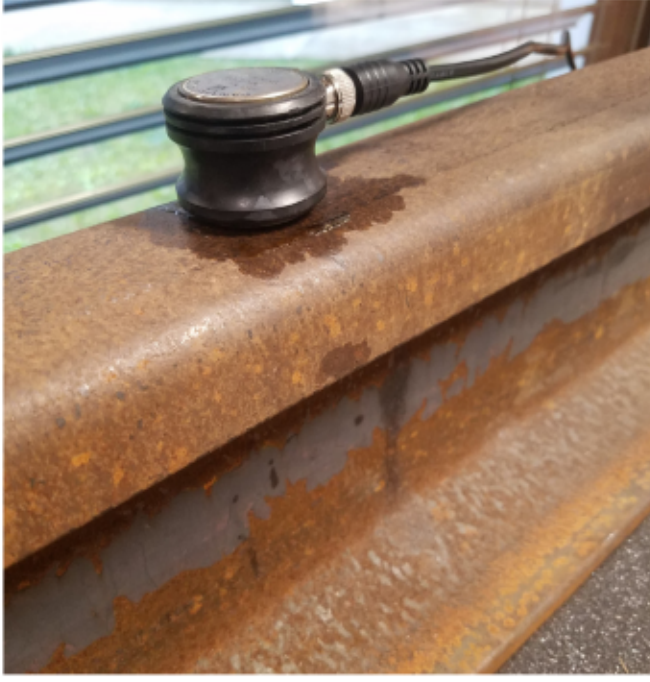
Fig. 2. The experimental apparatus for testing the numerical model.

To assess the model validity, comparisons with pulse-echo experiments are performed on a real rail sample inspected using a single one-inch piezoelectric transducer with successively out-of-plane and in-plane polarizations. The transducer is located at the center of the upper side of the rail head, as presented in Fig. 2.

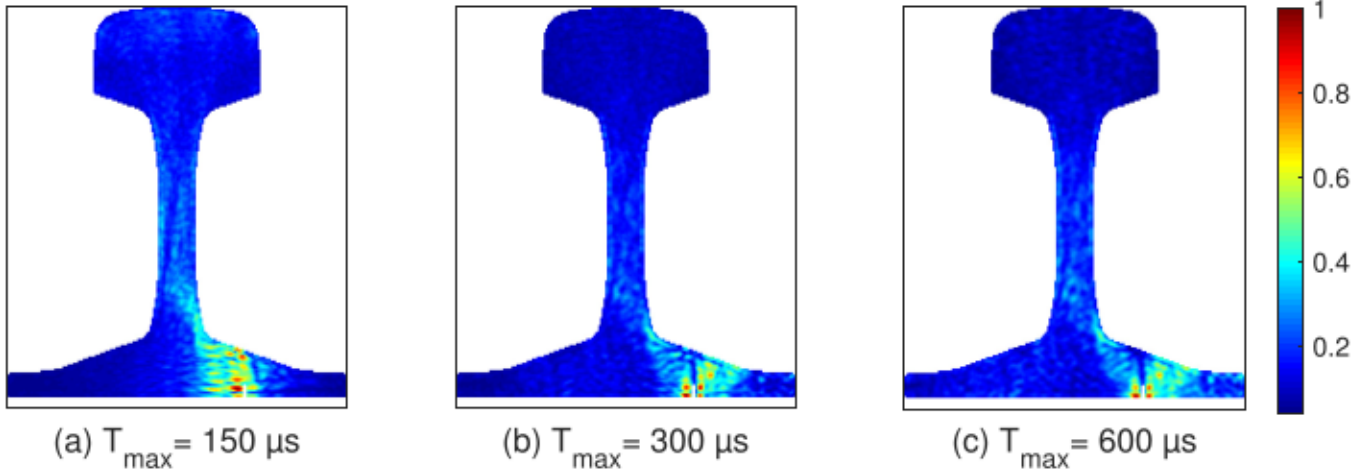
Fig. 9. Topological images of the rail section presenting a longitudinal vertical crack. The defect is represented by a white line. The polarization is out of the rail plane. Each image is computed considering acquisition durations of 150, 300 and 600 μs , and 16 transducers are used.

The acquisition duration defines the amount of reverberated field taken into account. When taking a duration that is too short, no information has the time to travel from the array to the defect and back to the array. When taking a short duration, only the first interactions among the incoming field, the surrounding medium and the defect are measured. When taking a longer duration, complex multiple interactions are also measured. The sensitivity of the image to the acquisition duration is studied in Fig. 8 and Fig. 9 for in-plane and out-of-plane polarizations, respectively, and in Fig. 10.

One could expect an improvement with increasing duration as more physical information is taken into account. For instance, for out-of-plane polarization, the artifact magnitude decreases when increasing the acquisition duration from 150 μ s to 300 μ s. However, this is not the case for in-plane polarization, as there are clearly more artifacts

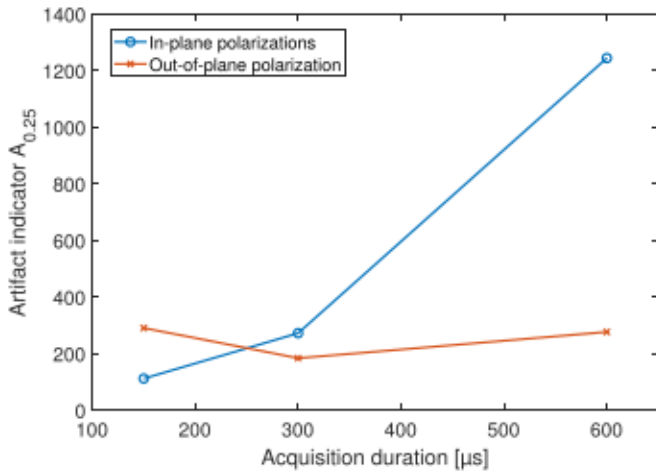
Fig. 10. Influence of the acquisition duration on the artifact indicators for images computed with a central frequency of 500 kHz, $N = 16$ transducers and in the presence of a vertical crack.

when increasing the acquisition duration from 300 μ s to 600 μ s. To summarize these results, the artifact indicators of these images are plotted in Fig. 10.

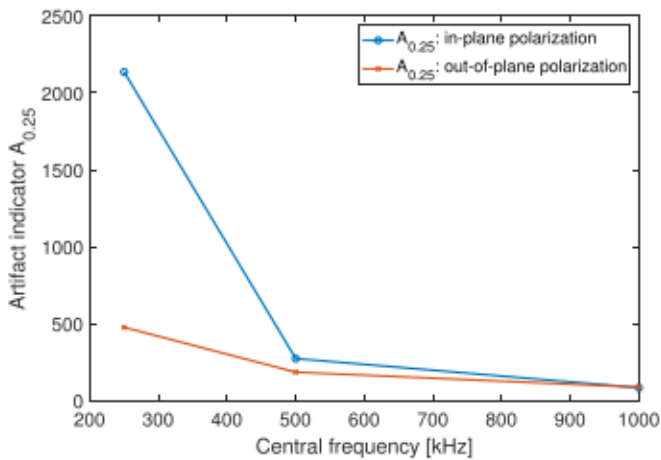
Fig. 16. Influence of the central frequency on the artifact indicators for images computed in the presence of a vertical crack.

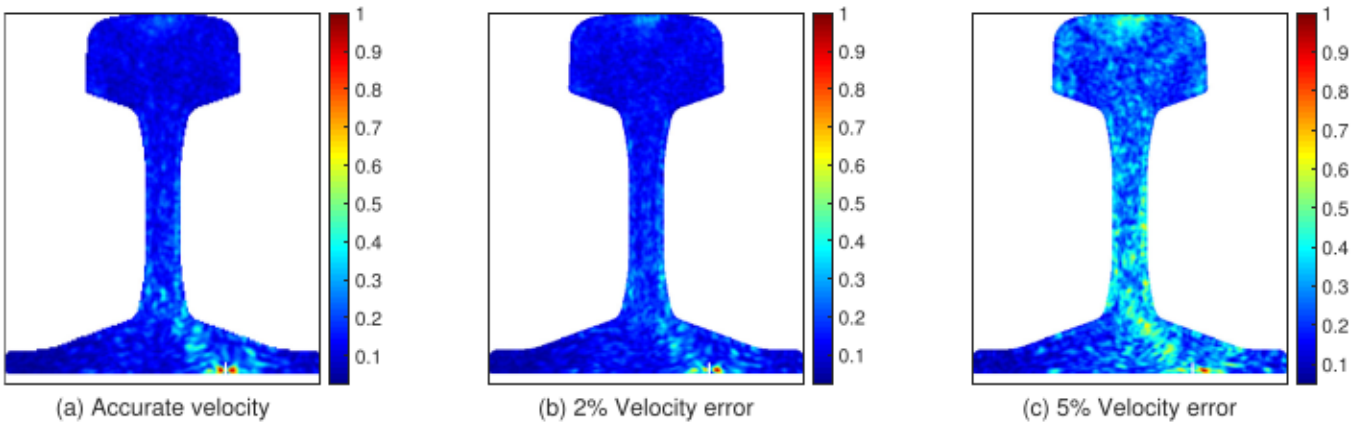
Fig. 21. Effect of an increasingly inaccurate velocity for building the images. The vertical crack case under in-plane wave investigation.

to sense the effect of property inaccuracy, the vertical crack and the corrosion pit cases are rerun assuming inaccurate wave velocity when computing wavefields $u(x, y, \omega)$ and $v(x, y, \omega)$ used to compute the image (Eqs. ((6),(7))). The velocity values are successively increased by 2 and 5 percent. The corresponding images are given respectively in subfigures (b) and (c) of Figs. 21 and 22. Keeping the inaccuracy below 2 percent makes it possible to maintain the image quality. Increasing it up to 5 percent strongly increases artifact magnitude despite a still correct defect localization. We expect that higher inaccuracy leads to imaging procedure failure. This relatively high sensitivity to the material properties implies that a careful experimental characterization is necessary for practical implementation of the method.
