P. Janardhana KIRAN, V. SRINIVAS, A. BASU, Corinne NOUVEAU, K. Ram Mohan RAO - Elevated Temperature Plasma Nitriding of CrMoV Tool Steel for the Enhancement of Hardness and Wear Resistance - Journal of Materials Engineering and Performance - Vol. 32, n°21, p.9540-9549 - 2023

# Elevated Temperature Plasma Nitriding of CrMoV Tool Steel for the Enhancement of Hardness and Wear Resistance

Elevated temperature plasma nitriding of Cr-Mo-V based tool steel was performed by varying the treatment time to enhance hardness and wear resistance. Steel samples after metallographic polishing were placed on the conducting substrate holder in the nitriding reactor and evacuated to 0.5 Pa pressure. The sample holder was then negatively biased at 250 V to accelerate the ions toward the surface of the samples. A gas mixture of N<sub>2</sub> and H<sub>2</sub> was then passed into the vacuum chamber to generate the plasma. After plasma generation nitriding was performed at variable temperatures 500°C and 550°C for 6 and 10 hrs. Then X-ray diffraction (XRD) and Scanning Electron Microscope/Electron Dispersive Spectroscopic (SEM/EDS) studies were followed to understand the structural modifications. XRD

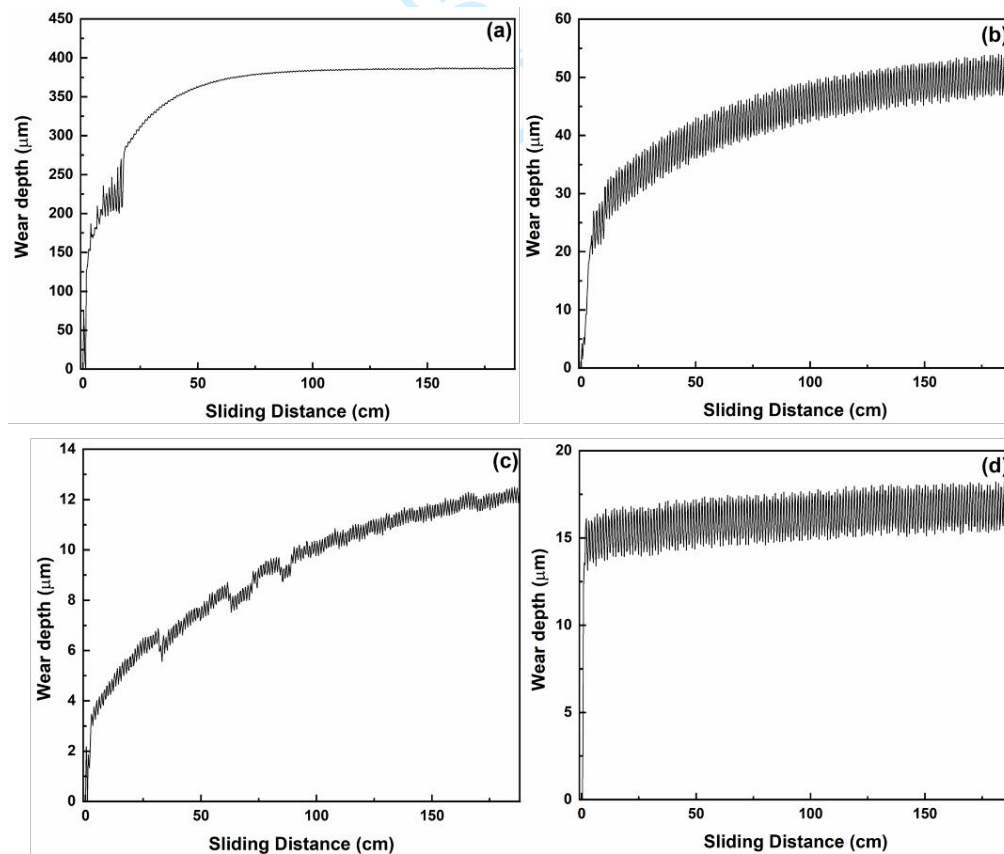
Fig. 5 displays the sliding distance vs. wear depth of all the samples as obtained from the wear testing equipment. To compare the wear response of the samples (bare steel and nitrided at different conditions), these plots were smoothed and stacked in a single plot as displayed in Fig. 6(a).

Fig. 5 Wear depth vs. sliding distance plots (raw data) of (a) S0, (b) S28, (c) S29 and (d) S30 steels.

The S0 (bare steel) exhibits maximum wear depth or the least wear resistance due to its soft nature compared to hard nitrided layers. The improvement in wear resistance is remarkable after plasma nitriding of the steel. All the nitrided steels show similar wear depth. However, S29 steel displays the best wear-resistant properties among these tested steels. This is due to high hardness and the reason is already discussed in the hardness section.

Fig. 5 Wear depth vs. sliding distance plots (raw data) of (a) S0, (b) S28, (c) S29 and (d) S30 steels.
