Jérémie GIRARDOT, Laurent BERTHE, Matthieu SCHNEIDER, Véronique FAVIER -
Investigation of delamination mechanisms during a laser drilling on a cobalt-base superalloy -
Journal of Materials Processing Technology - Vol. 213, p.1682-1691 - 2013

Investigation of delamination mechanisms during a laser drilling on a cobalt-base superalloy[☆]

J. Girardot*, M. Schneider, L. Berthe, V. Favier

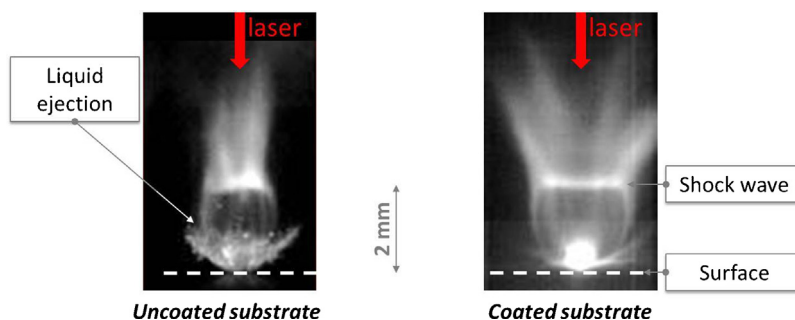
Fig. 14. Hydrodynamics of the gas ejection on the uncoated substrate (a) and the coated substrate (b) during laser drilling at normal angle of incidence. ($I_{\text{inc}} = 25.4 \text{ MW/cm}^2$; $\beta = 90^\circ$).

Fig. 14 shows fast camera images of the melt and gas ejection taken at the same time during the first pulse fired at 90° to the surface for both systems (Co-base superalloy with and without TBC). According to Schneider et al. (2011), the hydrodynamic behavior of the gas ejected is straight related to the surface temperature of the vapor front during the process. Thus, surface temperatures can be estimated and is more than 5000 K for an incident intensity of 25.4 MW/cm^2 which corresponds to a 18 kW peak power for the laser source. The local pressure at the same range of intensity is about 100 bar. On the movies, a shock wave was observed during the drilling for both systems. This shows that gas behaviors were both supersonic but the size of the shock wave was almost two

times larger in the case of coated substrate drilling than in the case of uncoated substrate drilling. This indicates that the temperature and ejection speed are much higher for a ceramic/laser than for a metal/laser interaction. Besides, for the drilling on uncoated substrate, liquid ejection as drops was observed on the edges of the ejection area for free-TBC substrate.
