Walid KHALFAOUI, Eric VALÉRIO, Michel AUTRIC, Jean-Eric MASSE - Excimer laser treatment of ZE41 magnesium alloy for corrosion resistance and microhardness improvement - Optics and Lasers in Engineering - Vol. 48, n°9, p.926-931 - 2010

Excimer laser treatment of ZE41 magnesium alloy for corrosion resistance and microhardness improvement

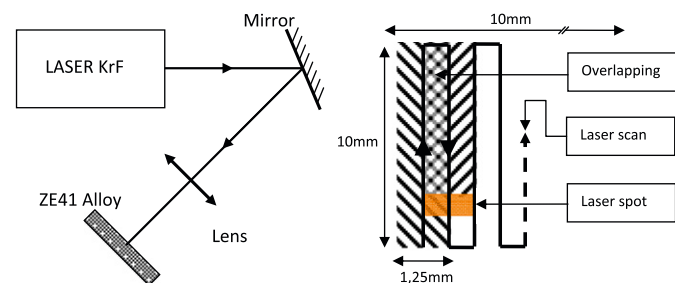
Fig. 1. Schematic diagram of the experimental set-up for laser surface melting of ZE41.

The magnesium specimens were irradiated in atmospheric conditions, without an assisting gas, using a Lambda Physik excimer laser using a KrF gas mixture. The wavelength of the laser was $\lambda = 248 \text{ nm}$ and its pulse duration was $\tau = 20 \text{ ns}$. The energy of each pulse and the repetitive rate of pulses were fixed respectively at $E_p = 100 \text{ mJ}$ and $F = 100 \text{ Hz}$. The laser beam has a rectangular shape with dimensions of $24 \times 10 \text{ mm}^2$. To perform laser surface melting treatment, the laser beam was focused thanks to a planoconvex lens with a focal distance of 130 mm . The LSTM was carried over a $1 \times 1 \text{ cm}^2$ area in a normal incidence by overlapping several melt tracks with a scan speed (V_b) varying between 250 and $50 \mu\text{m s}^{-1}$ and with an overlapping of 50%. (See Fig. 1).

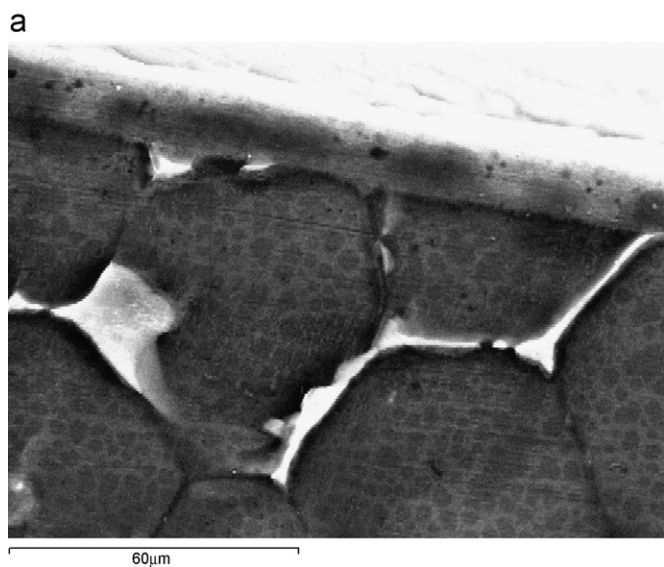
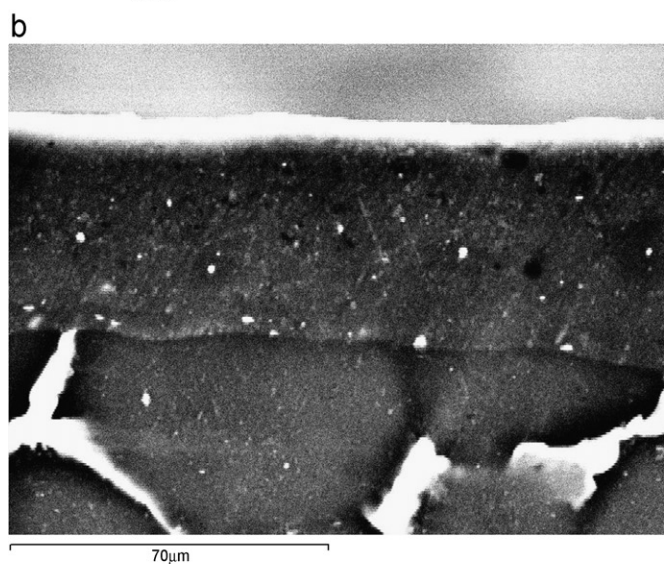
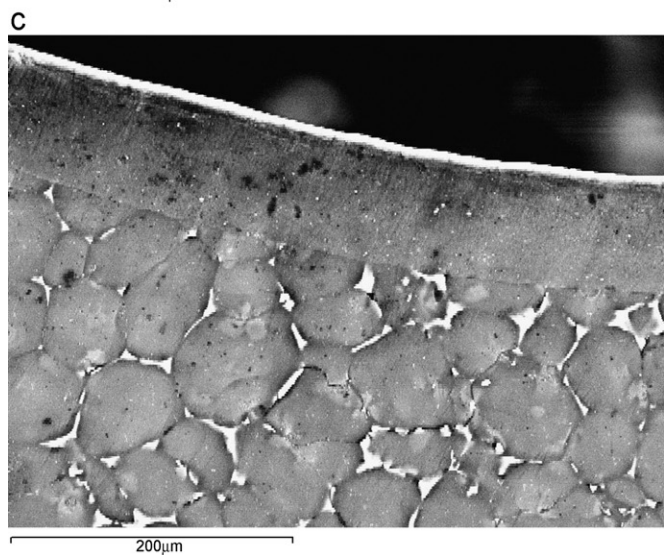
Fig. 2. SEM micrographs of laser-treated surface cross-sections: (a) $V_b = 250 \mu\text{m s}^{-1}$ ($\times 500$), (b) $V_b = 100 \mu\text{m s}^{-1}$ ($\times 500$), (c) $V_b = 50 \mu\text{m s}^{-1}$ ($\times 150$).

The laser surface melting treatments presented below were performed under 100 mJ pulse energy, 100 Hz repetitive pulse rate and a scan speed (V_b) varying between 250 and $50 \mu\text{m s}^{-1}$. Laser surface melting treatments were carried out ten times to ensure their repeatability and to provide enough samples for corrosion and microhardness tests. Fig. 2 shows the transverse section of the ZE41 specimen irradiated respectively at 250 , 100 and $50 \mu\text{m s}^{-1}$ scan speeds. The pictures show two zones: the lower one representing the granular structure of the as-received ZE41 specimen. The higher zone is the melted layer. Several measurements of laser-melted layer depth by image processing prove that the layer depth is uniform for each specimen and it is inversely proportional to scan speed. Fig. 3 shows the evolution of the laser-melted layer depth as function of the scan speed.

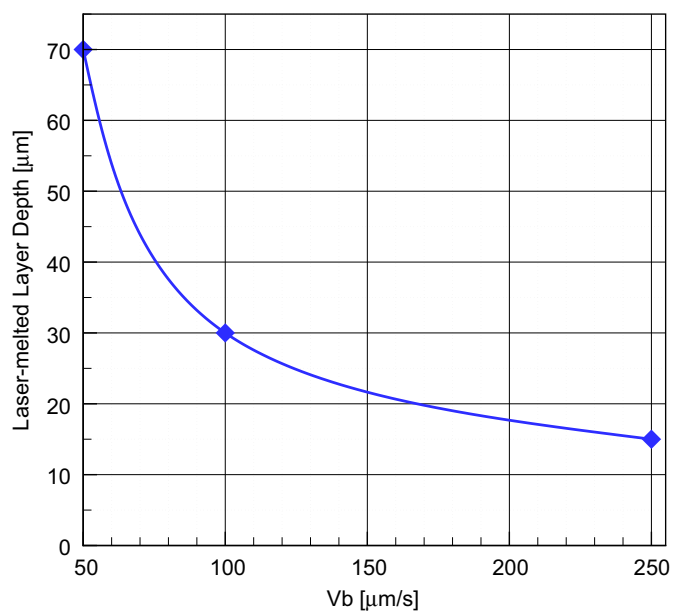
Fig. 3. Evolution of the laser-melted layer depth as function of the scan speed.

The cooling rate of the laser-melted layer plays an important role in microstructure transformations within the material. This cooling rate depends on the laser parameters such as laser energy pulse, laser scan speed, laser frequency and pulse duration. We noted in Section 3 (Fig. 3) the influence of the laser scan speed on the laser-melted layer depth, but SEM observations show that the melted zone has the same microstructure for the different laser scan speeds. The cooling rate of the material also depends on the boundary and initial conditions such as free or forced convection and initial material temperature. If these parameters change so that the cooling rate is slow, then the alloying elements – uniformly dispersed in $\text{Mg } \alpha$ -phase at high temperature – are able to move to grain boundaries during the cooling process, which reduces their effect in enhancing corrosion resistance. For these reasons, we performed laser surface melting treatments on two samples preheated to 373 and 673 K . SEM observations

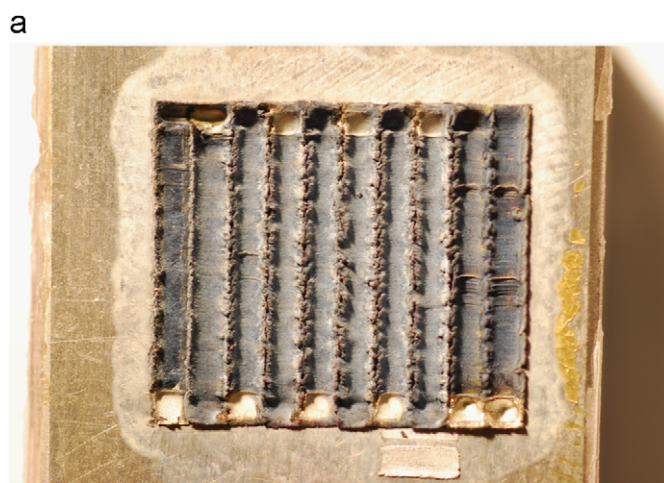
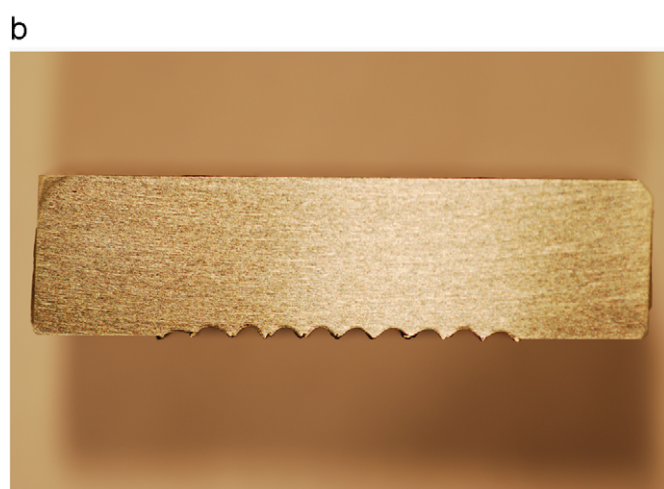
Fig. 4. Morphology of the irradiated surface.

After the laser surface melting treatment, the ZE41 displayed a complex rippled surface morphology. Fig. 4 shows a wavy morphology: a succession of hollows and hills can be seen on the irradiated surface of the ZE41 specimen. Each hollow corresponds to a laser beam track. Such morphology is due to several causes. The first one is loss of material by evaporation caused by the high power density (160 MW cm^{-2}) of the laser beam. This power density is not homogenous within the laser spot; it reaches the maximum at the centre of the beam and decreases whenever we approach the beam border. Therefore evaporation is emphasized at the centre and a hollow is created. In addition, the high power density brought by the laser pulse creates a temperature gradient around the irradiated zone. This temperature gradient induces a gradient of surface-shear stress, which increases with the distance from the irradiated surface. Consequently, the molten material is pushed away from the irradiation centre towards the beam periphery where the surface-shear stress is the highest. During laser surface melting treatment, we noticed a creation of plasma on the magnesium alloy surface. The plasma vapours' pressure drives shock waves and compresses the molten material beneath the incident laser beam, enhancing formation of the wavy topography. The irradiated surface is dark and covered with a white powder which can be wiped off. This white powder comes from ionized gas and metal from the plasma which reacts together and form solid products deposited on the magnesium surface as an extremely thin film. The dark thin layer on the irradiated surface is formed by the oxidation of the very hot laser-melted surface.

As noted in Section 3.1, the laser-melted zone displays a rippled surface morphology with several asperities, especially in laser track borders (Figs. 4 and 5). These asperities can give rise to crevice corrosion [14]. Examining the sample after 24 h of immersion in a 0.5 M NaCl solution, we find that this surface was uniformly corroded. We cannot determine whether crevice corrosion took place or not. In addition, the salt-spray test shows that, after 131 h of exposure, the laser-treated surface is intact, and devoid of any sign of crevice corrosion. Knowing that the later type of corrosion needs an incubation time, after which the corrosion process begins to develop rapidly, this incubation time may be longer than 131 h. Therefore we cannot detect it during the tests performed.

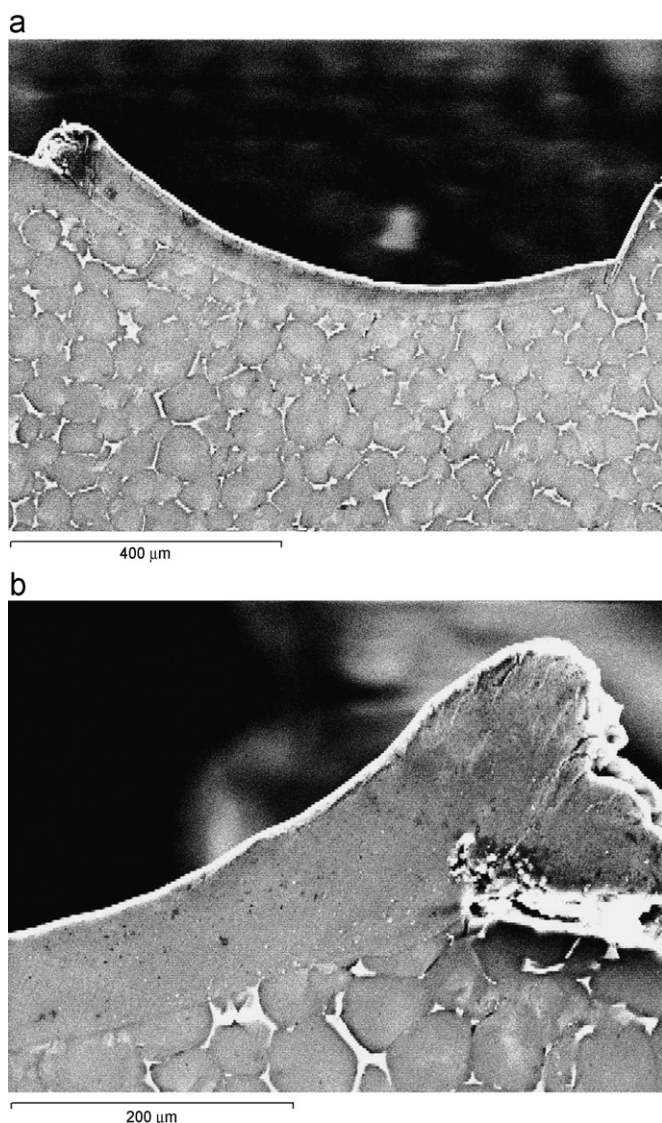
Fig. 5. SEM micrographs of laser-treated surface ZE41 cross-sections, $V_b = 50 \mu\text{m s}^{-1}$.

Fig. 5 shows the transverse section of a ZE41 specimen treated with $E_p = 100 \text{ mJ}$, $F = 100 \text{ Hz}$ and $V_b = 50 \mu\text{m s}^{-1}$. This section was observed by a scanning electron microscopy (SEM) after being mounted, ground to 1200 SiC, polished with diamond suspensions to $0.05 \mu\text{m}$ and finally etched using a 4% nital solution.

As mentioned before, pictures present two zones, the higher one being the laser-melted layer. It has a uniform depth of $70 \mu\text{m}$ ($\text{Max} = 73 \mu\text{m}$, $\text{Min} = 69 \mu\text{m}$). The lower zone represents the structure of the as-received ZE41 specimen. This structure is composed of magnesium grains having an average size of $70 \mu\text{m}$ and surrounded by intermetallic compounds, where alloying elements were held. In the laser-melted layer, we cannot observe a crystalline structure because the crystallites are extremely small. We can notice also that there is no intermediary zone between the laser-melted layer and the granular structure because of the rapid heat exchanges during heating and cooling processes. In fact, a small surface of the magnesium alloy absorbs a quantity of the laser energy in an extremely short

time ($20 \times 10^9 \text{ ns}$). A very thin layer melts and reaches high temperatures, while the surrounding mass of material is steel cold. Hence, the melted zone is subjected to a high cooling rate and there is not enough time for the heat affected zone to be formed.

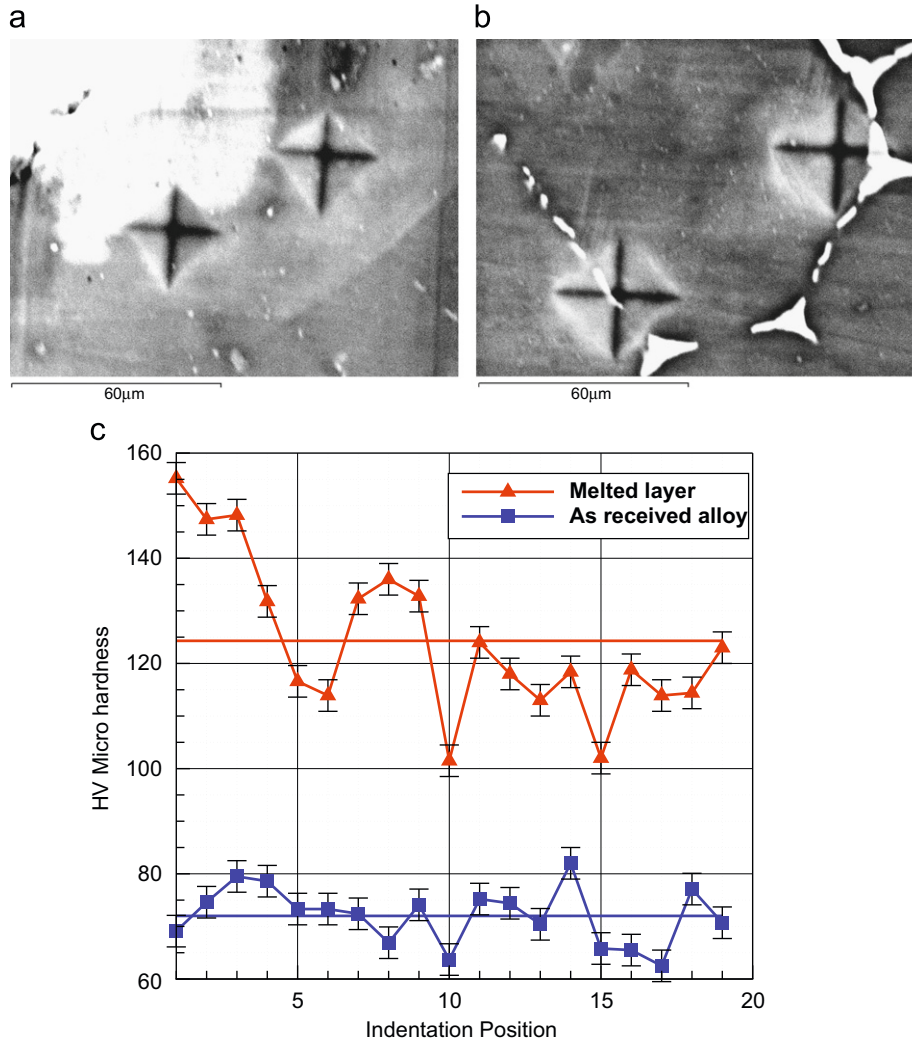
Fig. 6. Microhardness in the ZE41 laser-melted layer and in the substrate.

The microhardness of the treated specimen was measured within a laser and a non-laser-melted zone. These measurements are not taken with respect to the depth of the melted zone because it is too thin ($70 \mu\text{m}$) to perform several indentations on it, but we carried out many measurements along the melted zone in the different laser tracks to see whether microhardness is uniform (see figure). Each indentation is done under a load of 0.49 N during 15 s with a Vickers indenter. Fig. 6 shows the microhardness measurements along the two zones. From this figure it can be observed that the microhardness of the laser-treated magnesium alloy is higher than that of the as-received specimen. The averages of the microhardness values in the laser-melted layer and in the bulk are respectively 124 and

72 HV , these results are confirmed in two other samples treated in the same conditions. The laser surface melting treatment has improved the microhardness of the ZE41 by a factor of about 170% . This improvement may be attributed, in the case of a crystalline material, to the grain refinement of the metallurgic structure and the homogenous distribution of the alloying elements in the magnesium matrix. The formation of new solid phases by precipitation can also increase microhardness. Whether the melted layer is amorphous, this non-ordered material can acquire better mechanical properties such as hardening.

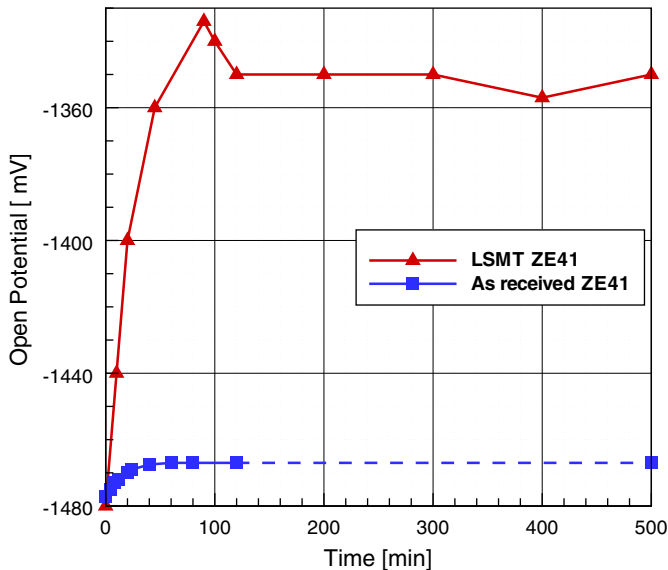
Fig. 7. Evolution of open-circuit potentials of LSM and as-received ZE41 alloy during immersion in 0.5 M NaCl solution of pH 10 at 293 K.

Fig. 7 shows open-circuit corrosion potentials for the as-received ZE41 and its laser-modified surface. This test was performed twice in a 0.5 M NaCl solution at $\text{pH}=10$ and 293 K . The open circuit potentials were recorded continuously for 24 h of immersion using a saturated calomel reference electrode. Comparing the two curves (Fig. 7), we can notice that the corrosion potentials of the alloy were increased by laser surface melting treatment by up to 117 mV after 24 h . Therefore, the laser-treated alloy became nobler than the untreated one [12]. This improvement in the corrosion resistance is confirmed twice by salt-spray tests carried out with respect to the ASTM B 117-97 standard. As shown in Fig. 8, a ZE41 specimen – presenting a $10 \times 10 \text{ mm}^2$ laser-treated surface and a similar untreated surface – is exposed to a KCl salt spray (5 mass\% KCl solution, $\text{pH}=6.9$) in a closed chamber maintained at 35°C . After two hours of salt-spray exposure, several corrosion pits are observed in the untreated surface while the laser-treated layer is unaltered. Fig. 8 shows a completely corroded as-received alloy after 131 h of KCl spray exposure, although the treated surface is still intact. This better resistance to corrosion can be attributed to the microstructure transformations, due to rapid cooling of the laser-melted alloy [13]. These transformations lead to non-equilibrium microstructures which are more resistant to corrosion. The alloying elements added to the magnesium α -phase matrix improve the resistance corrosion of the ZE41 alloy. In equilibrium microstructures, these elements are localized in grain boundaries because of their low solubility in the $\text{Mg } \alpha$ -phase. However, at high temperature, these alloying elements are more soluble in Mg and with a rapid cooling of the melted material, they are caught in the magnesium α -phase which increases the concentrations of alloying element in the α -solid solution and makes them much more efficient for corrosion protection of a ZE41 alloy. In addition, LSMT resulted in significant refinement of the granular microstructure due to the rapid cooling of the melted material producing therefore a more uniform distribution of the rare earth elements.

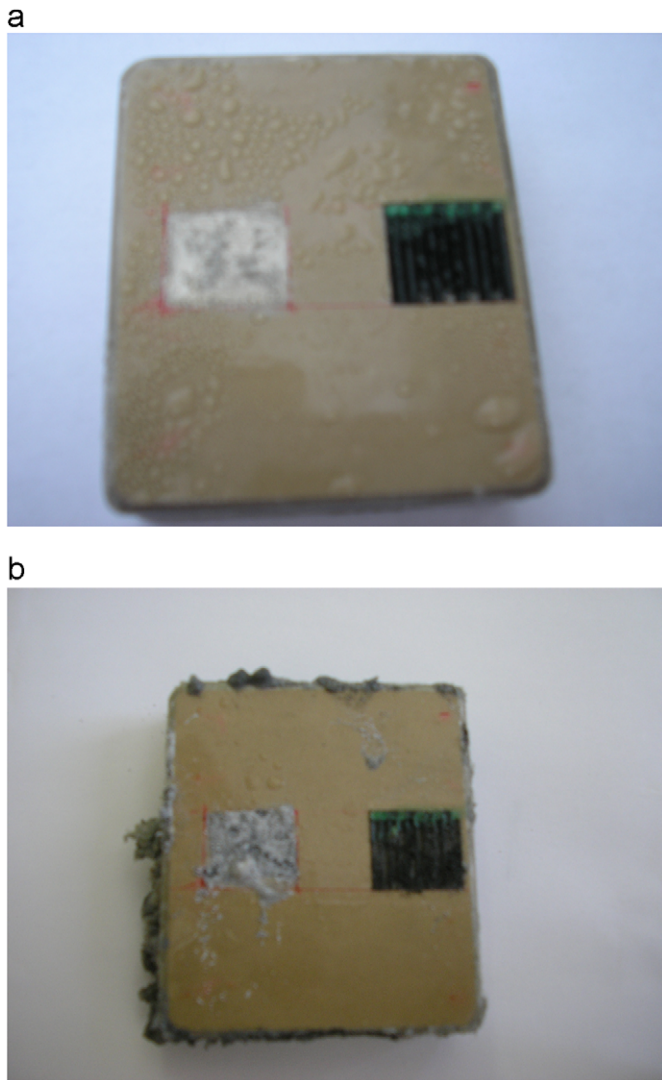
Fig. 8. Evolution of the corrosion in a salt-spray room of a LSMT and an as-received ZE41 alloy: (a) after 2 h of exposure and (b) after 131 h.
